Service Bulletin

Bulletin No.: 22-NA-008

Subject: Malfunction Indicator Lamp (MIL) Illuminated, Reduced Engine Power Message on Drivers Information Center (DIC) - DTCs U060F, U1346, P0101, P0102, P1101 and/or P14B6 Set

Brand:	Model:	Model Year:		VIN:		Engine:	Transmission:
		from	to	from	to		
Buick	Encore GX	2020	2022	SOP	KL4MMDS2XPB000138		
Chevrolet	Trailblazer (VIN M)	2021

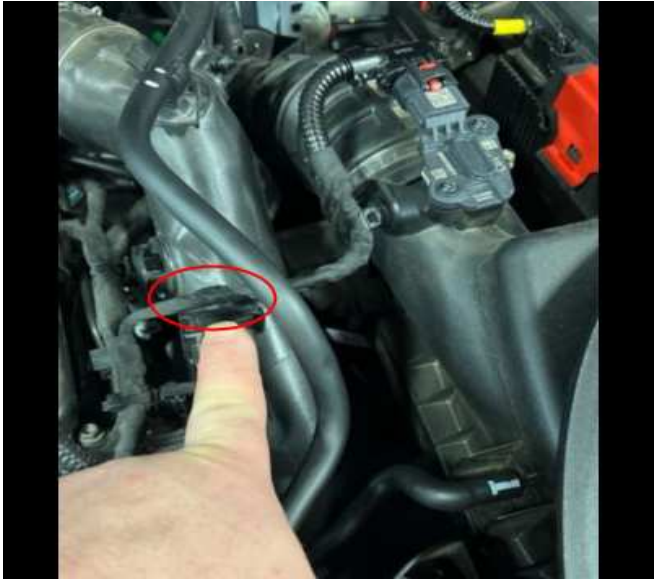
Involved Region or Country	North America
Condition	<p>Some customers may comment on one or more of the following conditions:</p> <ul style="list-style-type: none"> • MIL illuminated • Reduced Power displayed on DIC <p>Some technicians may find one or more of the following DTCs set:</p> <ul style="list-style-type: none"> • U060F • U1346 • P0101 • P0102 • P1101 • P14B6
Cause	<p>This condition may be caused by a possible broken wire in the harness in circuits 492 of the multifunction sensor.</p> <div style="text-align: center;">

</div> <p style="text-align: right; font-size: small;">5956039</p> <p>– The zip tie at the retainer may be pulled too tight and when the harness flexes on accelerations the wire can break at the zip tie.</p>

Correction	<p>Inspect the 2nd retainer back from the MAF sensor with the engine running. If the zip tie is too tight the wire may break at the zip tie during acceleration:</p> <p>⇒ Wiggle or pull on the harness to induce and identify a break inside the harness.</p> <p>⇒ Repair circuit using published wire to wire repair for the MULTIFUNCTION INTAKE AIR SENSOR (MAF SENSOR).</p> <p>⇒ Rewrap the wiring harness as required.</p>
-------------------	--
