Service Campaign S7646

May 2022

Mack MMD Steering Column Bracket Hardware

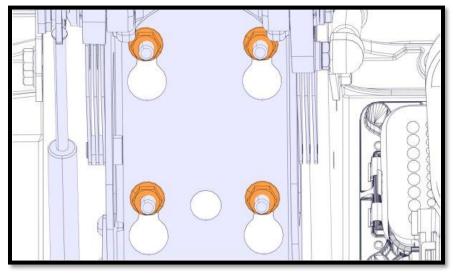
10.Inspect the four steering column mounting nuts for proper installation, followed by checking their relaxed torque.

If the nuts move when checking at 9Nm (relaxed torque), STOP! Take pictures, email the reliability group (below information) at <u>reliability@volvo.com</u> and wait for further instructions.

Relaxed Torque Check	
Steering column, nut	9Nm (6.5 ft-lb)

11. Using a torque wrench, extension, and 13mm socket check relaxed torque on the four nuts.

- VIN
- Milage/HRs
- Pictures
- Service tech contact information
- 12. If the nuts do not move at 9Nm (relaxed torque) loosen the four mounting screws and retorque hardware to spec.

Tightening torque	
Steering column, nut	24 ±4 Nm (17±3 ft-lb)
