Service Bulletin

Bulletin No.: 22-NA-117

Subject: Information on Driver Side Outside Rearview Mirror (OSRVM) Image Distortion, Mirror Glass Appears Distorted, Blurry or Wavy

Brand:	Model:	Model Year:		VIN:		Engine:	Transmission:
		from	to	from	to	Engine.	ITAIISIIIISSIOII.
Chevrolet	Spark	2021	2022	_	_	All	All

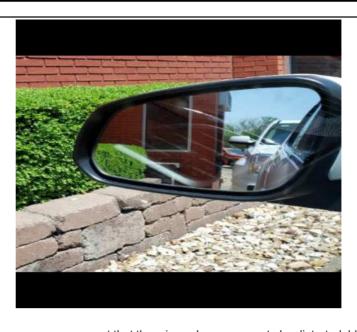
6083507

Some customers may comment that the mirror glass appears to be distorted, blurry, or wavy.

The cause of the condition may be that when viewed in full sunlight, the mirror appears to be blurry or wavy. The distortion is actually a reflection of the left side I/P vent onto the driver's side glass, as reflected in the mirror.
