## AHM Support

## miniMoto / Sport

Editor: Trevor Blackburn E-mail *The Wrench* at: [EditorTheWrench@ahm.honda.com](mailto:EditorTheWrench@ahm.honda.com)

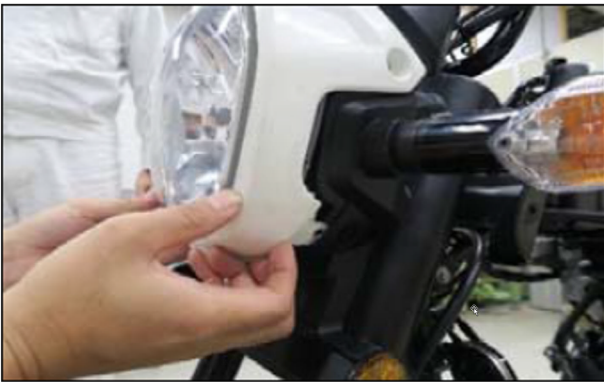
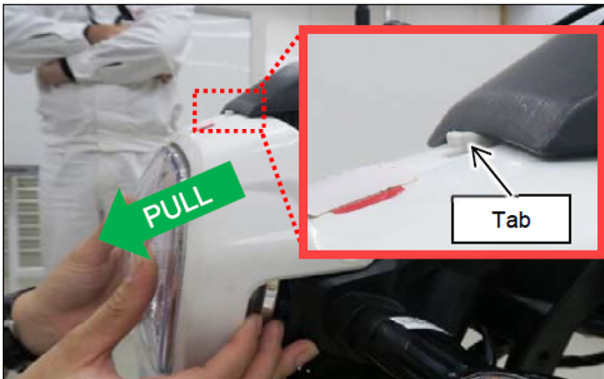
### Meter Cover/Headlight Removal (NVA110 '22)

To prevent breaking the meter cover tab:

- Remove the meter cover before removing the headlight.
- Remove the four bolts from the left and right sides of the headlight assembly.
- Pull the lower part of the headlight outward slightly, then release the tab that secures the meter cover to the headlight assembly and pull the assembly straight out.

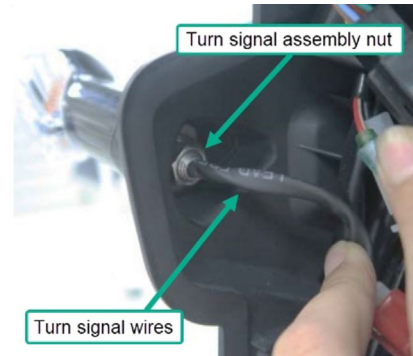
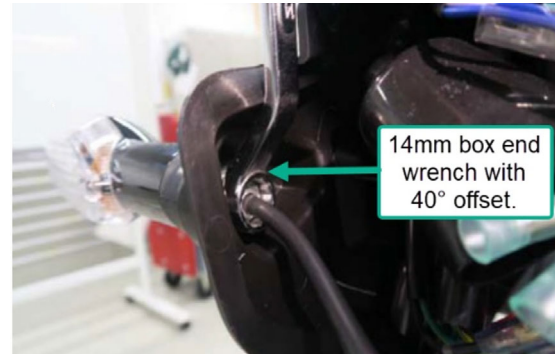
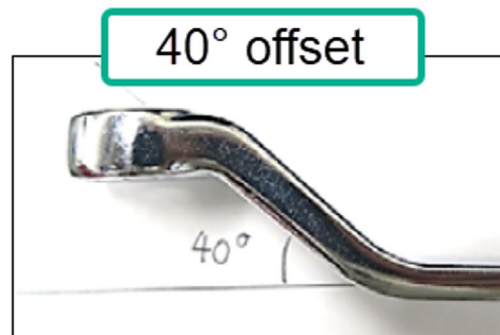
### Front Turn Signal Removal (NVA110 '22)

The nut securing the front turn signal is recessed into the cowl and is difficult to access. After removing the headlight assembly, disconnect the turn signal sub-harness and pass it through a 14mm box end wrench with an offset of 40°. The wrench offset will allow access to the turn signal nut.

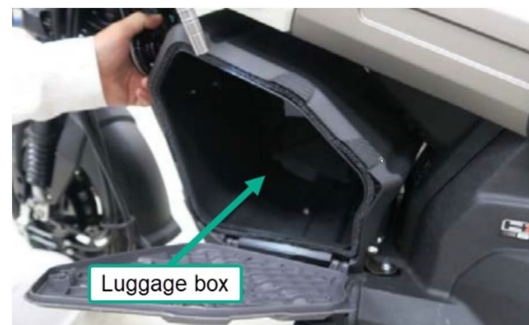
### Luggage Box (NVA110 '22)

The luggage box is not entirely watertight. Water may enter the luggage box when ridden in the rain or during washing. Advise your customers to protect any valuables or electronics when stored.

**NOTE:** Do not use high-pressure water or aim water directly at the luggage box.

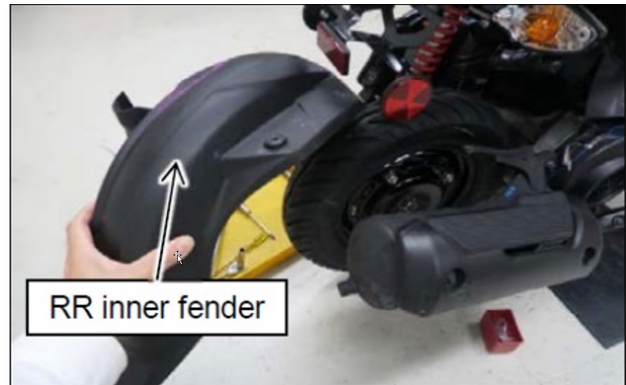
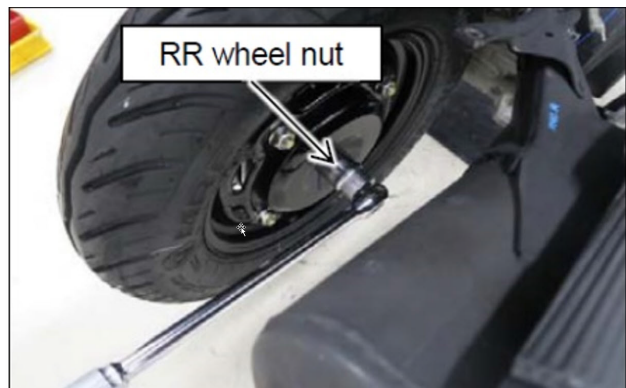
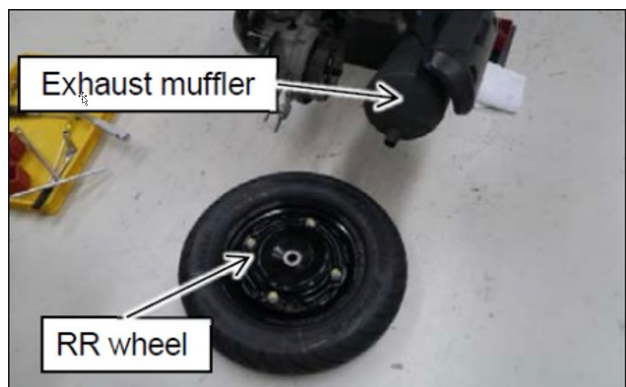
## Rear Wheel Removal (NVA110 '22)

The rear wheel can be removed without removing the muffler. Remove the inner fender, then loosen the rear axle nut.

**NOTE:** Make sure the muffler is cool to the touch before removal.

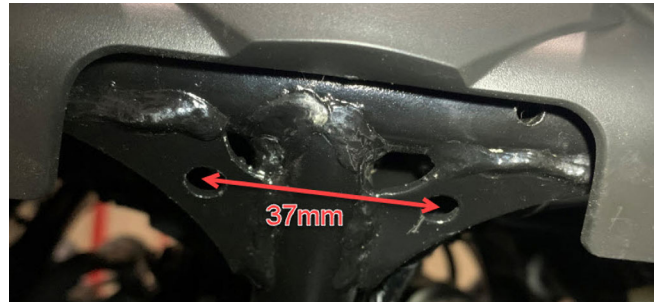
### Accessory Light Bar Installation (NC750X/D - '21 and Newer)

When installing the NC750X/D accessory light bar (p/n 08A70-MJL-D30 or p/n 08A70-MGS-D30), ensure the front cowl stay holes are drilled in the correct position. The distance between the two mounting holes should be 37mm. If the mounting holes are less than 37mm, the front cowl stay (p/n 08A70-MJL-D30 or p/n 08A70-MGS-D30) will need to be replaced to install the accessory light bar. If the front cowl is in need of replacement, use the standard parts ordering system and file a regular warranty claim.

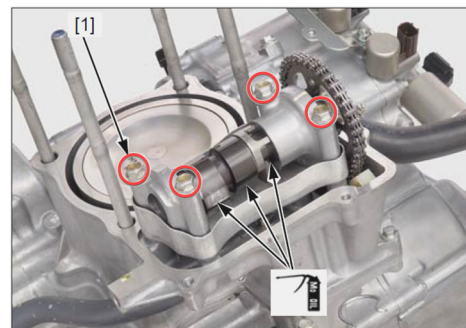
### Cam Holder B Torque Value Specification Change (SXS700M2/M4 - All Year Models)

If cam holder B is over-torqued during installation, potential damage could occur to the camshaft bearing. Should you encounter a situation where a repair necessitates removing and reinstalling the camshaft (p/n 14100-HL3-A40) and cam holder B (p/n 12210-HN8-A60), the tightening torque applied to the 6x65 flange bolts is now 11 N·m. The reduction in torque is to prevent damage to the cam holder bearing.

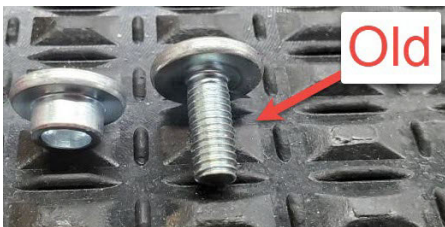
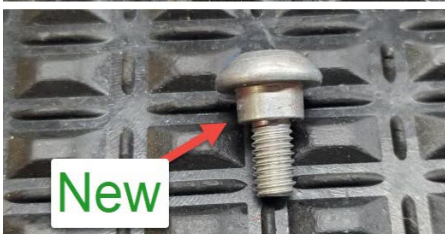
## Air Box Set Screw (SXS1000M/S Pioneer '16-'22 and Talon '19-'22)

The original set screw, p/n 17216-HL4-A00, is no longer available. Please order p/n 90102-HL4-AK0 should you need to replace it.

**IMPORTANT:** To install the new set screw correctly, you must remove the collar from the hole you wish to replace with the new screw. Proper torque will not be achieved if the collar is not removed from the set screw hole. Leaving the collar in place could also lead to stripped threads in the lower half captured nut.

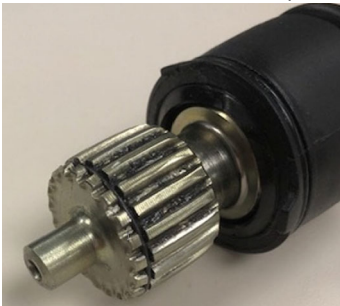
### Front Final Drive Squealing (TRX420/520 - All SXS700 - All)

**2WD / 4WD:** The noise in both 2WD and 4WD models is likely due to the lack of grease in the pinion seal. Apply waterproof grease to the seal to eliminate the squealing.

**2WD Only:** Likely due to the lack of moly grease at the front tip of the prop shaft. Apply grease to the front of the shaft to eliminate the squealing.

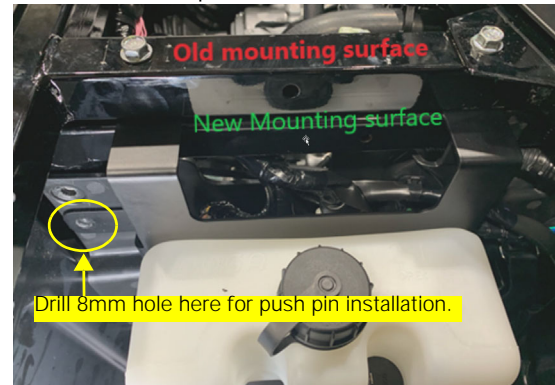
### Windshield Wiper Washer Kit: P/N 0SE10-HL4-A00 (SXS1000M - '22)

The current installation location of the washer tank bracket will cause interference between the washer tank and the seat bottom. The NEW mounting loca-

tion will not interfere with the seat but requires drilling an 8mm hole to complete the bracket installation. You need Honda push pin (p/n 90653-HC4-900) to place in the newly drilled hole.

**Note:** If necessary, loosen the right side seat frame mounting bolts and use a small pry bar between the seat frame rails to allow clearance to install the washer bracket in place.

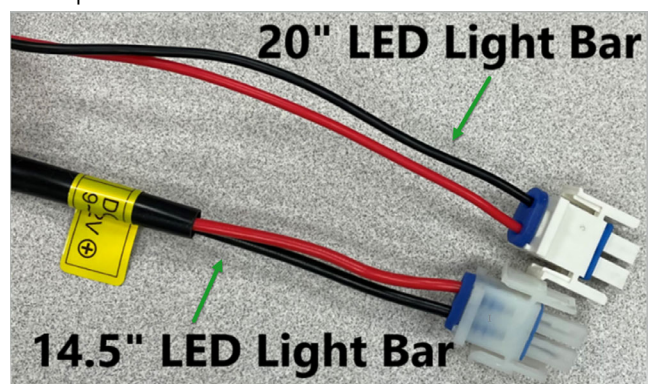
### 20" LED Light bar: P/N OSV31-HL4-A00 (SXS1000M -'21 and prior, SXS700/520/500 -'22 and prior)

If you install the new 20" LED light bar and it does not turn on, the polarities could be reversed.

- Remove the pins and reverse the polarity in the light bar connector. (See image below).
- Or, contact *TechLine* to request the service part adapter.
