## Particulate Matter (PM) Sensor Troubleshooting Guide - US14+OBD16 And Newer Emissions

# SCR Fittings, One Box, Replacement

# Exhaust Particulate Sensor, Repair

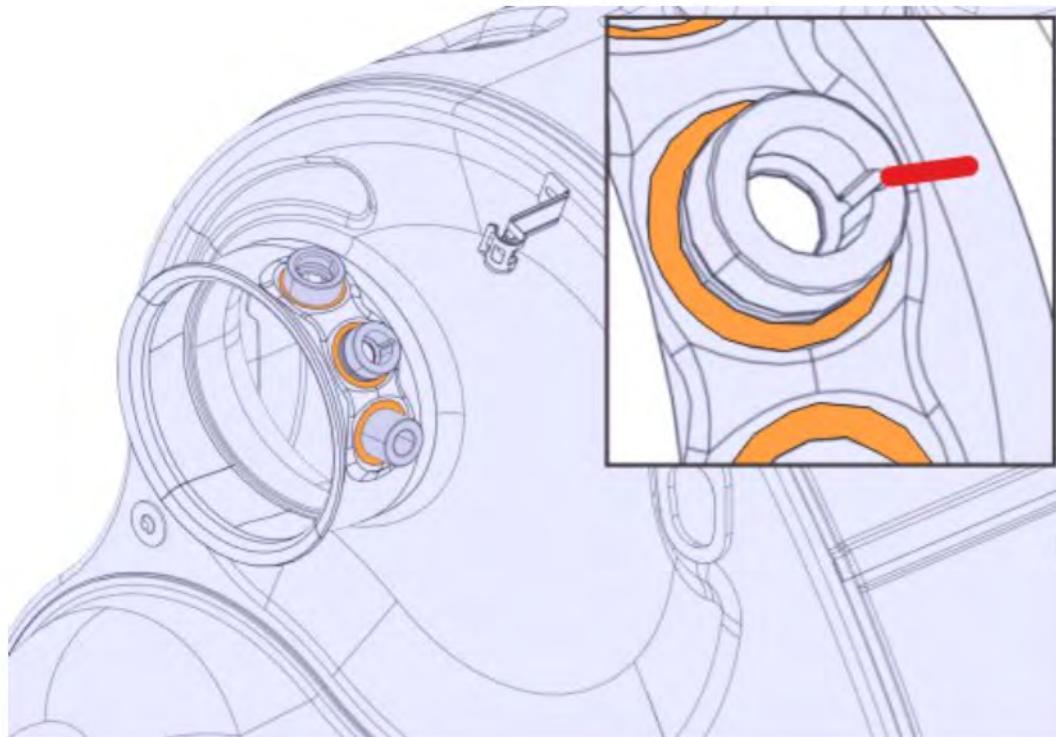
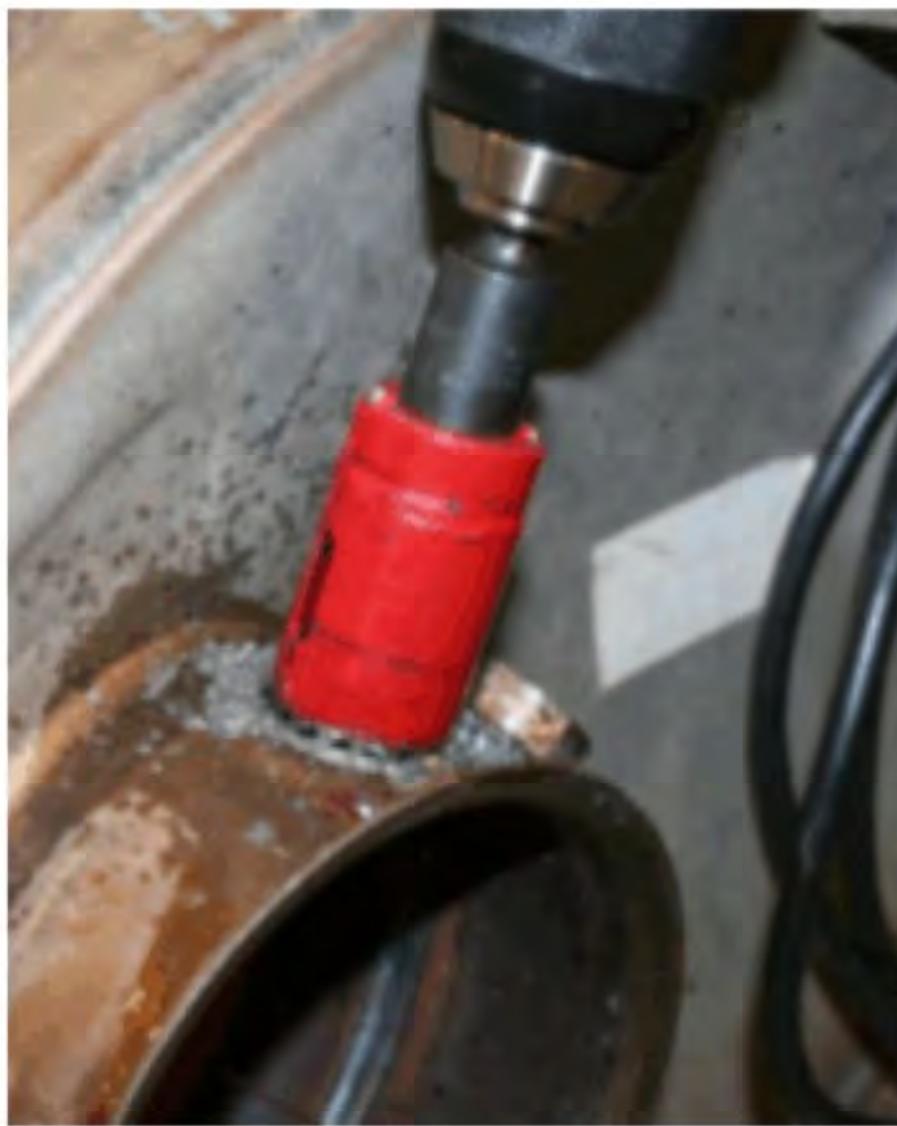
**Note:** If the PM sensor boss is damaged as shown in the illustration mark the position of sensor boss notch before removing the boss welding. The notch of PM sensor boss is always set in the 3'o clock position.

**Note:** When removing the sensor boss weld, check the depth frequently to prevent the damaged sensor boss from falling inside the aftertreatment muffler. Also ensure that the notch mark is not removed.

1. Remove the damaged boss welding.

**2. Remove the damaged boss/bosses (Temperature/NOx/PM sensors).**

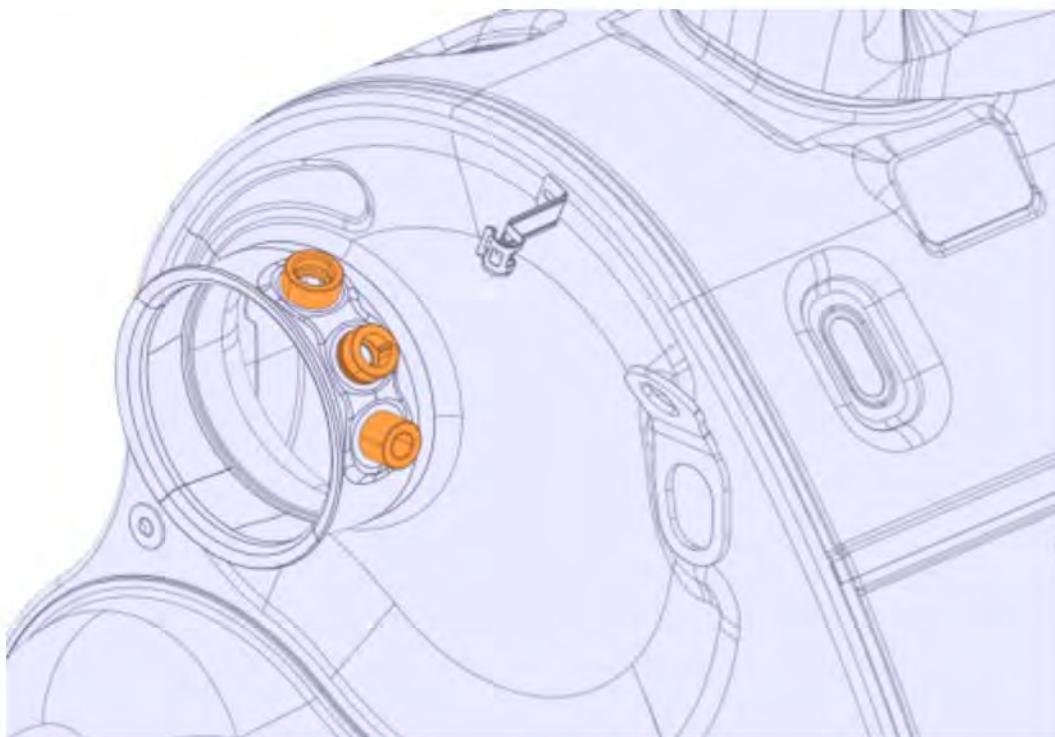
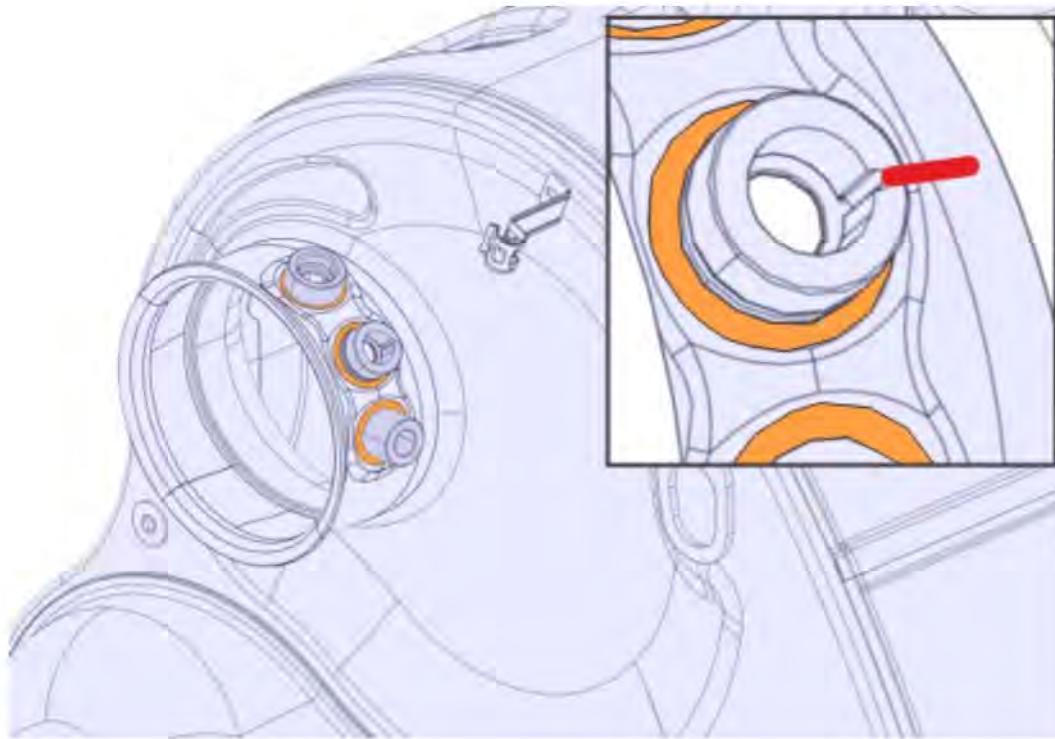
Note: When replacing the PM sensor boss, position the notch of new boss as marked. The notch of PM sensor boss is always set in the 3'o clock position.

5. Install the new sensor boss and perform the welding.

6. Tack weld the sensor boss, complete the weld around the boss.

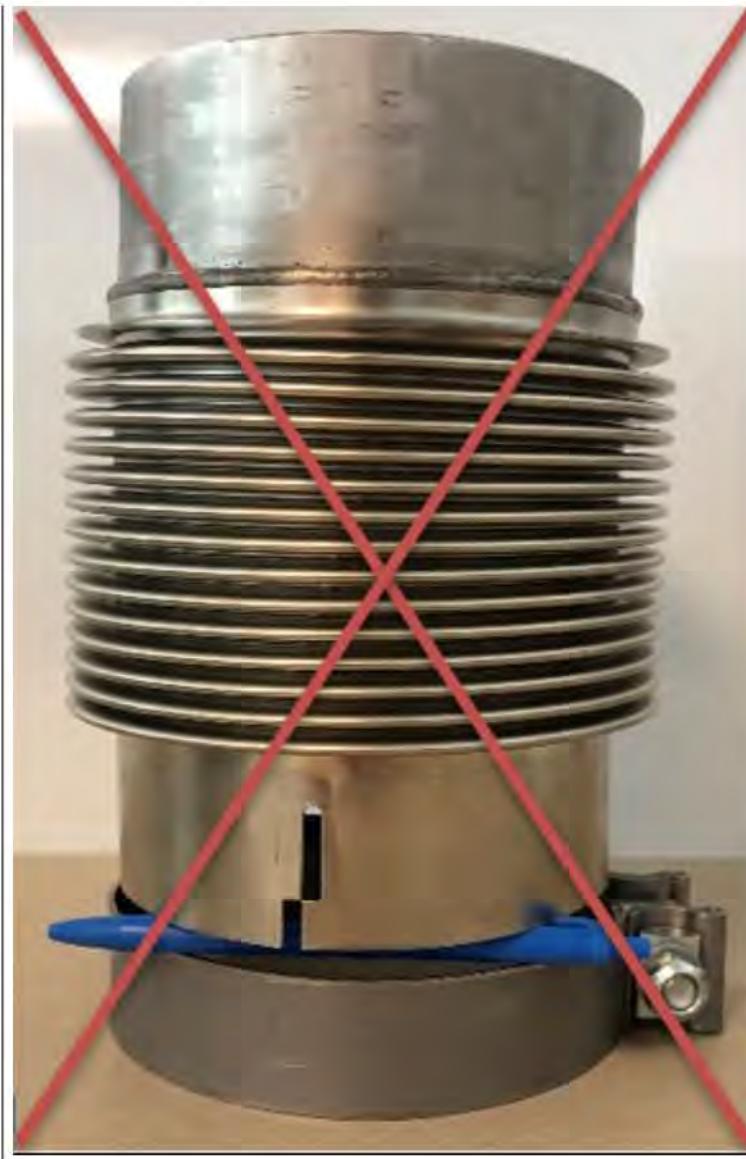
<p><b>Scenario 1</b></p> <p>This style Flex Pipe and Clamp will no longer work with the upper adjacent connecting pipe. The below parts in scenario 2 are required to perform this FSB.</p> <p>Follow the repair below that is applicable for your configuration.</p>
--	---

Determine which Flex Pipe and Clamp the truck currently has installed on it. If the truck you are repairing has the Flex Pipe and Clamp shown in scenario 1, you will need to order the improved Flex Pipe (P/N 21142254) and Clamp (P/N 25172497). If the truck you are repairing has the Flex Pipe and Clamp shown in scenario 2, this truck already has the improved parts and ordering a new Flex Pipe and Clamp is NOT required.

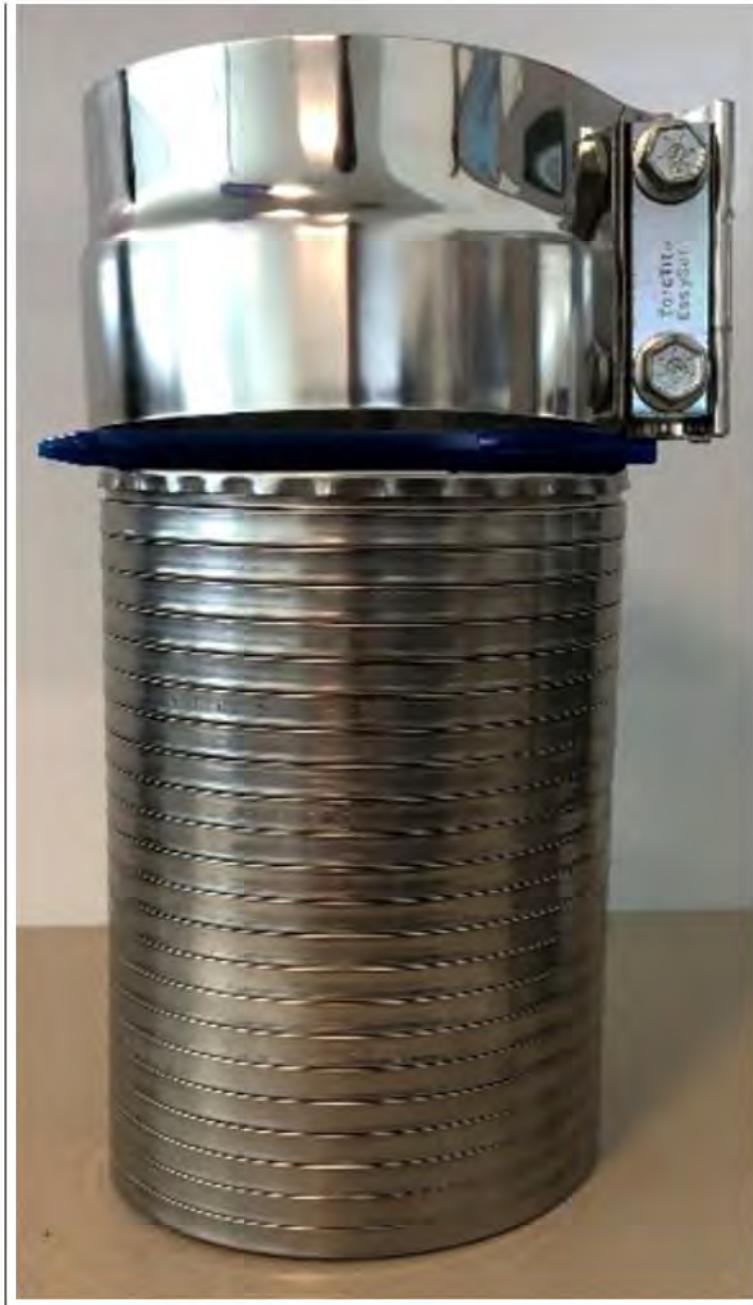
This style Flex Pipe and Clamp only needs the upper adjacent pipe replaced. Reuse the existing Flex Pipe and Clamp, or order as needed.

Flex Pipe –  
21142254

Clamp –  
25172497

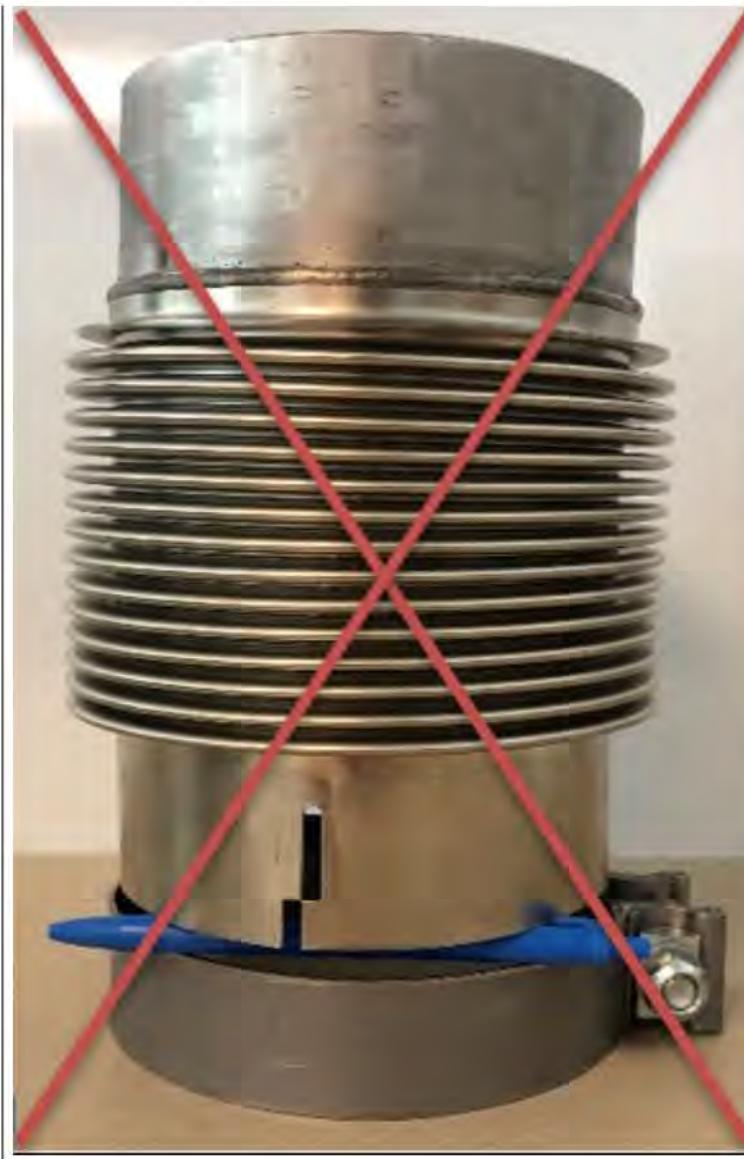
Scenario 1  This style Flex Pipe and Clamp will no longer
--	--

work with the upper adjacent connecting pipe. The below parts in scenario 2 are required to perform this FSB.

Determine which Flex Pipe and Clamp the truck currently has installed on it. If the truck you are repairing has the Flex Pipe and Clamp shown in scenario 1, you will need to order the improved Flex Pipe (P/N 21142254) and Clamp (P/N 25172497). If the truck you are repairing has the Flex Pipe and Clamp shown in scenario 2 or 3, this truck already has the improved parts and ordering a new Flex Pipe and Clamp is NOT required.

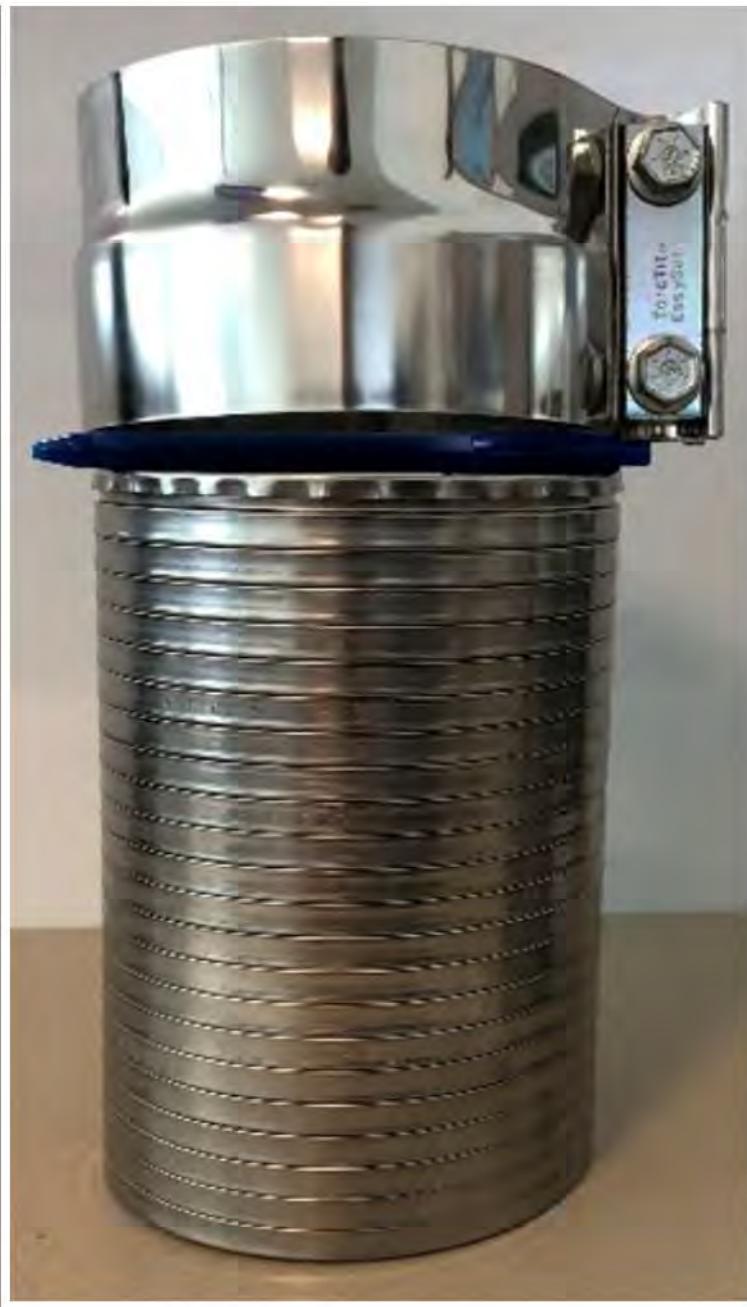
**Scenario 2**  
This style Flex Pipe and Clamp only needs the upper adjacent pipe replaced. Reuse the existing Flex Pipe and Clamp, or order as needed.

Flex Pipe – 21142254

Clamp – 25172497

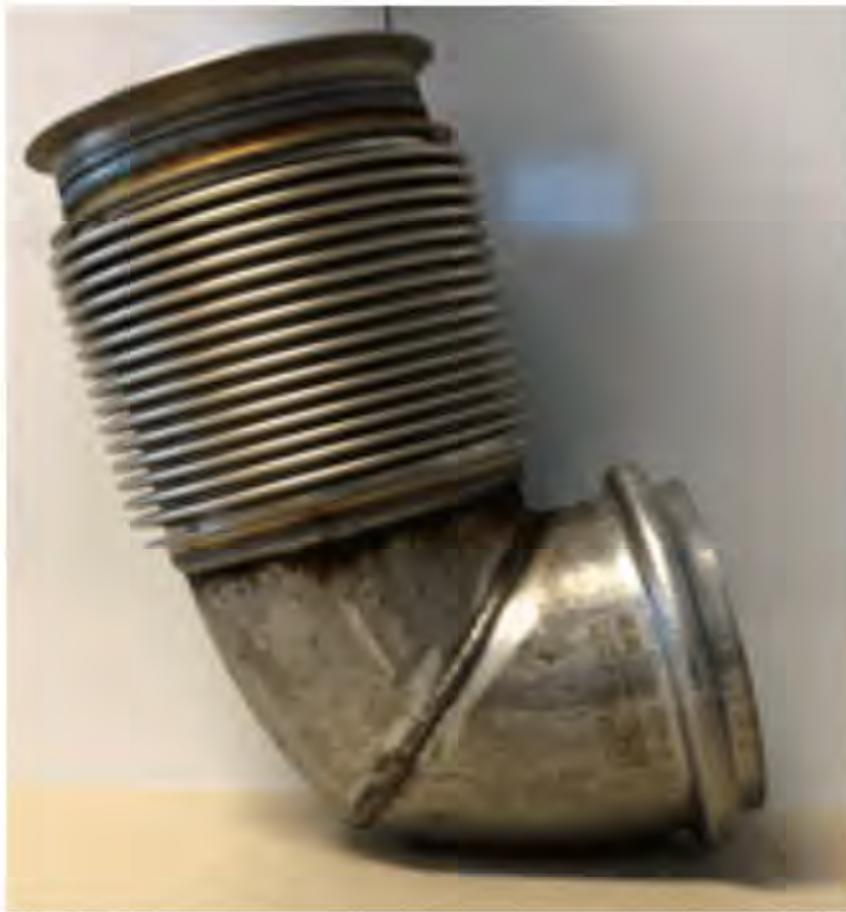
#### Scenario 3

This style Flex Pipe and Clamp only needs the upper adjacent pipe replaced. Reuse the existing Flex Pipe and Clamp, or order as needed.
