TECHNICAL SERVICE BULLETIN

Classification: EL20-039A	Reference: NTB20-085A	Date: April 21, 2022
------------------------------	--------------------------	-------------------------

TELEMATICS CONTROL UNIT RESET AFTER AUTOMATIC COLLISION NOTIFICATION

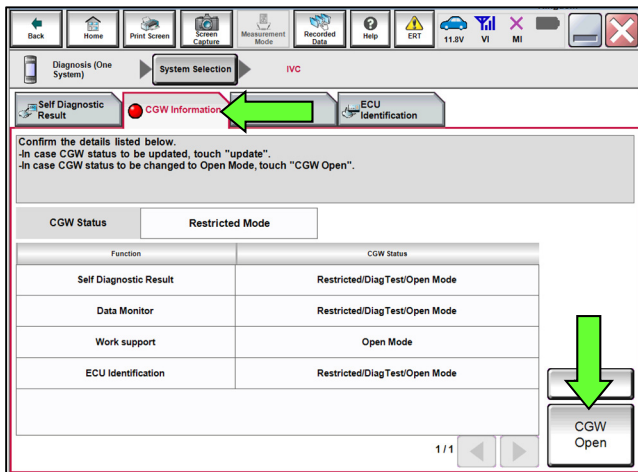
Figure 3

- If there is a red indicator next to **CGW Information** (Figure 3), select **CGW Open**, follow the login instructions (Figure 4), and then proceed to Step 7.
- If there is a green indicator next to **CGW Information**, proceed to Step 7.
