# TECHNICAL SERVICE BULLETIN

Classification: AN22-006	Reference: NTB22-027	Date: April 12, 2022
-----------------------------	-------------------------	-------------------------

## B2E01-96 (INTERNAL BATTERY) DTC STORED AS CURRENT IN IVC

**APPLIED VEHICLES:** 2021-2022 Armada (Y62) – All  
2021-2022 Rogue (T33) – SV, SL, PLT  
2022 Pathfinder (R53) – SV, SL, PLT  
2021-2022 Sentra (B18) – SR w/premium  
2021-2022 Kicks (P15) – SR w/premium  
2020-2022 Titan (A61) – SV, SL, PRO-4X, PLT  
2021-2022 Maxima (A36) – All  
2022 Frontier (D41) – Pro-4X/X

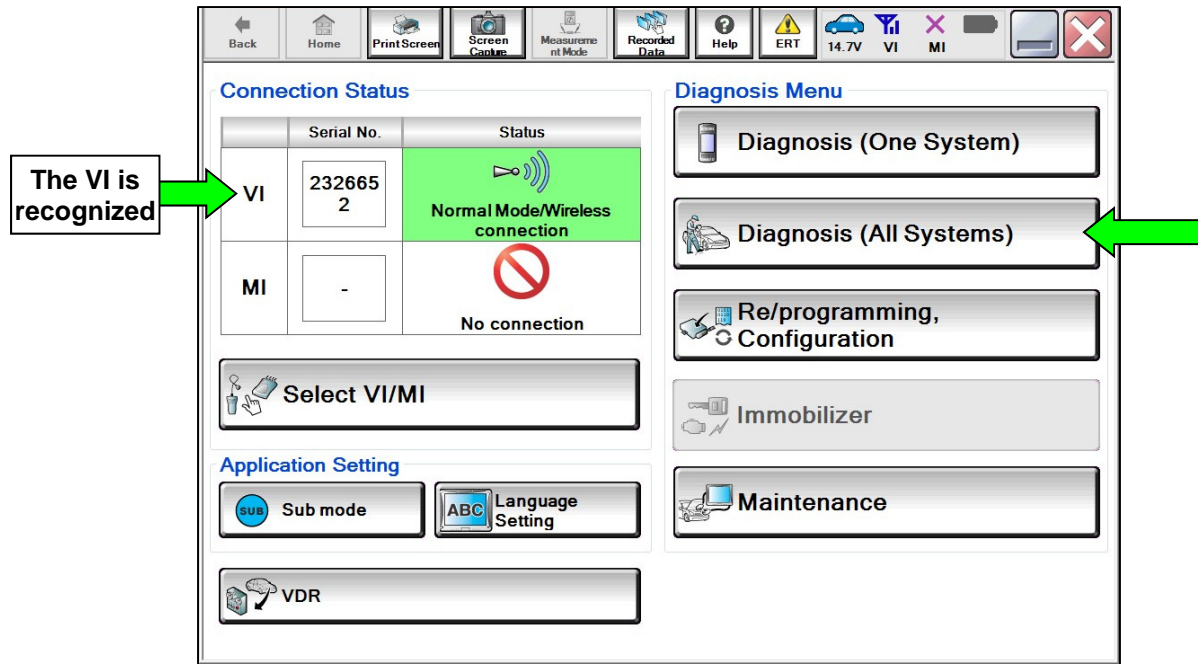
Figure 1

1. Connect a battery maintainer/smart charger to the vehicle.
2. Turn the ignition ON.
3. Connect the VI to the vehicle.
4. Start CONSULT-III.
5. Wait for the VI to be recognized.
  - The serial number will display when the VI is recognized (Figure 1 on page 3).

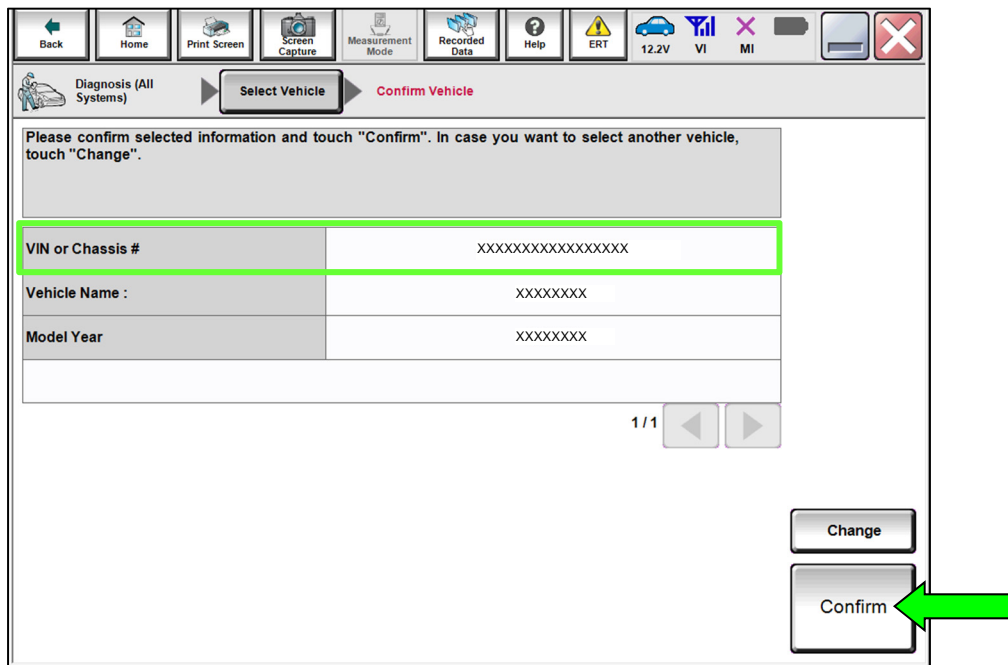
Figure 2

7. Verify the correct **VIN or Chassis #** is populated (Figure 2).

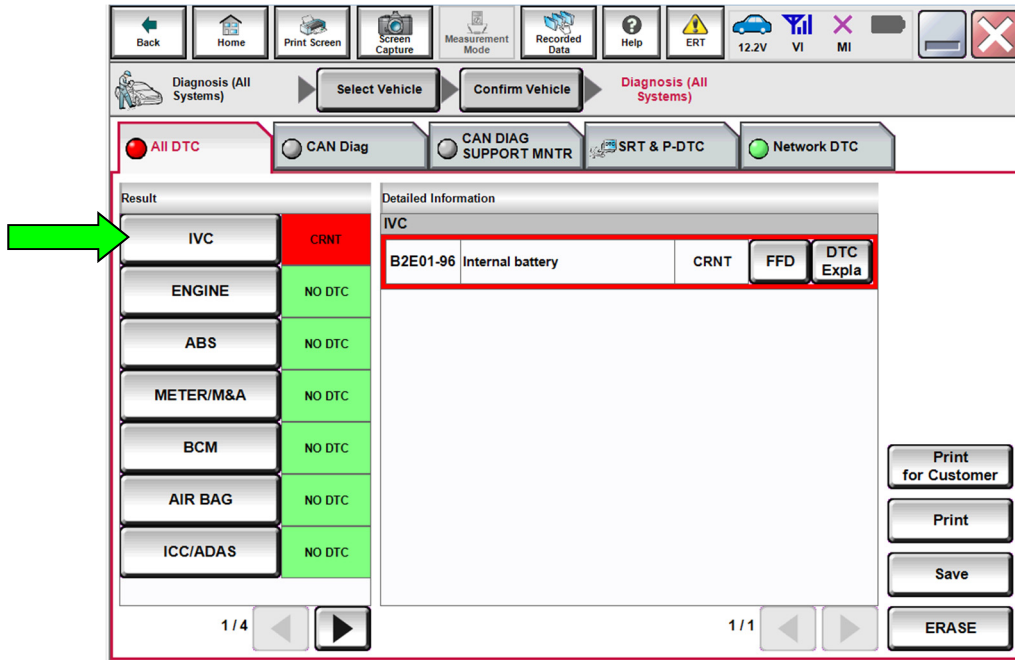
Figure 3

9. Confirm that DTC B2E01-96 for Internal battery is “CRNT” in the **IVC**.
  - If only DTC B2E01-96 is present, select **IVC** (Figure 3) and then proceed to step 10.
  - If additional DTCs, other than B2E01-96, are present in the **IVC**, refer to the ESM for further diagnostic information and repair first, and then proceed to step 10.

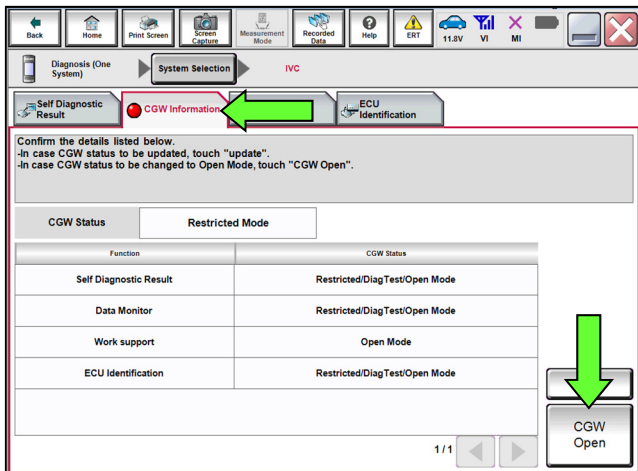
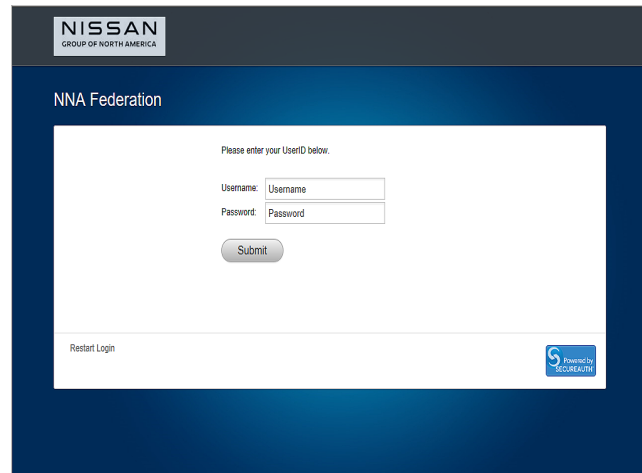
10. Select **CGW Information**.
  - If there is a red indicator next to **CGW Information** (Figure 4), select **CGW Open**, follow the NNA net instructions (Figure 5), and then proceed to step 11 on page 5.
  - If there is a green indicator next to **CGW Information**, proceed to step 11 on page 5.

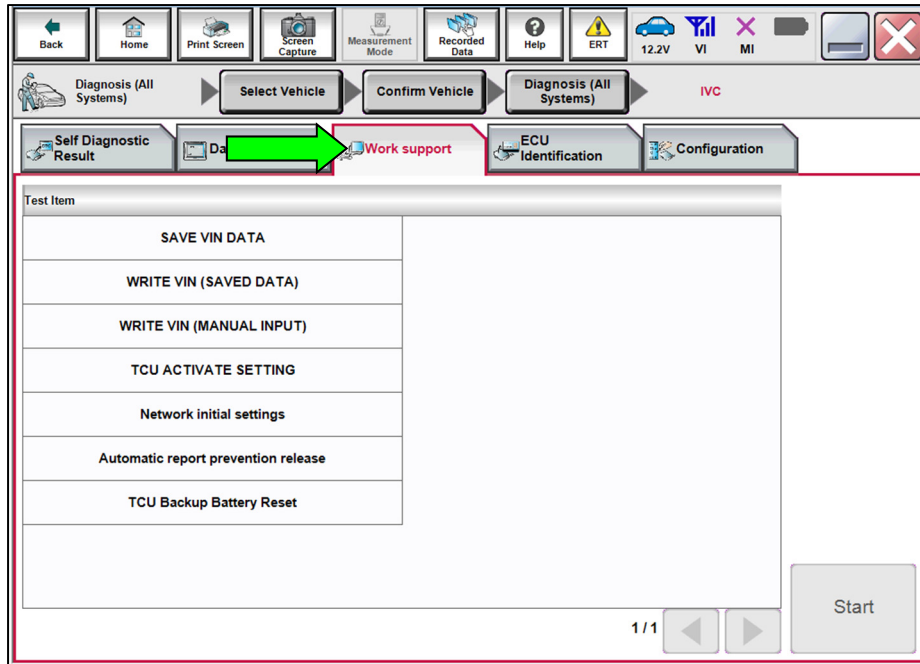
Figure 6

11. Select **Work support**.

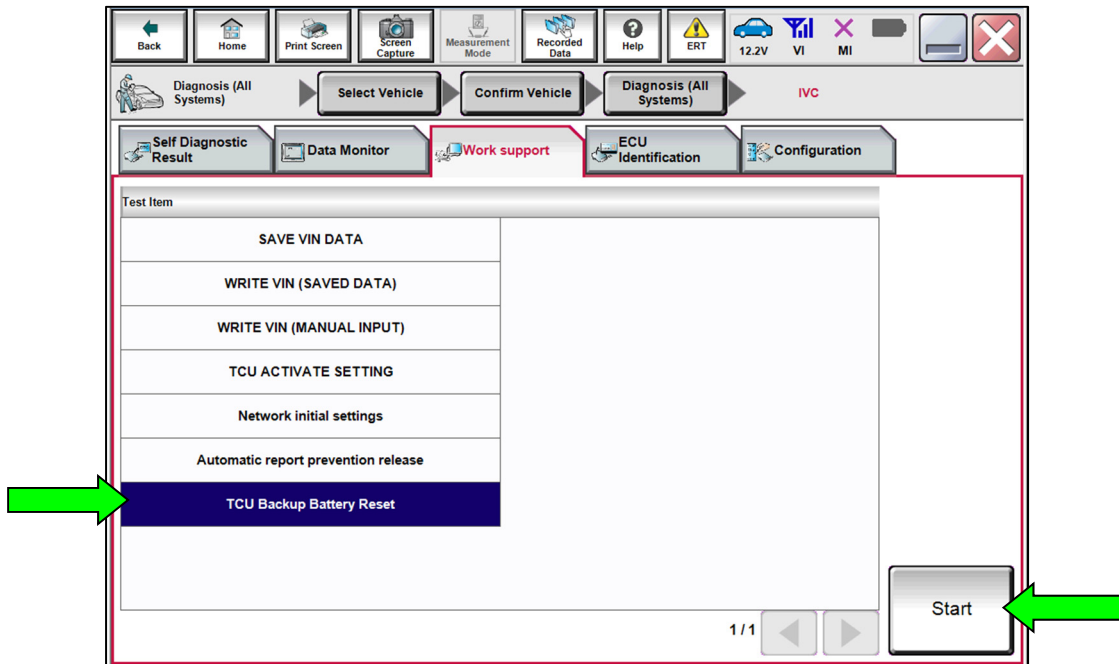
Figure 7

12. Select **TCU Backup Battery Reset**, and then select **Start**.

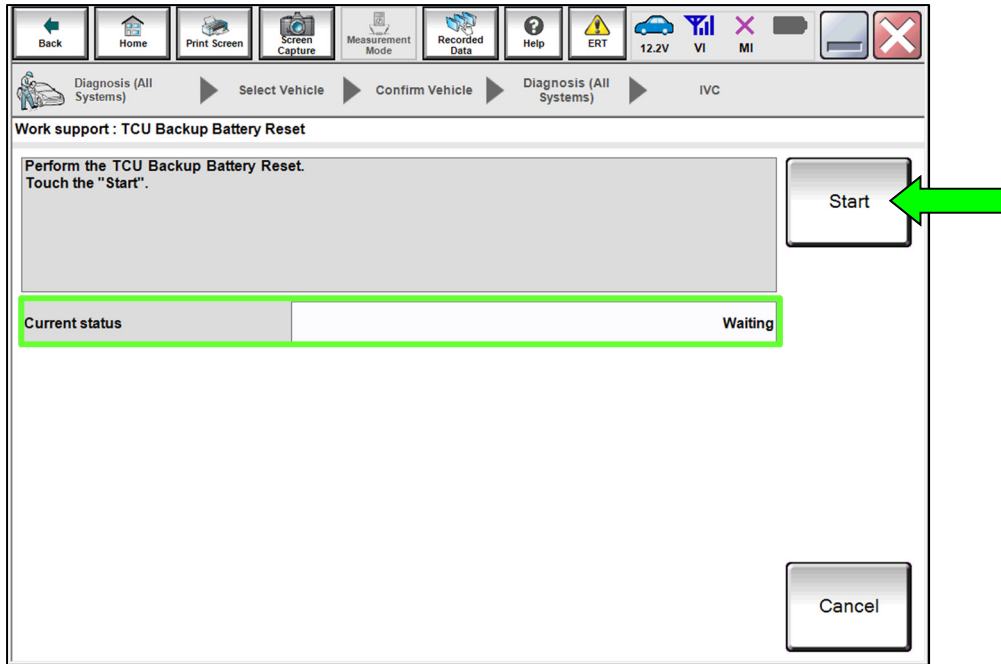
Figure 8

13. Verify that the **Current status** indicates “Waiting”, and then select **Start**.

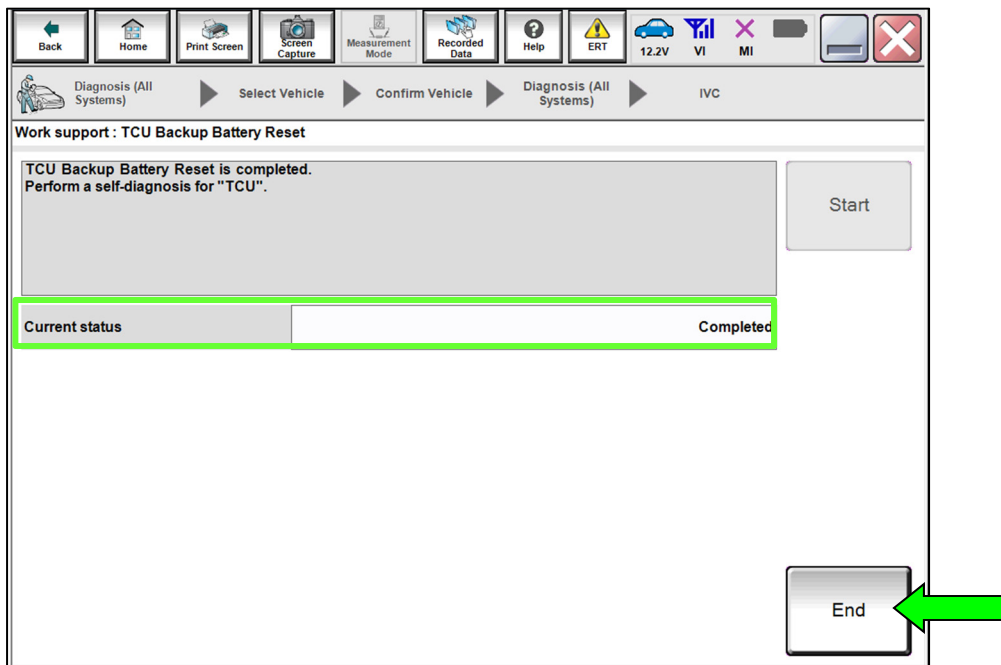
Figure 9

14. When the **Current status** has changed to “Completed” select **End**, and then proceed to step 15 on page 7.

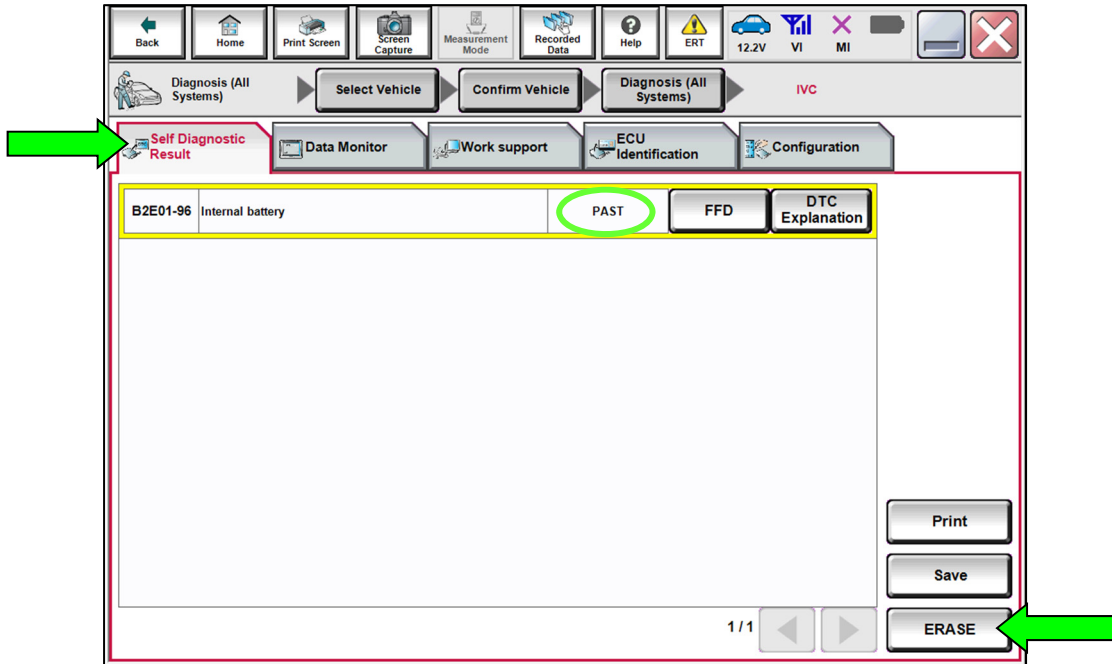
Figure 10

15. Select **Self Diagnostic Result** and confirm that DTC **B2E01-96 Internal battery** is “PAST”, and then select **ERASE**.
  - If **B2E01-96 Internal battery** will not change to “PAST”, refer to the ESM for further diagnostic information.

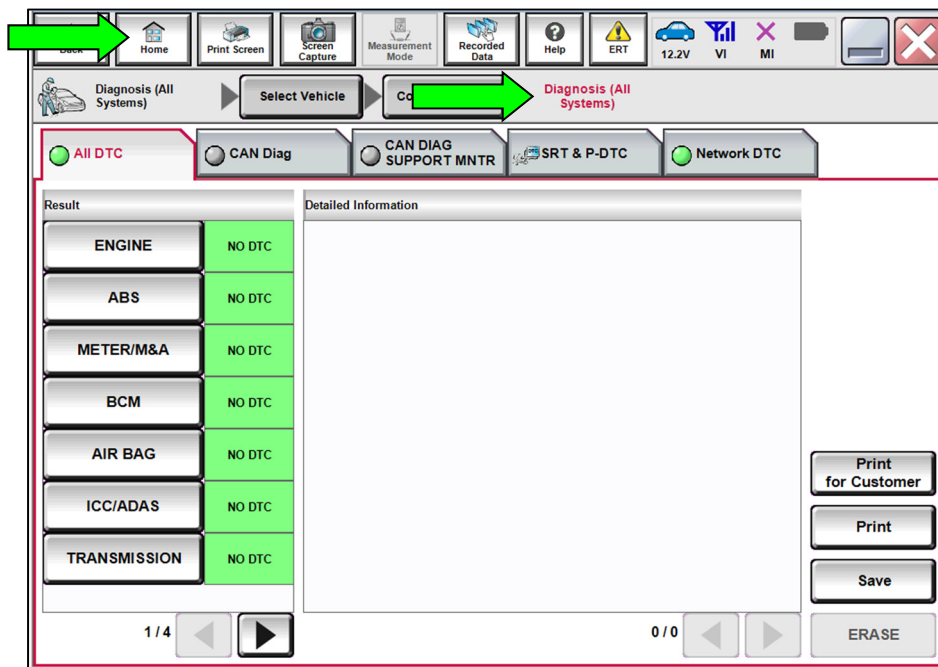
Figure 11

16. Select **Diagnosis (All Systems)**, where shown in Figure 11.
17. In **Diagnosis (All Systems)**, confirm that **B2E01-96 Internal battery IVC** has not returned, and then select **Home**.
  - If **B2E01-96 Internal battery** returns as “CRNT” or will not **ERASE**, refer to the ESM for further diagnostic information.
