TECHNICAL SERVICE BULLETIN

Classification: AT22-002	Reference: NTB22-030	Date: April 19, 2022
-----------------------------	-------------------------	-------------------------

“SERVICE AT POWER REDUCED” WARNING DISPLAYED AND DTC P0715 STORED IN THE TCM

APPLIED VEHICLES: 2022 Pathfinder (R53)
APPLIED DATES: Built before March 21, 2022

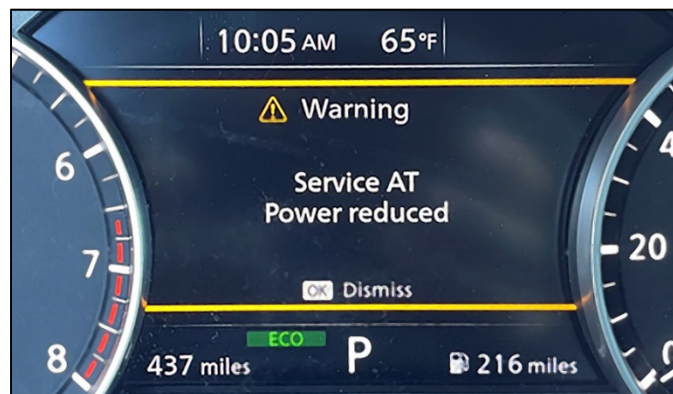
Figure 1

The customer states the “Service AT Power reduced” warning message (Figure 1) is/was displayed,

DTC P0715 (INPUT SPEED SENSOR A) is the only DTC stored in the TCM.

1. Confirm the current TCM part number.
2. Reprogram the TCM, if applicable.
