**RECREATIONAL VEHICLE CUSTOMER SATISFACTION**

Customer Satisfaction Campaign: 22-425

**CUSTOMER SATISFACTION CAMPAIGN**

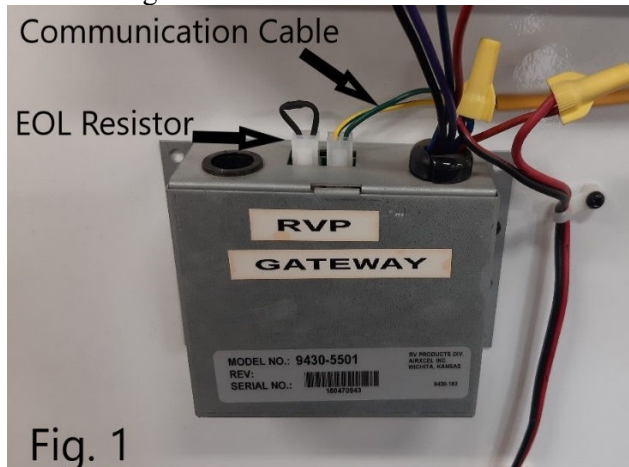
Fig. 1

Figure 1-Shows a Gateway, the communication cable from In-Command system and the EOL resistor as it should be for proper operation.

4. Note: When a 2<sup>nd</sup> A/C is installed later, unplug the EOL resistor from the 1<sup>st</sup> Roof A/C Gateway, reinstall the 2<sup>nd</sup> A/C communication cable. Install the Pre-wired Communication cable and the EOL resistor into the 2<sup>nd</sup> A/C Gateway as seen in Figure 1.

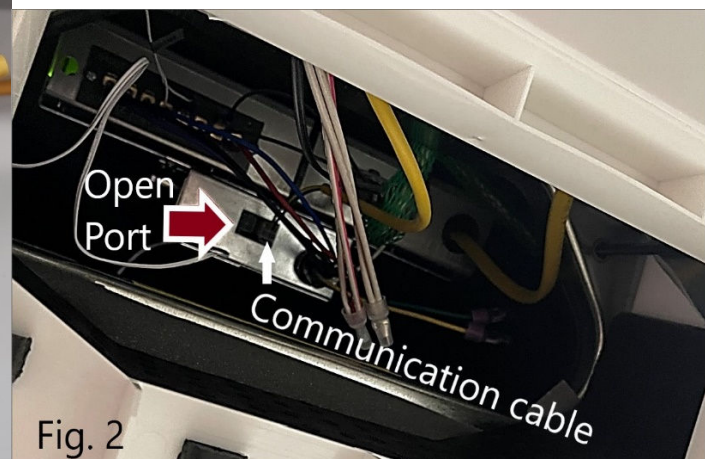
Fig. 2

1. System with one Roof A/C. Turn off the A/C, remove the return air grill, and locate the Gateway (See Figure 2). If there is an open port as seen in Figure 2 & 3, corrective action is needed. Upon completion, the wiring should be as seen in Figure 1.

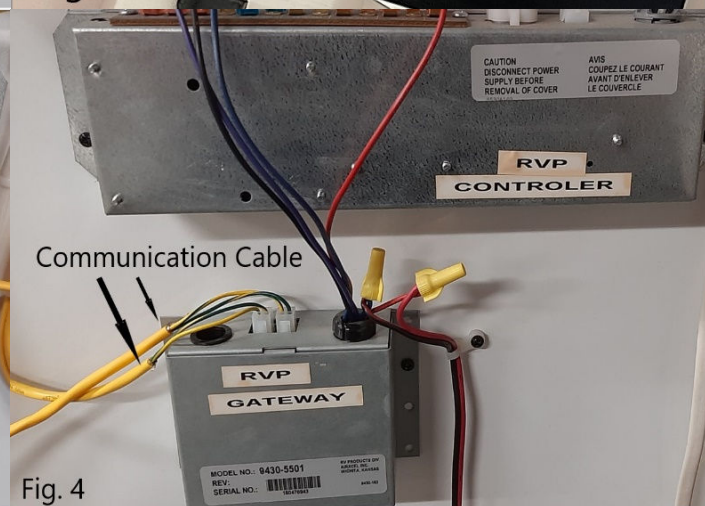
Fig. 4

2. System with two Roof A/C's. Turn off the A/C's, remove the return air grill, and locate the Gateway's. The EOL will need to be installed on the 2<sup>nd</sup> A/C's Gateway. The first A/C Gateway (typically the middle of the unit) will have two communication cables plugged in (See Figure 4). One cable from In-Command to the 1<sup>st</sup> A/C, one cable from the 1<sup>st</sup> A/C to the 2<sup>nd</sup> A/C. The second A/C Gateway should look like Figure 1, if not, take corrective action.

3. System with one Roof A/C and Pre-Wired for 2<sup>nd</sup> A/C. If Pre-Wired for 2<sup>nd</sup> A/C, the 1<sup>st</sup> A/C Gateway may have two communication cables plugged in, See figure 4. One cable from In-Command to the 1<sup>st</sup> A/C, one cable from the 1<sup>st</sup> A/C to the 2<sup>nd</sup> A/C. The 2<sup>nd</sup> A/C communication cable will need to be unplugged and the EOL Resistor will need to be plugged in to that port. See Figure 1. The 2<sup>nd</sup> communication cable can be left protected and unplugged. To determine which communication cable is "live" unplug one cable at a time and operate the A/C functions at the In-Command panel.
