# Service Bulletin

Bulletin No.: 16-NA-109

**Subject: Grease or Sealant Visible on Electronic Power Steering Gear - Should Not Be Interpreted as Leak**

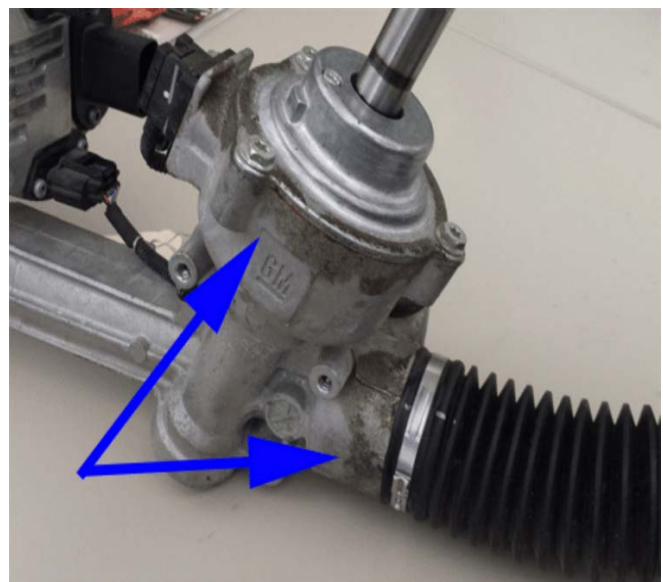
4483616

The graphics below are photo examples, which include arrows showing some of the common areas where grease may be evident after the vehicle has been driven for a length of time.

If upon inspection, the steering gear assembly clamps, boots, and fasteners are all in place, the visual evidence of grease/sealant on the exterior of the steering gear is considered normal and no correction is necessary. If excess grease is noted, it should be wiped off the exterior of the gear, however, sealant should be left in place as a barrier to water and contamination, and no cleaning is required.
