Service Bulletin

Bulletin No.: 21-NA-183

Subject: Intermittent Door Locks Inoperative, DTCs B3125, B3130, B3135, B3979, B3980, Various U Codes, IP Lamps Illuminate, Immobilizer, Unwanted Horn or Hazard Flasher Operation

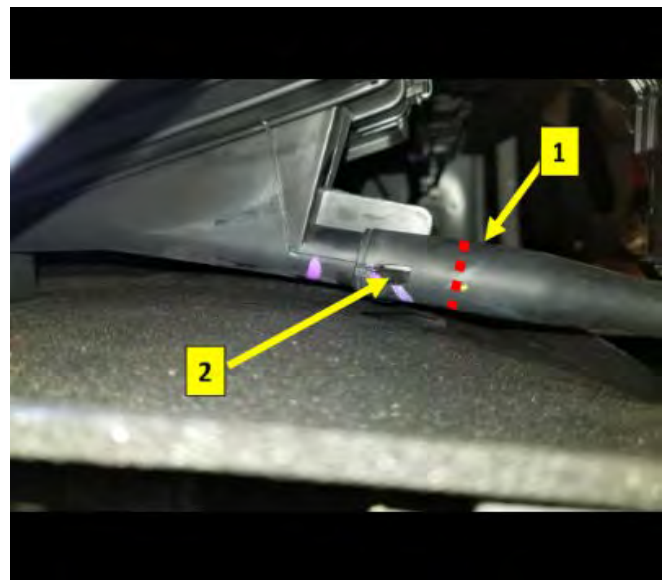
5883903

Note: Inspect the drain hose connection to the HVAC module. If leaking, water will be seen at the notch in the hose (2), or just above. Addition of a tie strap will prevent further leakage at this connection.

7. Install a tie strap on the drain hose, below the locking nib seen near the top of the drain hose connection to the HVAC module. Install the tie strap where the red dashed line (1) is shown in the graphic above.

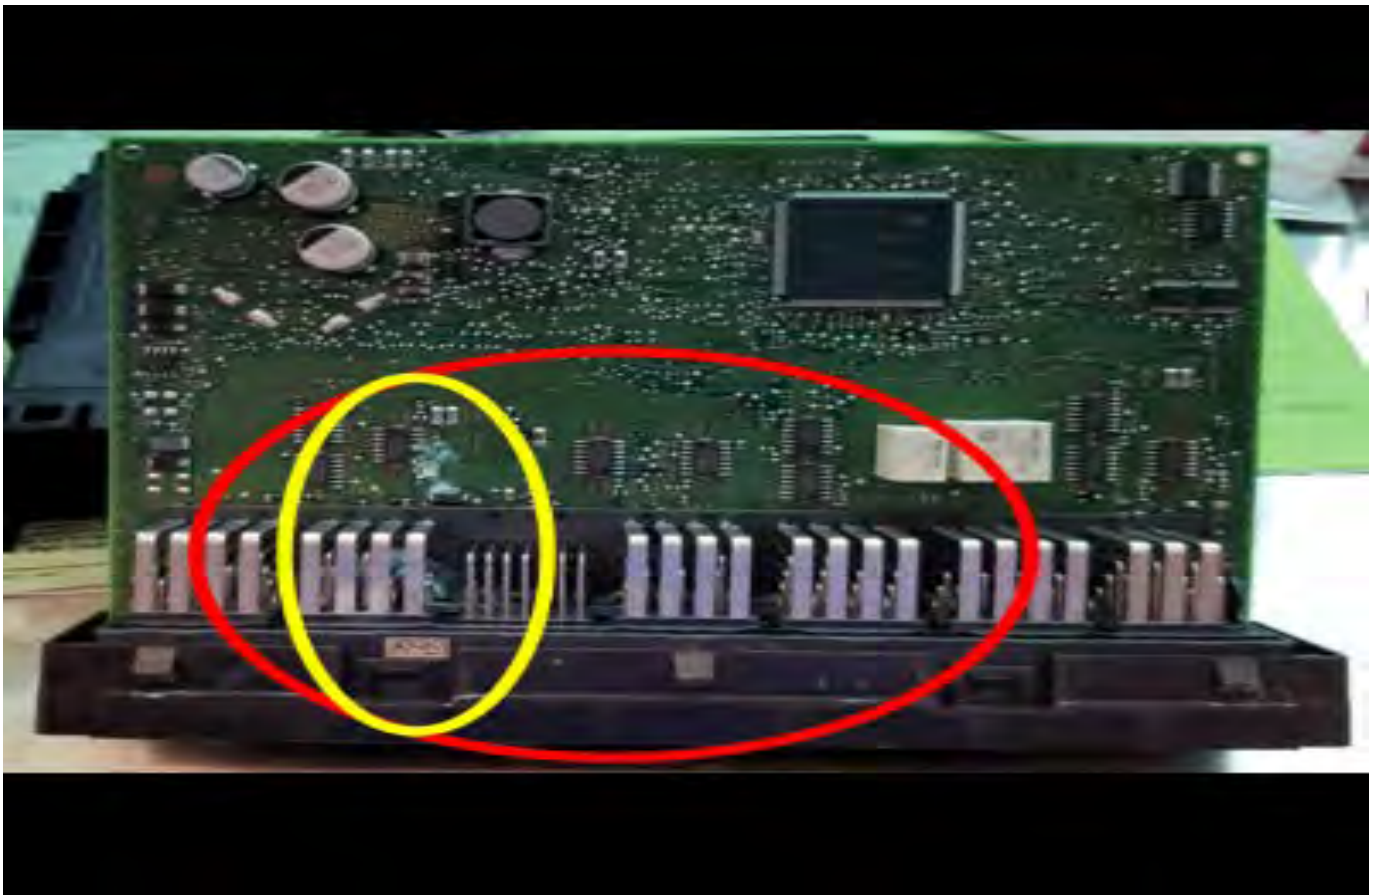
5883904

If water has been leaking from the drain hose, it has most likely entered the BCM. If you see any signs externally, you can verify the need to replace the BCM by disconnecting and removing the BCM, then opening the case. You will see internal damage similar to that shown in the graphic below.

1. Yellow oval highlights corrosion in this BCM.
2. Red oval highlights area to inspect for corrosion.

Damage internal to the BCM
