HYUNDAI Technical Service Bulletin	GROUP AUTOMATIC TRANSMISSION	NUMBER 22-AT-007H
	DATE MAY 2022	MODEL(S) TUCSON (TL) 1.6T SONATA (LFa) 1.6T KONA (OS) 1.6T
SUBJECT: DUAL CLUTCH TRANSMISSION JUDDER DETECTION AND TCU SOFTWARE UPDATE

This TSB supersedes 21-AT-014H to include 2018-21MY Kona (OS) 1.6L Turbo vehicles.

Description: Certain vehicles (listed below) equipped with 7-speed Double Clutch Transmissions (DCT) may exhibit abnormal vibration at low speeds. This bulletin outlines the procedures for diagnosing clutch judder, updating the Transmission Control Unit (TCU) with revised logic, and/or replacing the Double Clutch.

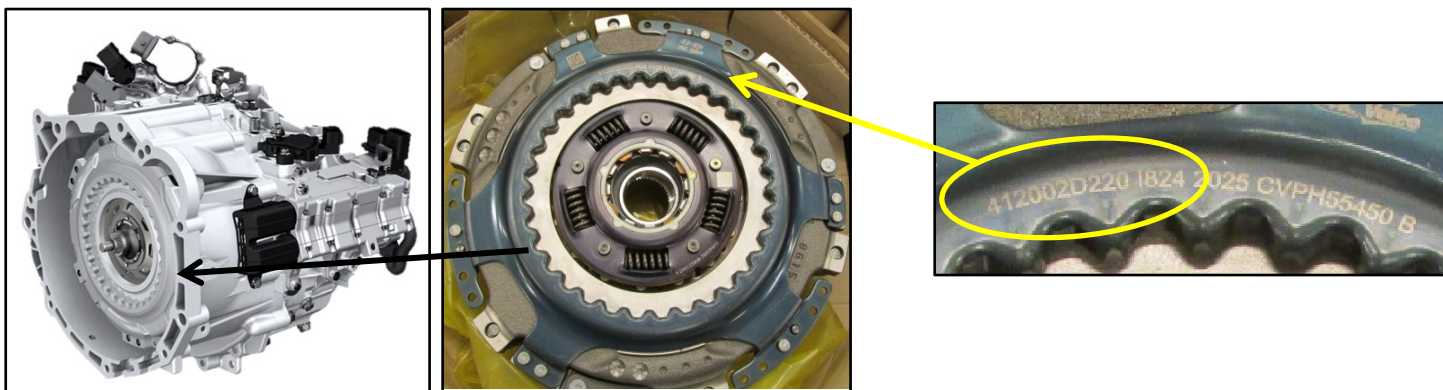
Updated F850 Clutch Material Identification:

MODEL	PREVIOUS CLUTCH PART NUMBER (F833DS)	NEW CLUTCH PART NUMBER (F850)
2016-2017 Tucson (TL) 1.6L Turbo 2015-2017 Sonata (LFa) 1.6L Turbo	41200-2D101	41200-2D220
Kona (OS) 1.6L Turbo (Equipped with F850 from start of production)	N/A	41200-2D220

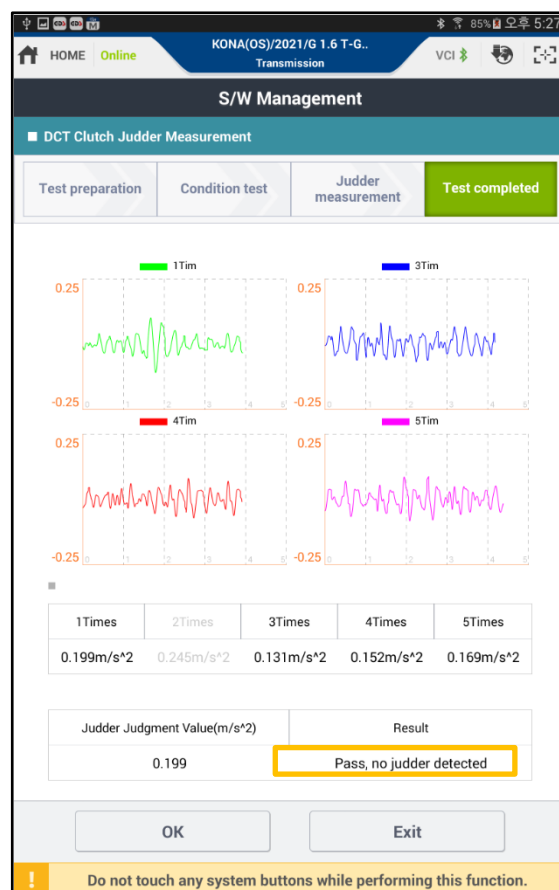
- After the measurement is complete, apply the brakes for 4-5 seconds.
- If the result is **“PASS, No Judder Detected”**, the service procedure is complete.

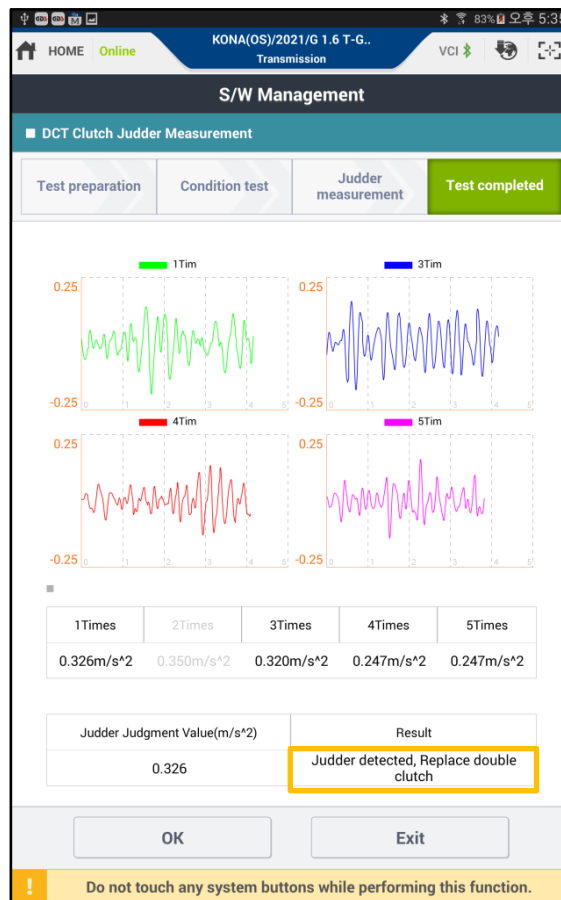
8. If the result is, “**Judder Detected, Replace Double Clutch,**” reflash TCU with latest update by referring to section **B. Automatic TCU Upgrade Procedure.**

Update the TCU with the latest software and retest before replacing the **Double Clutch.**

9. After updating the TCU, retest for Judder following GDS-M Clutch Judder Inspection steps 1-8, starting on Pages 4-7.

If the result is still “**Judder Detected, Replace Double Clutch,**” replace the double clutch assembly by referring to section **D. Clutch Replacement Procedure** on page 14.

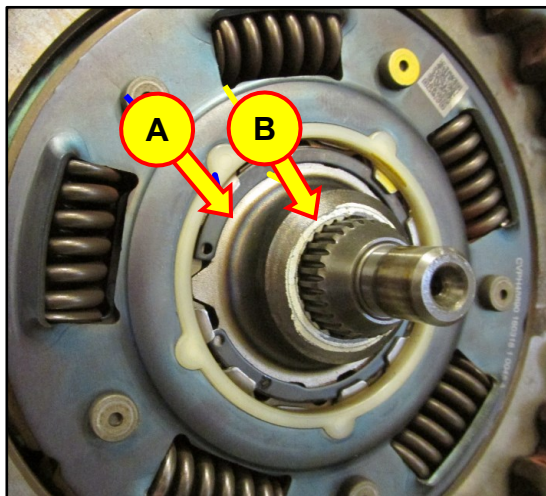
The snap ring can become deformed in the removal process. Do not reuse the existing snap rings when reinstalling the Double Clutch into the transmission.

1. Remove the Dual-Clutch Transmission following the shop manual procedure.
2. Remove the retaining ring (A) (41126-2D100) and the splined hub (B).

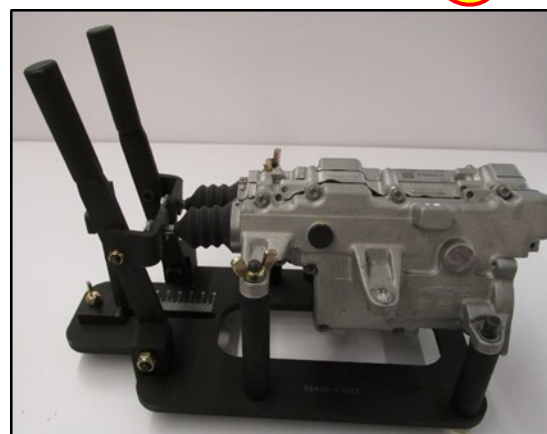
When installing a new Double-Clutch, the clutch actuator rod length must be reset back to the factory zero. If the rod length is not adjusted correctly, the GDS-M DCT relearn procedure will not complete.

7. Follow the service shop manual procedure to initialize the rod length for both odd and even clutch actuator rods.
