Technical Service Bulletin

GROUP Body Electrical	NUMBER 22-BE-002H
DATE MAY 2022	MODEL(S) PALISADE (LX2)

SUBJECT: LX2 ICU UPDATE – HAPTIC MOTOR WARNING MESSAGE

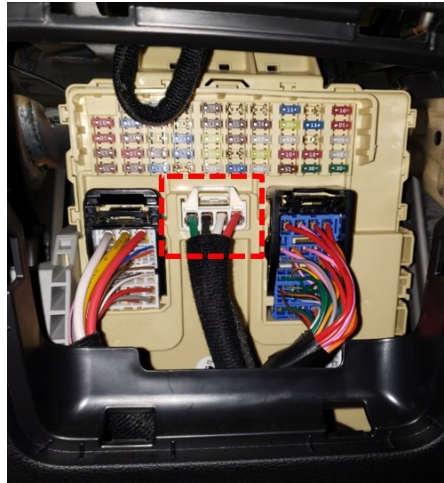
1. Perform GDS Mobile software update per TSB **15-GI-001**.
2. After successful completion of **ECM software update**, disconnect the power connector in the junction box located on the driver's side lower dash for 5 seconds, then reconnect it.
