# Service Bulletin

Bulletin No.: 13-08-116-001G

**Subject:** Aftermarket ALDL or DLC Interface Devices Causing Multiple Issues

**Models:** 2022 and Prior GM Passenger Cars and Trucks

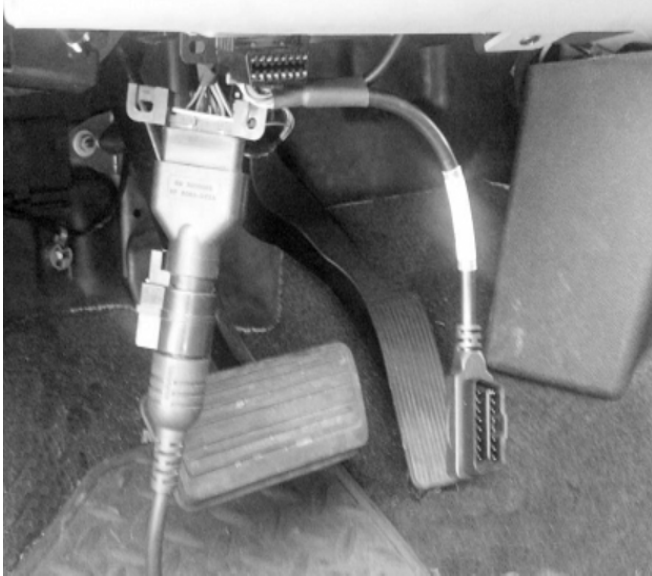
**Device W/Secondary DLC Connector**

This device has another DLC connector on it. The rest of the harness along with the device can be placed out of sight hidden from the technician, who may not notice the diagnostic connector is not in the factory location.
