Bulletin No.: PIT5912

Preliminary Information

PIT5912 Lane Keep Assist Unavailable / Adaptive Cruise Control Inop / Service Driver Assist Systems / Amber Front Collision Icon On / Front View Camera DTC U3000 49

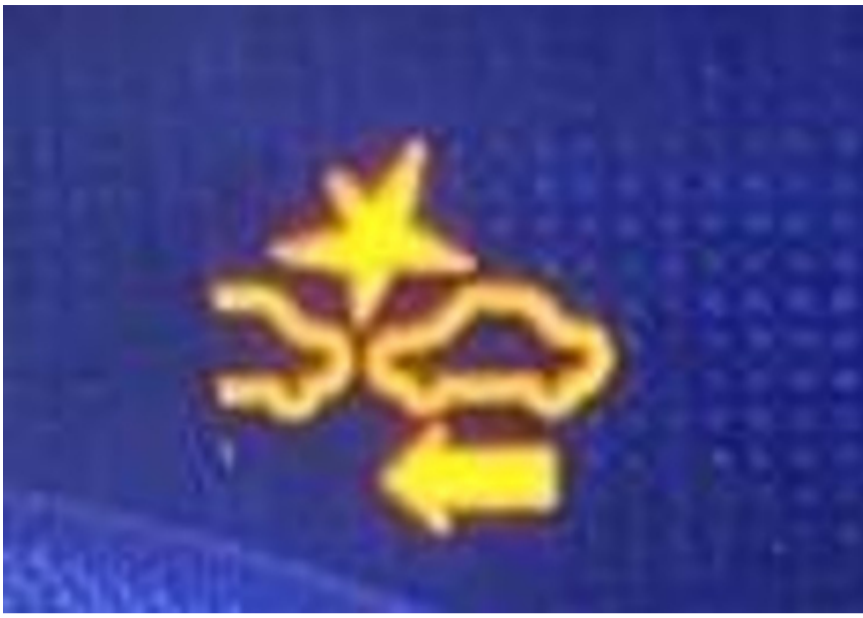
| Condition | <p>Some customers may comment on an amber Forward Collision icon displayed in the IPC, as shown below. Also, DTC U3000 sym49 may be set current in the Front View Camera Module. Customers may also notice certain features related to the Front View Camera are unavailable, such as:</p> <ul style="list-style-type: none"> - Forward Collision Alert (RPO: UEU) - Following Distance Indicator (RPO: UE4) - Low Speed Collision Mitigation Braking (RPO: UHY) - Pedestrian Collision Mitigation Braking (RPO: UKJ) - Lane Keep Assist (RPO: UHX) - Automatic High Beam Assist (RPO: TQ5) - Adaptive Cruise Control (RPO: KSG) |
| Cause | The cause of this concern could be Onstar performing a task, which causes the B174W Front View Camera to set the DTC and disable during the next vehicle start up. |

Do NOT replace the B174W Front View Camera Module for this concern. Engineering is aware of the issue and working on a fix. In the meantime, to recover the Front View Camera function perform the following:

1. Turn the ignition off.
2. Remove the F11DR fuse for the B174W Front View Camera, located in the X51R Right Instrument Panel Fuse block.
3. Leave the fuse removed for 1 minute, then reinstall the fuse.
4. Clear any DTC's and check camera operation.
5.
 - If the camera operation has returned, then no further action is required.
 - If the camera operation has NOT returned, then perform a camera relearn using GDS2.
6.
 - If the camera operation has returned after the camera relearn, then no further action is required.
 - If the camera operation has NOT returned after the camera relearn then perform normal SI diagnostics and repair as necessary.
