Bulletin No.: PIT5915

PIT5915 No Crank Due To Dead or Low Battery (N212351590)

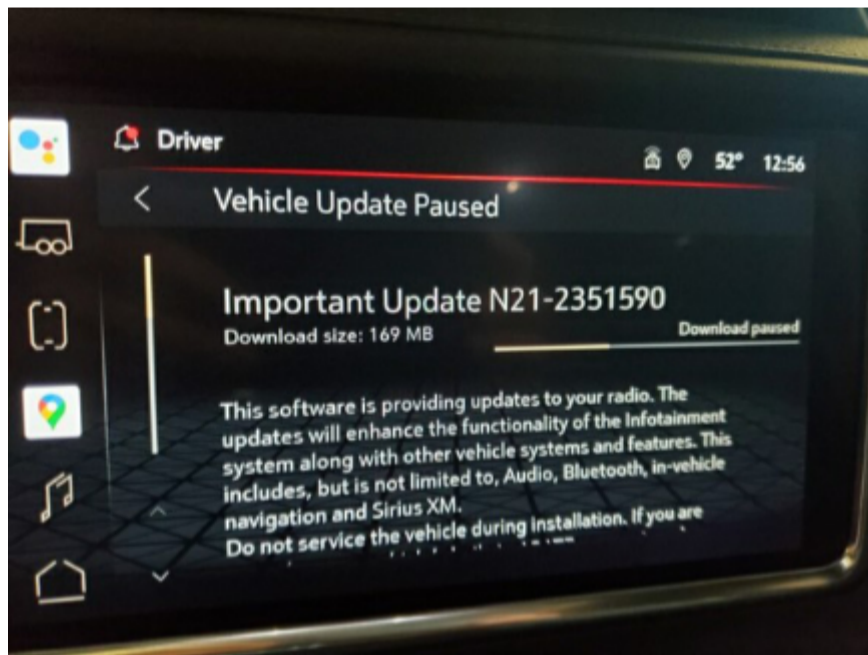
Involved Region or Country	North America
Condition	Some customers may experience a no crank due to a low or dead battery.
Cause	The cause of this concern could be a failed Over The Air (OTA) update.

Charge the battery and test using the GR8 or DCBS to make sure the battery is good. After the battery is recovered, check the radio/infotainment update menu for a pending update. If the update shows download paused, example shown above, then the dead battery was the result of the OTA event. Next, turn the ignition off and remove fuse F12DR location in the Right I/P fuse block for the Serial Data Gateway module. Leave the fuse removed for 1 minute and reinstall. Then update the radio using Techline Connect SPS2 by performing Radio Programming followed by USB file transfer. Refer to SI for proper radio programming procedures.
