Preliminary Information

PIT5918 Driver Side Headlight and/or Turn Signal Lights Stuck on/off/flickering / Dead battery and/or Accessory Illuminated Emblem Inoperative

Product Investigation Review Required

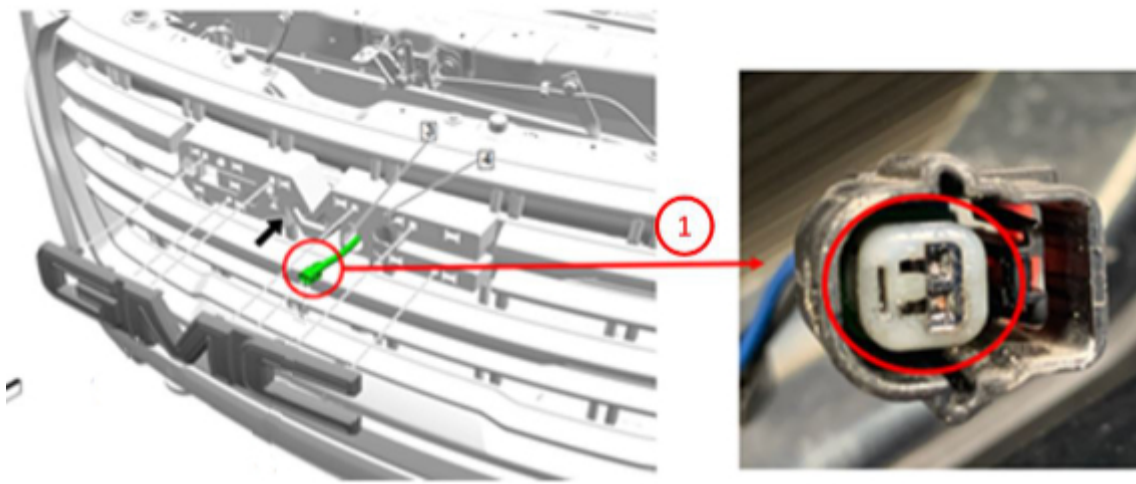
| Cause | The cause of these concerns could be water intrusion from GM Accessory Illuminated Emblem, which connects inline with the Driver's Side Headlight. |

1. At the GM Accessory Illuminated Emblem Connection(1), shown below.

3. - If water/corrosion is found, then perform all necessary repairs to the Headlamp connector on the Body Harness and clean the Headlamp Assembly terminals. Plug the original Headlamp connector from the body harness back into the headlight assembly. This will eliminate/bypass the GM Accessory Illuminated Emblem Harness. It is NOT necessary to clean/repair the GM Accessory Illuminated Emblem or Accessory Harness connectors as they will be temporarily disabled until a fix becomes available. Verify Headlamp operations.

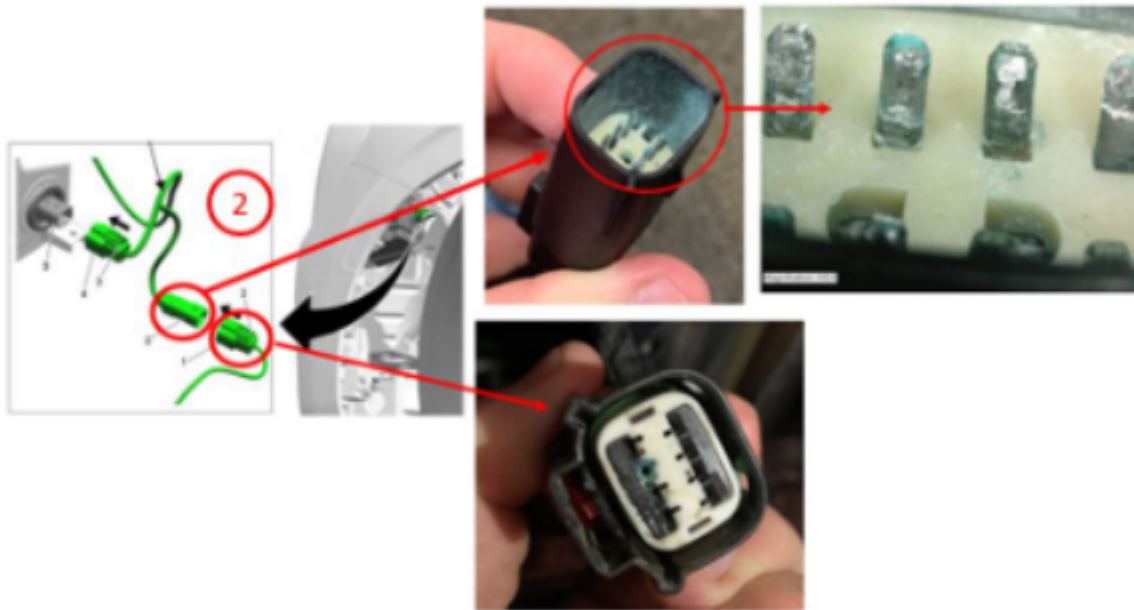
2. At the Drivers side headlight connector and the inline GM Accessory Illuminated Emblem Harness (2), shown below.

- If NO water/corrosion is found at any of the connectors, then the source of the issue is not the GM Accessory Illuminated Emblem and normal SI diagnostics will need to be followed. BUT the GM Accessory Illuminated Emblem will still need to be disabled to prevent any future failures from occurring. Plug the original Headlamp connector from the body harness back into the headlight assembly. This will eliminate/bypass the GM Accessory Illuminated Emblem Harness. Verify Headlamp operations.
