### PIP5854 Diagnostic Tip: DTC p0420 With A Possible Exhaust Backfire Under Load, Hard Starting Or Crank No Start Condition And/or Multiple Misfire Or Ignition Coil Related DTC's

Brand:	Model:	Model Years:	VIN:		Engine:	Transmissions:
			from	to		
Chevrolet	Silverado	2022	All	All	2.7 L3B	All
GMC	Sierra	2022	All	All	2.7 L3B	All

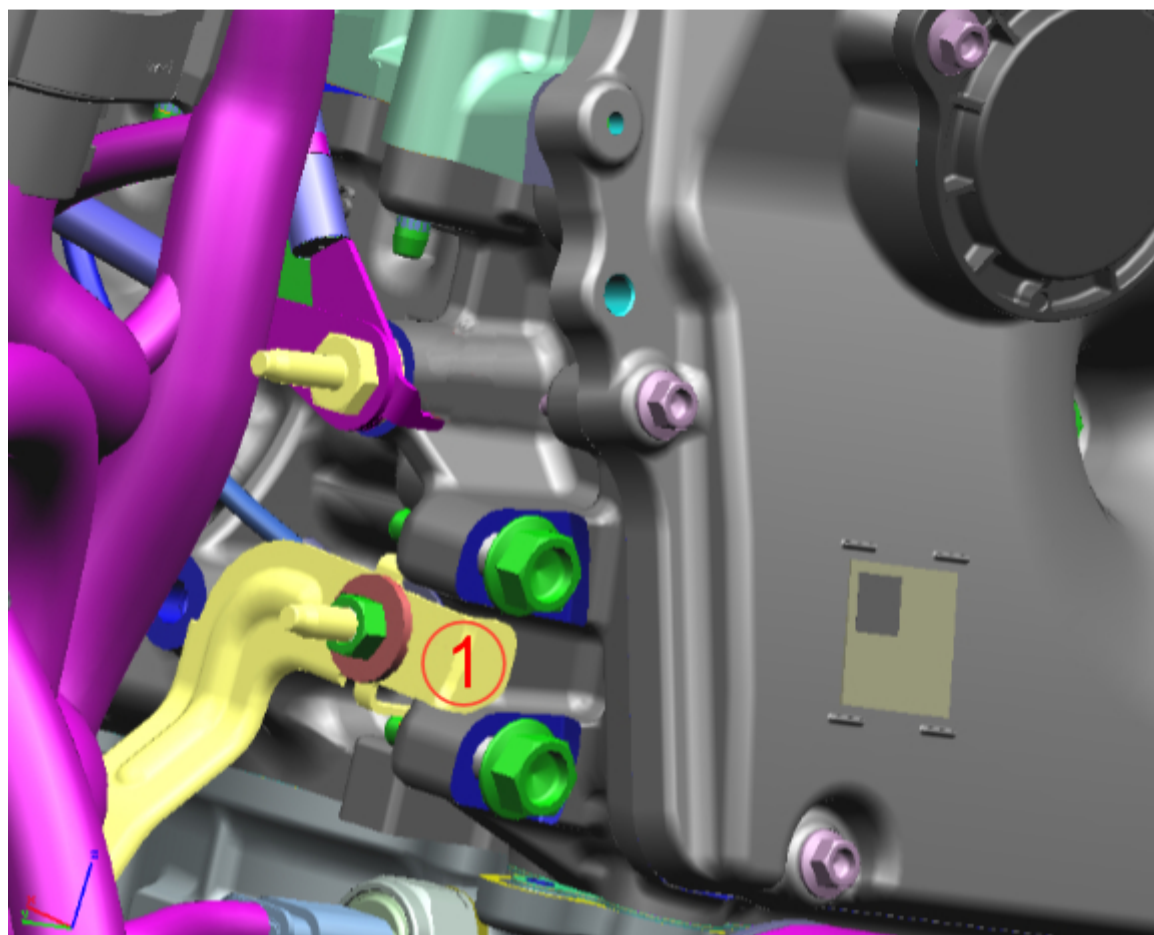
<b>Involved Region or Country:</b>	North America
<b>Condition:</b>	Exhaust backfire under load, engine hard starting, crank no start, DTC p0420 and/or multiple misfire or ignition coil related DTC's
<b>Cause:</b>	Poor clamp load on Ignition Coil ground G121 (Global A) or G178B (VIP Architecture)

**(#1) Callout in picture below shows actual ground stud location.**

If the ground was found loose this may be caused by the ground stud fastener being too long or a concern with the threaded hole allowing the fastener to bottom out before making

contact with the ground eyelet.

If you encounter a vehicle with the above conditions physically inspect Ignition Coil Ground G121 (Global A) Or G178B (VIP Architecture) for being loose due to poor clamp load.

Remove and inspect the length of the ground stud fastener. This fastener size should be M8x1.25x24mm. If the ground stud fastener size is correct then suspect a possible issue with the threaded hole allowing the ground stud fastener to bottom out. In this case the ground stud fastener would need to be shortened slightly in order for the proper clamp load to be achieved.
