## Preliminary Information

### PIC6460 Hood Ajar Message Displayed

Brand:	Model:	Model Years:	VIN:		Engine:	Transmissions:
			from	to		
Chevrolet	Impala	2014 - 2020	All	All	LKW, LCV	All

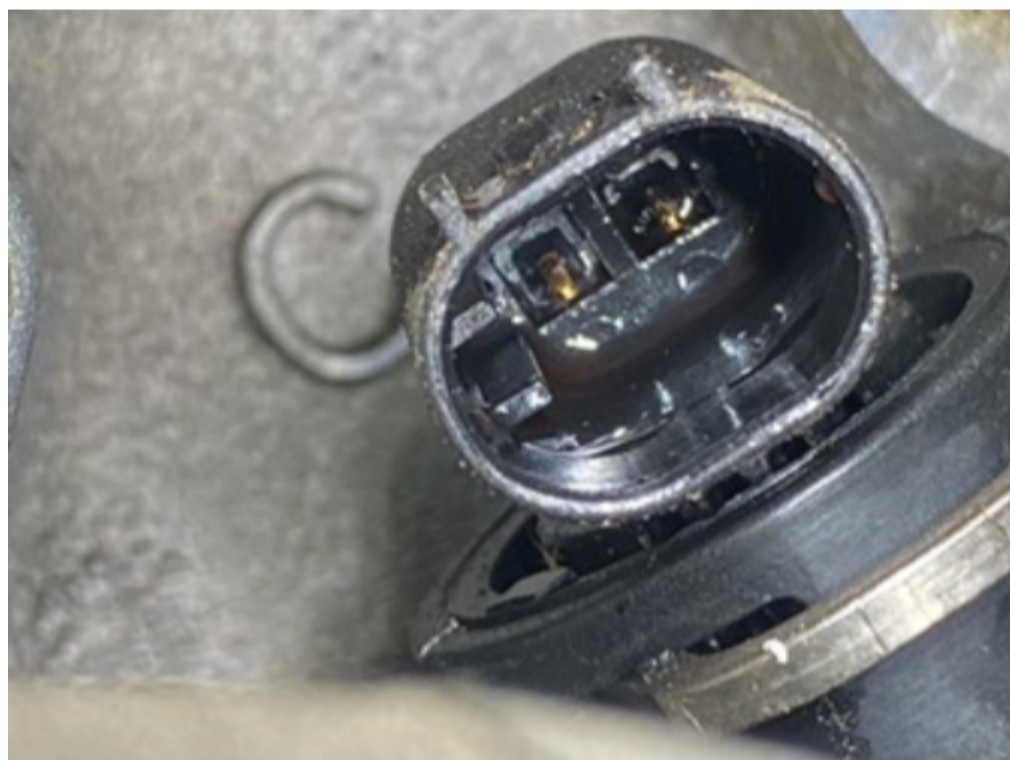
Involved Region or Country	North America
Condition	A Customer may comment that the hood ajar message is displayed on the DIC with the hood completely closed. The check engine light may also be illuminated and a P257D for engine hood switch performance is present.
Cause	Inspect for coolant leaking from the coolant temperature sensor connector wicking up circuits 410 and 2761 from the coolant temp sensor to the ECM connector X3 at Pins 7, 8, 23, and 24. This may cause a short across circuits 5350 and 470 at pins 7 and 23 which is the hood open switch signal and sensor low reference.

1. Inspect for coolant leaking internally from the ECT sensor by disconnecting the sensor connector.

3. If coolant corrosion or discoloration is found, replace circuits 410 and 2761 from the engine coolant temperature sensor (ECT) to ECM connector X3. Replace the coolant temperature sensor and replace or clean connector X3 at the ECM.

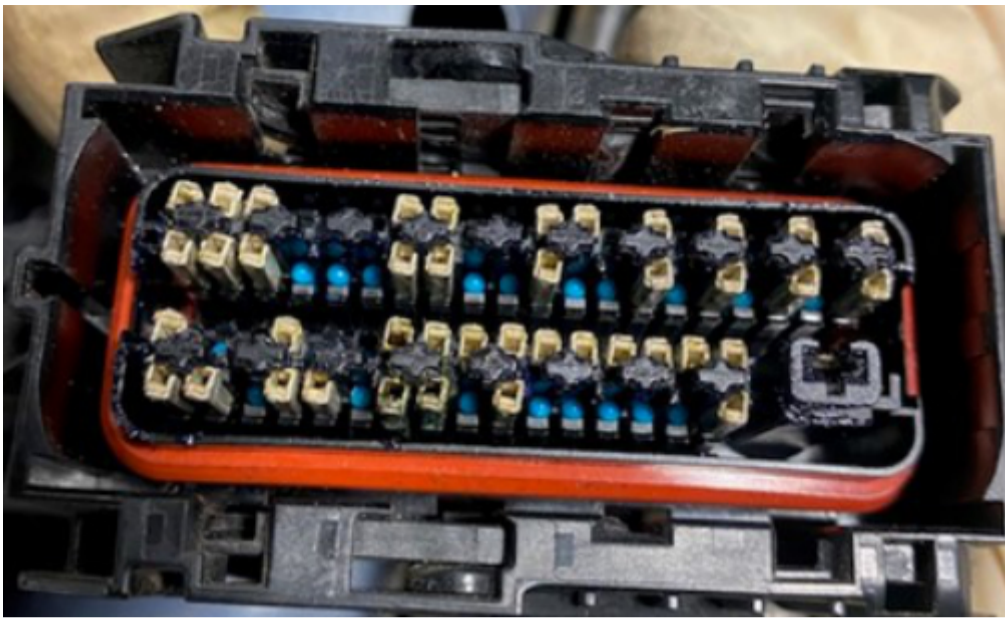
2. Trace the circuits back to the X3 connector at the ECM and inspect for coolant contamination / corrosion.

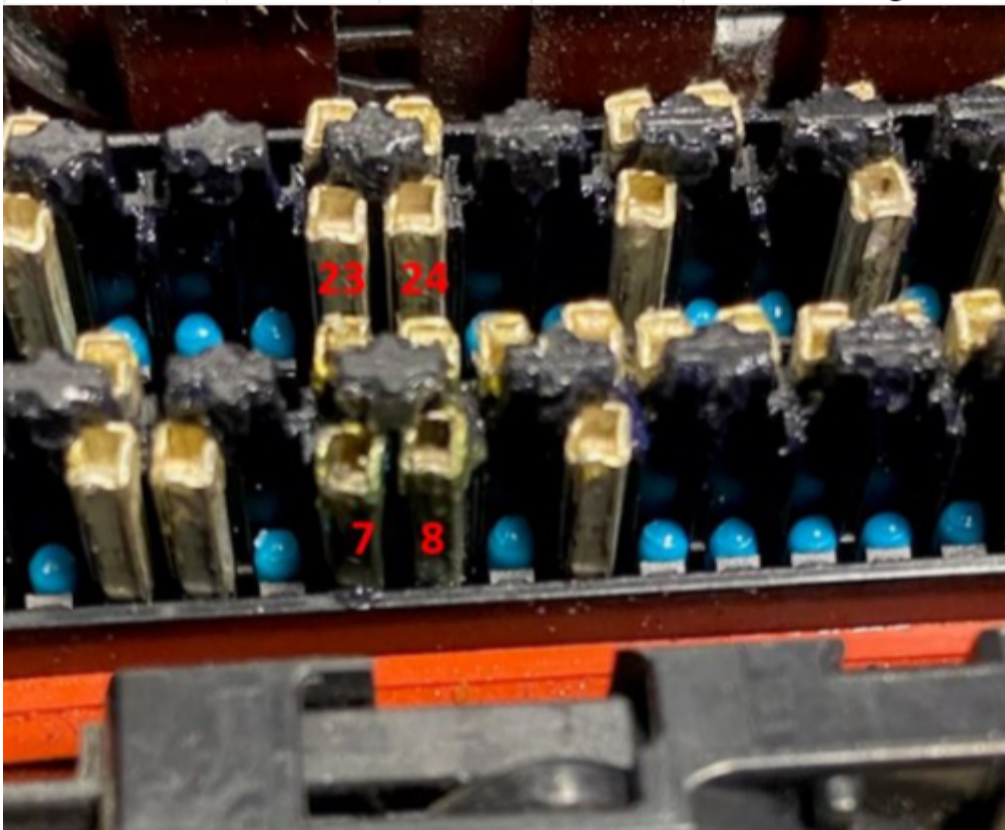
Pin	Size	Color	Circuit	Function
23	0.5	BK/VT	470	Sensor Low Reference
24	0.5	BK/BN	2761	Coolant Temperature Sensor Low Reference
7	0.5	YE	5530	Hood Open Switch Signal
8	0.5	D-BU	410	Engine Coolant Temperature Signal
