Preliminary Information

PIP5849A LUV/LUJ Intermittent P0299 Codes

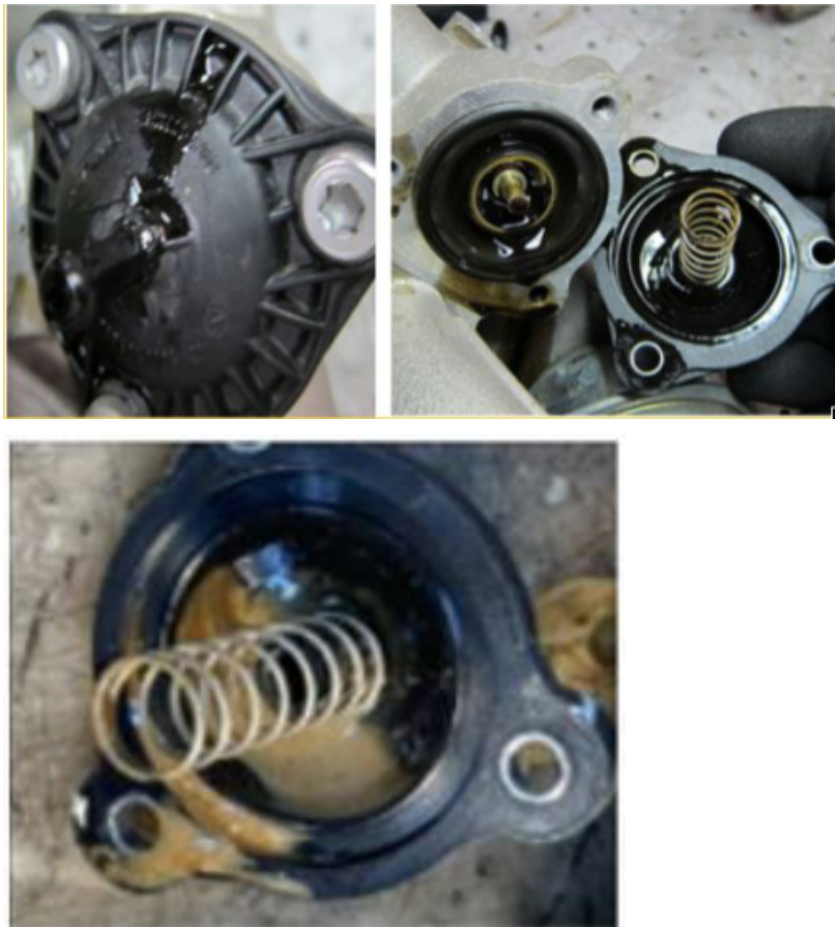
1. Inspect the Charge Air Bypass Valve for oil/water/sludge build-up in the vacuum side port.

- If oil/water build up in the valve port, disassemble and clean the components. Refer to SI document titled "Charge Air Bypass Valve Replacement".
- Only if necessary, replace the components.

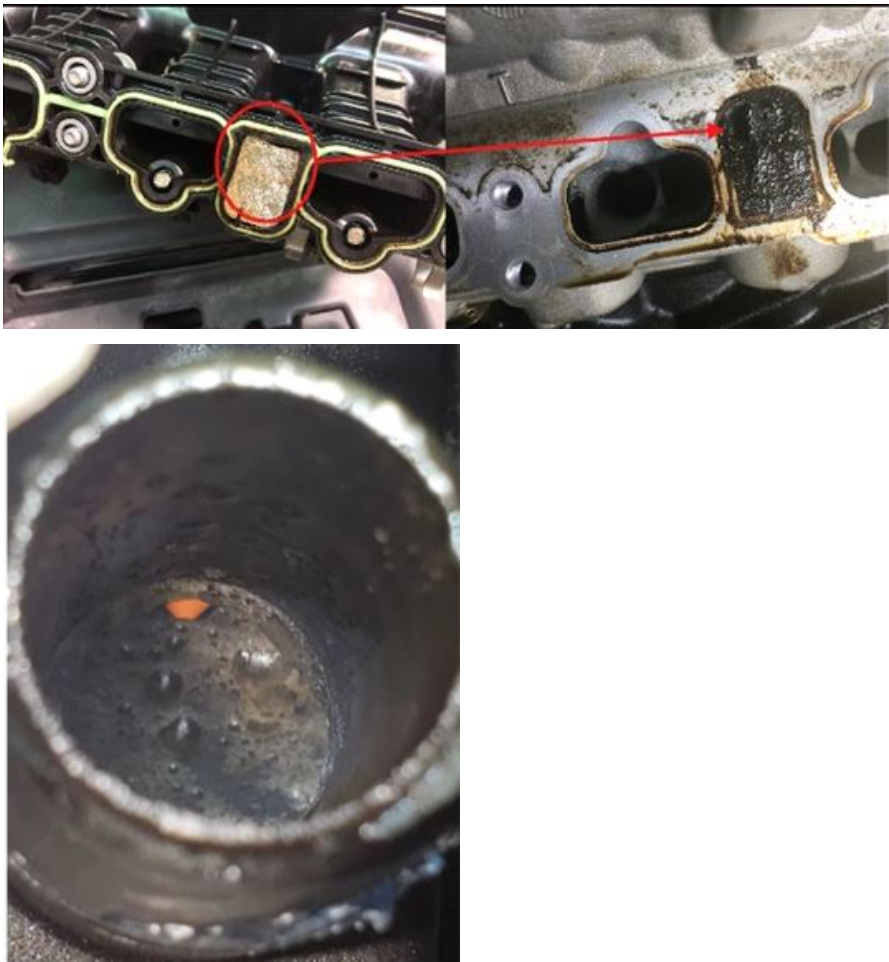
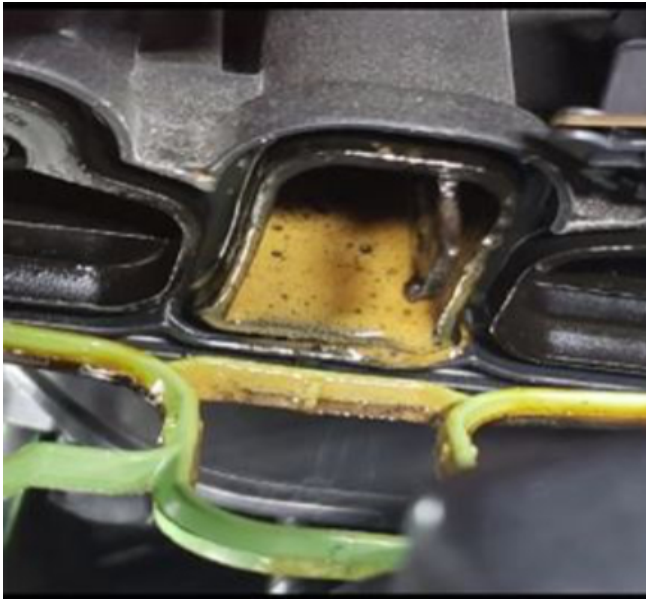
- 3. Inspect the vacuum ports of the intake manifold for ice/water/oil accumulation.
- 4. Inspect the PCV intake runner for ice build-up, or sludge blocking the cylinder head as shown above.
- 5. Clean any ice/sludge/water/carbon out of the cylinder head, cam cover and PCV pipes.

If above condition exists then, replace the Intake manifold. Refer to SI document titled "[Intake Manifold Replacement](#)".
