MAS003093 (MSC 22-17)

Campaign 486  
FROM Maserati TSO  
TO Maserati Network

# Service Campaign 486 MC20 - Suspension Lifter 3-Way Block Oil Leakage

DATE: MAY 18 2022

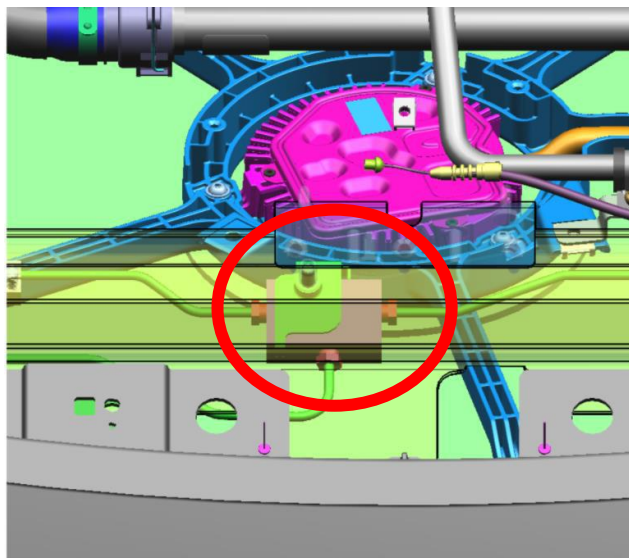
- Always check in ModisCS+ to see if the vehicle is involved in this campaign and if the campaign has not been previously performed
- Remove the luggage compartment container:  
**09.64 – 1 (09.61.066) - LUGGAGE COMPARTMENT CONTAINER - Removal and refitting**
- The 3-way block is under the front crossbar to access the pipe screw fittings for the Hydraulic Lines.
