MAS003094 (MSC 22-18)

Campaign 485  
FROM Maserati TSO  
TO Maserati Network

## Service Campaign 485 MC20 - Potential Inox Kick Plate Detachment

DATE: MAY 18 2022

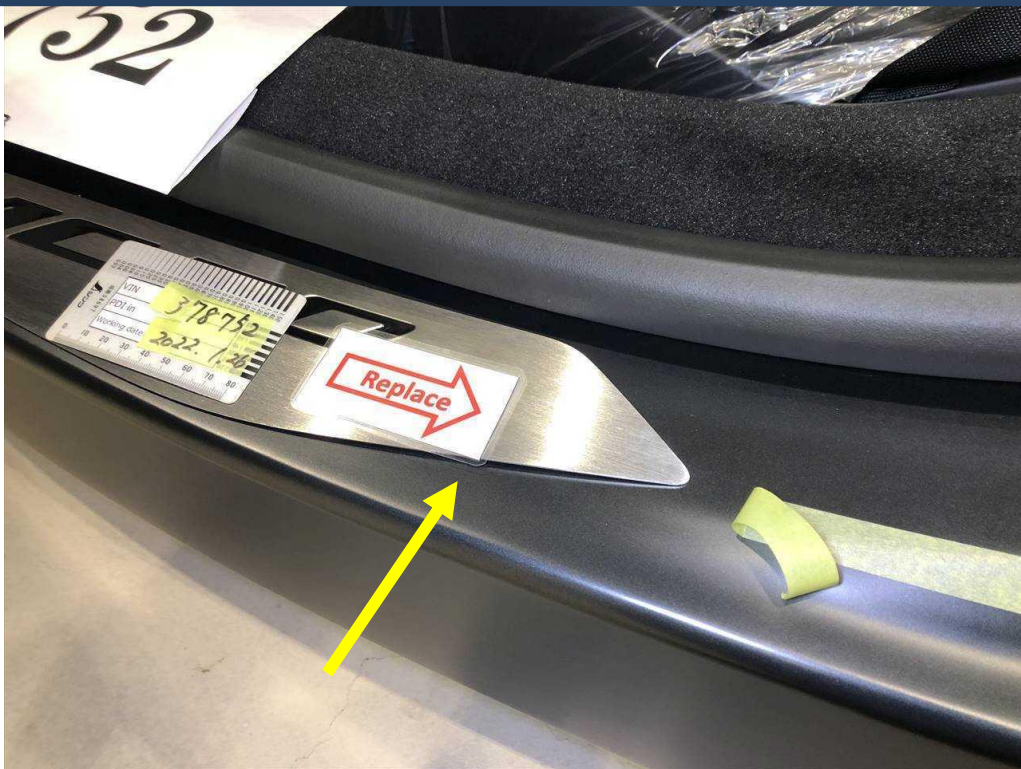
Certain Maserati MC20 (M240) vehicles listed in ModisCS+ are involved in a Service Campaign to prevent the detachment of the inox (Stainless Steel) kick plate. This event could occur due to insufficient coupling between the kick plate and the tub. For this reason, a small gap could appear between the kick plate and the chassis.

A stress test is needed to check the correct connection and eliminate any risk of detachment.

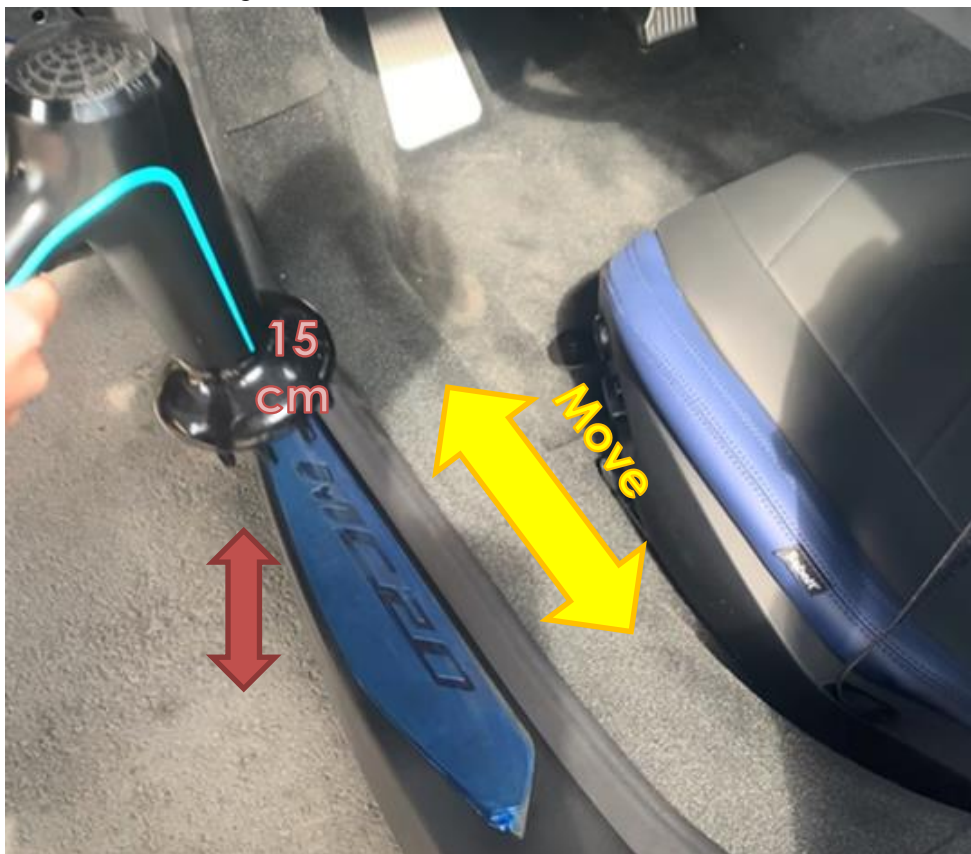
1. Always check in ModisCS+ to see if the vehicle is involved in this campaign and if the campaign has not been previously performed.
2. Take a common/domestic hairdryer (1500-1800W) with diffuser. **Don't use an industrial one.**
3. Perform a heating treatment (as shown in Video attached) of the kick plate following these rules:
  - Place the diffuser at a distance of 15 cm (6 Inches) from the plate
  - Turn ON the hairdryer at maximum speed and maximum temperature
  - Move the phon (hairdryer) left and right along the entire length of the Driver Side Kick Plate for 30 minutes until the target temperature of about 140°F (60°C) is reached and verified using a Laser Thermometer.

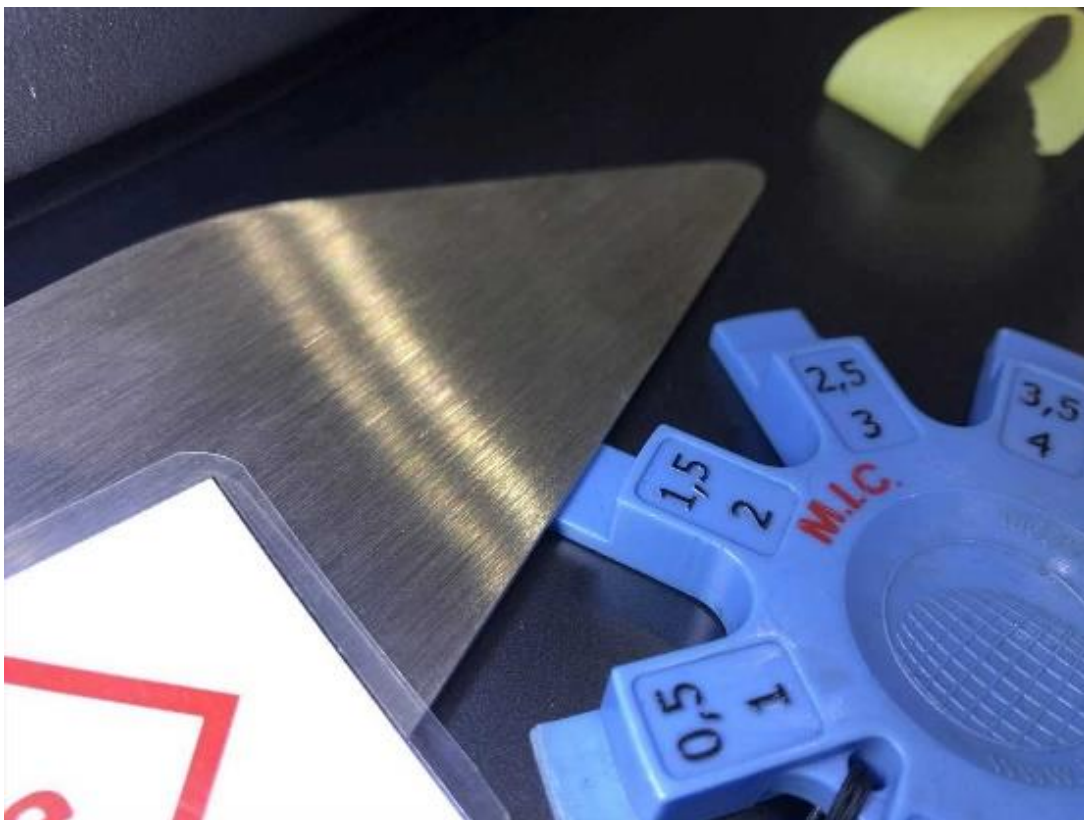
4. Once temperature of the Kick Plate has been reached. Inspect the Kick Plate for any deformation and or separation between the chassis and the kick plate.
5. If separation is observed, use a plastic thickness feeler gauge and measure the gap near the edges.

6. If the stress test result is **NOT OK** and the kick plate is detached or a gap of 1.5-2.0 mm is present near the edges after the treatment, the kick plate must be replaced.
7. If the stress test result is **OK** and no deformation has been detected, no other actions are required. ►The operation is completed.
8. Repeat the procedure for the passenger side.  
**NOTE:** Only the defective kick plate has to be replaced.
9. If deformation of the kick plate has been detected, proceed with the replacement procedure:  
**09.15.241.0 – PILOT SIDE KICK PLATE - Mounting**  
(09.15.240.0 – PASSENGER SIDE KICK PLATE – Mounting)
10. The procedure is completed.
