MAS002969/A – Blow-by pressure sensor faults

DATE: MAY 26 2022

MODELS: M156, M157, M161

ENGINE TYPES: F160 (V6), F154 (V8)

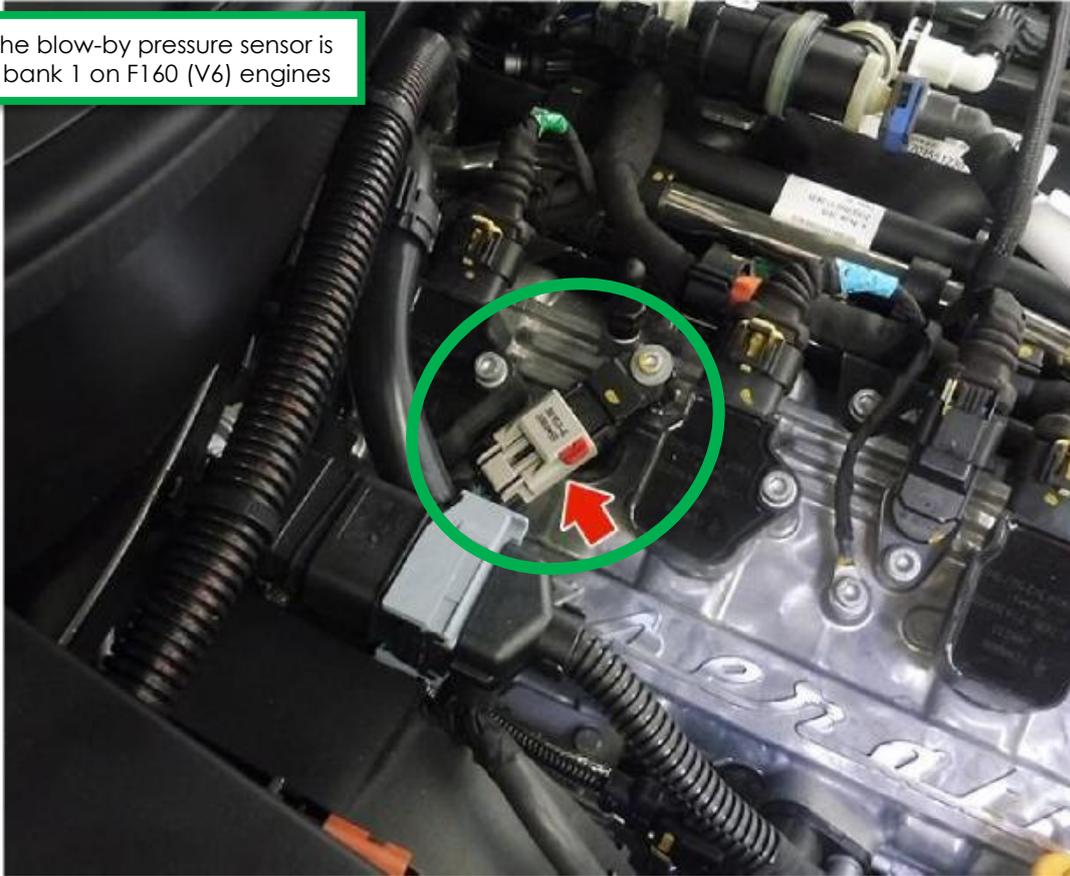
Picture 1 – the blow-by pressure sensor is located on bank 1 on F160 (V6) engines

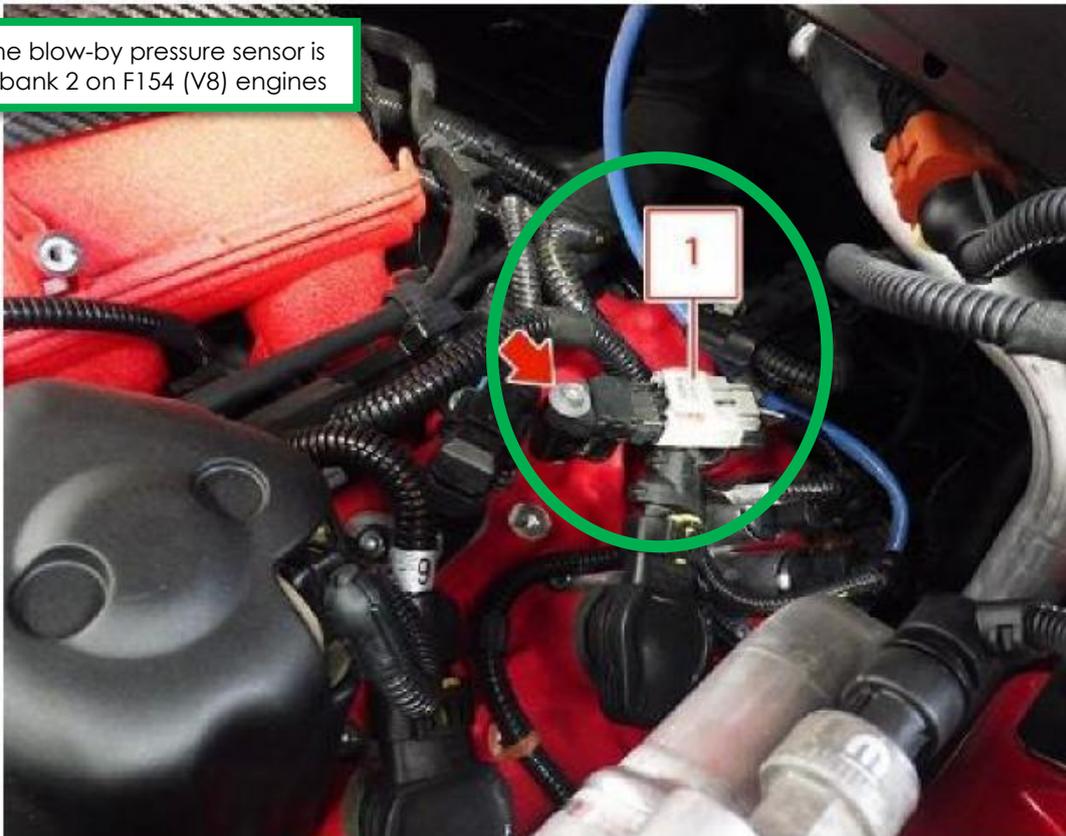
Picture 2 - the blow-by pressure sensor is located on bank 2 on F154 (V8) engines

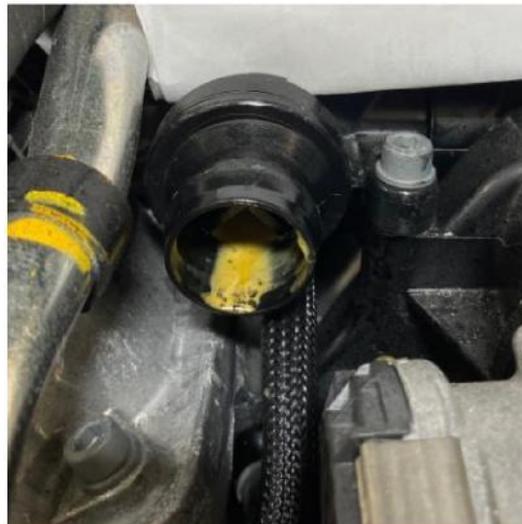
Picture 6 - blow-by valve contamination check

- 9) Disconnect the pipe between the blow-by valve and the RH turbocharger in correspondence to the area indicated in **Picture 4** (V6) and **Picture 5** (V8) below. Take pictures of the blow-by valve (see example shown in **Picture 6** as a comparison).
