Technical Journal

Center wheel caps, removal instructionREF NO:
TJ 28739.3.0ISSUING DEPARTMENT:
Technical ServiceCAR MARKET:
United States and CanadaPARTNER:
3 US 7510 Volvo Car USAISSUE DATE:
2022-04-29STATUS DATE:
2022-05-06FUNC GROUP:
7718FUNC DESC:
Hub cap**Page 1 of 7**

TJ Instruction VCC-471202-1

Title	Wheel cap	Page	1 (4)
Action	Removal	Operation number:	98522-2

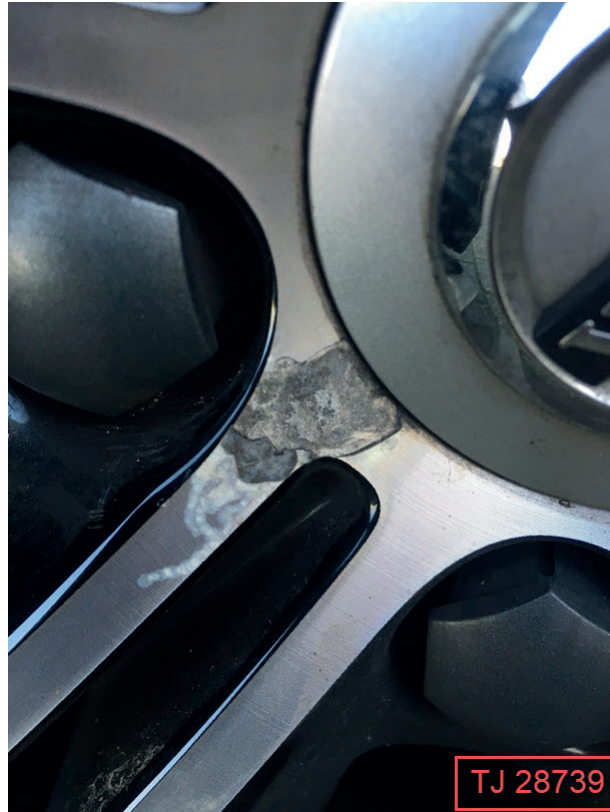
If the center wheel cap is removed incorrectly, for instance using a smallscrew driver to remove the center wheel cap from the front side, **Note:** Doing this will cause damage to the rim.

The correct way to remove the center wheel cap is to push it out from the inner side, refer to the attached TJ instruction.
