V O L V O

Technical Journal

TITLE: TCAM Rebooting, VIDA Cannot maintain connection, Loss of connectivity

REF NO:	ISSUING DEPARTMENT:	CAR MARKET:			
TJ 36254.1.1	Technical Service	United States and Canada			
3 US 7	PARTNER:	ISSUE DATE:	STATUS DATE:		
	7510 Volvo Car USA	2022-04-27	2022-05-06		
FUNC GROUP: 3970	FUNC DESC: Mobile data services	Page	1 of 6

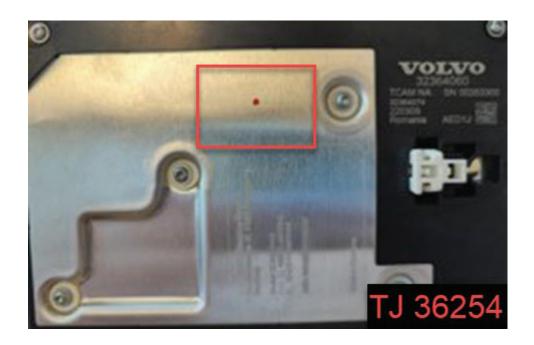
The issue has been fixed by the supplier and in production as of structure week 2022w13. Updated parts can be identified by a red or black dot marking on the underside of the TCAM (see attachment).
