GROUP	MODEL
ELE	2023MY Sportage (NQ5a)
NUMBER	DATE
256 (Rev 1, 06/03/2022)	May 2022

## TECHNICAL SERVICE BULLETIN

SUBJECT: **SERVICE ACTION: TRANSMISSION WIRE HARNESS UPGRADE AND RELATED DTC P07XX, P0880 (SA499)**

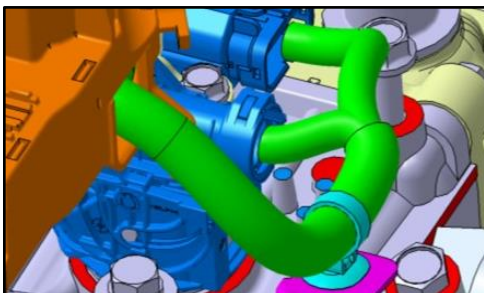
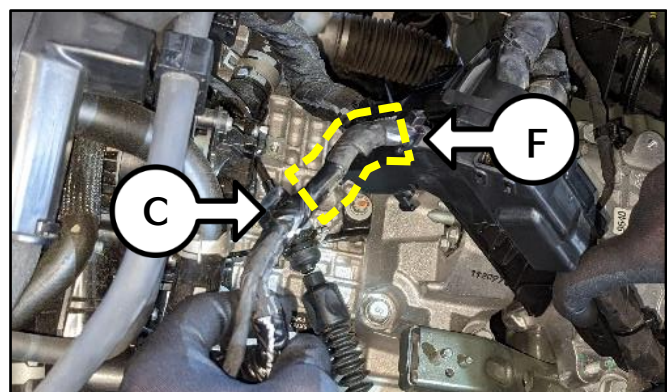
4. Locate the repair area shown between the harness clip (C) and zip tie (F).

If damage to the wire insulation is found, wrap the affected wire(s) with electrical tape prior to continuing with the repair procedure below.
