Technical Journal

Cannot lock/unlock vehicle with remote control key

| REF NO: TJ 36195.1.2 | ISSUING DEPARTMENT: Technical Service | CAR MARKET: United States and Canada | |

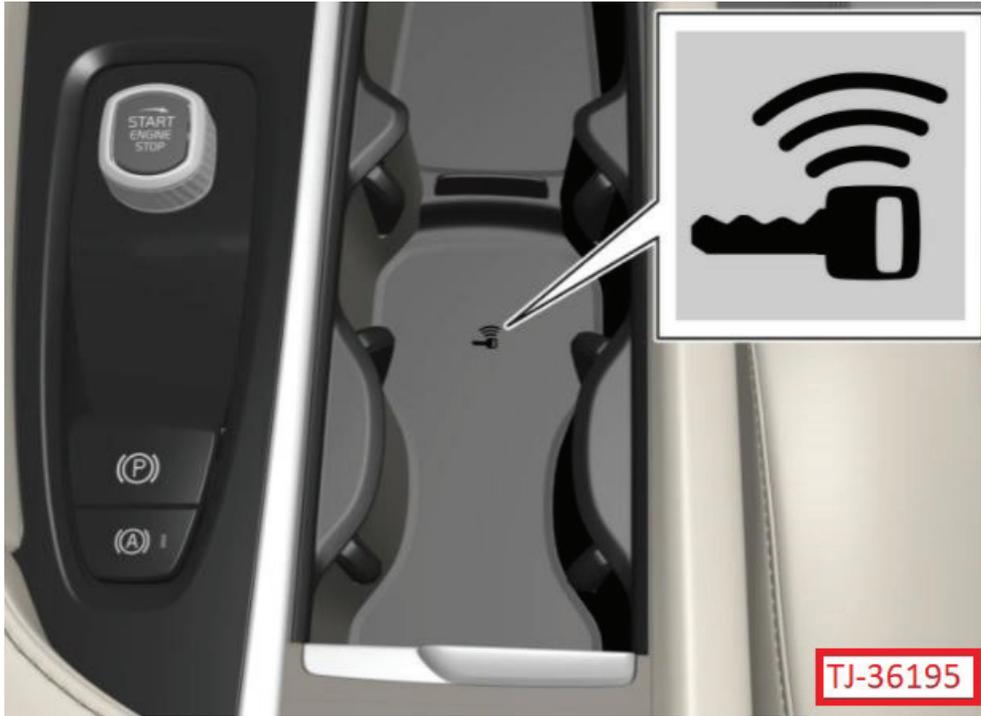
| File Name | File Size |
|---|---|
| Backup Position SPA.JPG | 0.0517 MB |

3. The vehicle can be started with the “RCK” in the backup position located in the tunnel console, while having DIM message “SOS E-call service required”. (see attachments “Backup position”)
4. No communication when attempting to connect/readout vehicle with VIDA.

1. Unlock the vehicle with the mechanical key blade inside the “RCK”.
2. Place the “RCK” in the backup position (see attachments for locations).
3. Turn the ignition switch.
4. If the vehicle “wakes up,” Press the central unlock button according to attachment (Visualization of the steps in attachment TJ-36195 PHEV.jpg)

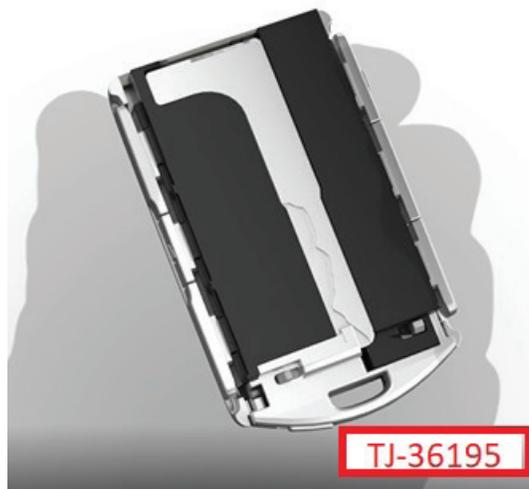
| File Name | File Size |
|---|---|
| Mechanical location.jpg | 0.0217 MB |

1. Cannot Lock/unlock vehicle with the “RCK”, but vehicle can be unlocked with the mechanical key blade located inside the “RCK” (see attachment “**Mechanical location**”).
2. If symptom #1 has been confirmed and starting the vehicle with the “RCK” in the backup position and DIM message stating, “Key not found”. (See picture for backup position location)
