Service Bulletin

Bulletin No.: 20-NA-079

Subject: Front Brake Squeal Noise Heard During Light Brake Pedal Application

Brand:	Model:	Model Year:		VIN:		Engine:	Transmission:
		from	to	from	to		
Buick	Encore GX	2020	2022	—	—	All	All
Chevrolet	Trailblazer (VIN M)	2021	2022

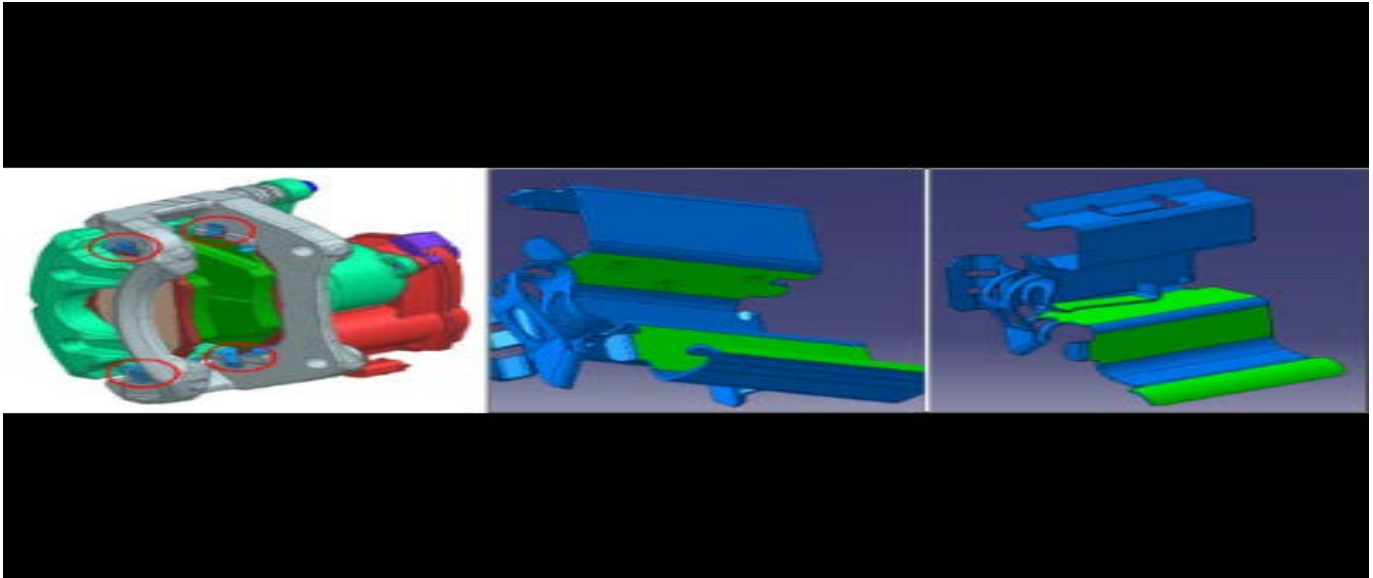
5964684

Note: There are 4 Pad abutments per caliper. The green area shown above designates the required grease positions.

2. Clean the pad spring abutment area on the caliper and anti-rattle clip.

Note: The recommended grease volume is about 1.1 g per caliper.

3. Apply Molykote M-77 Grease (GM P/N 19356408) on caliper pad spring abutment and clip as shown in the graphic above.
4. Install new front brake disc pads and sensors. Refer to *Front Disc Brake Pads Replacement* in SI.
5. Verify brake noise has been eliminated.

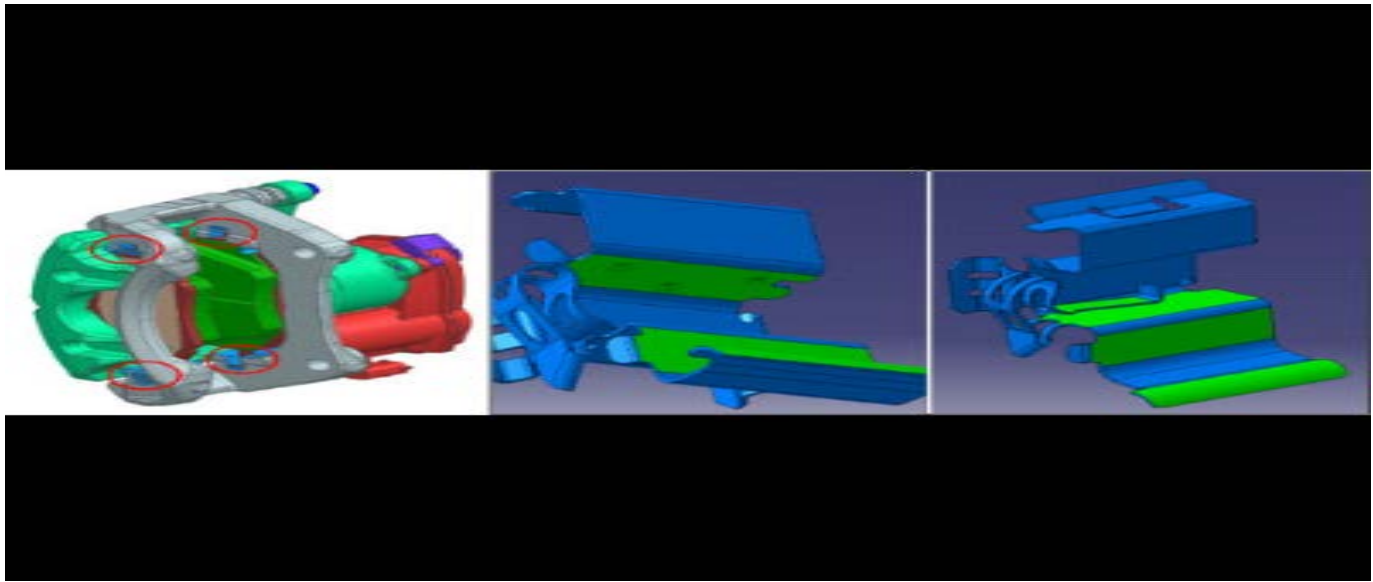
5964684

Note: There are 4 Pad abutments per caliper. The green area shown above designates the required grease positions.

2. Clean the pad spring abutment area on the caliper and anti-rattle clip.

Note: The recommended grease volume is about 1.1 g per caliper.

3. Apply Molykote M-77 Grease (GM P/N 19356408) on caliper pad spring abutment and clip as shown in the graphic above.
4. Then reinstall the existing pads. Refer to *Front Disc Brake Pads Replacement* in SI.
5. Verify brake noise has been eliminated.
