# Service Bulletin

Bulletin No.: 20-NA-165

**Subject: Flutter or Boom Noise at 1200 RPM- Service Calibration and DTC U182B Set**

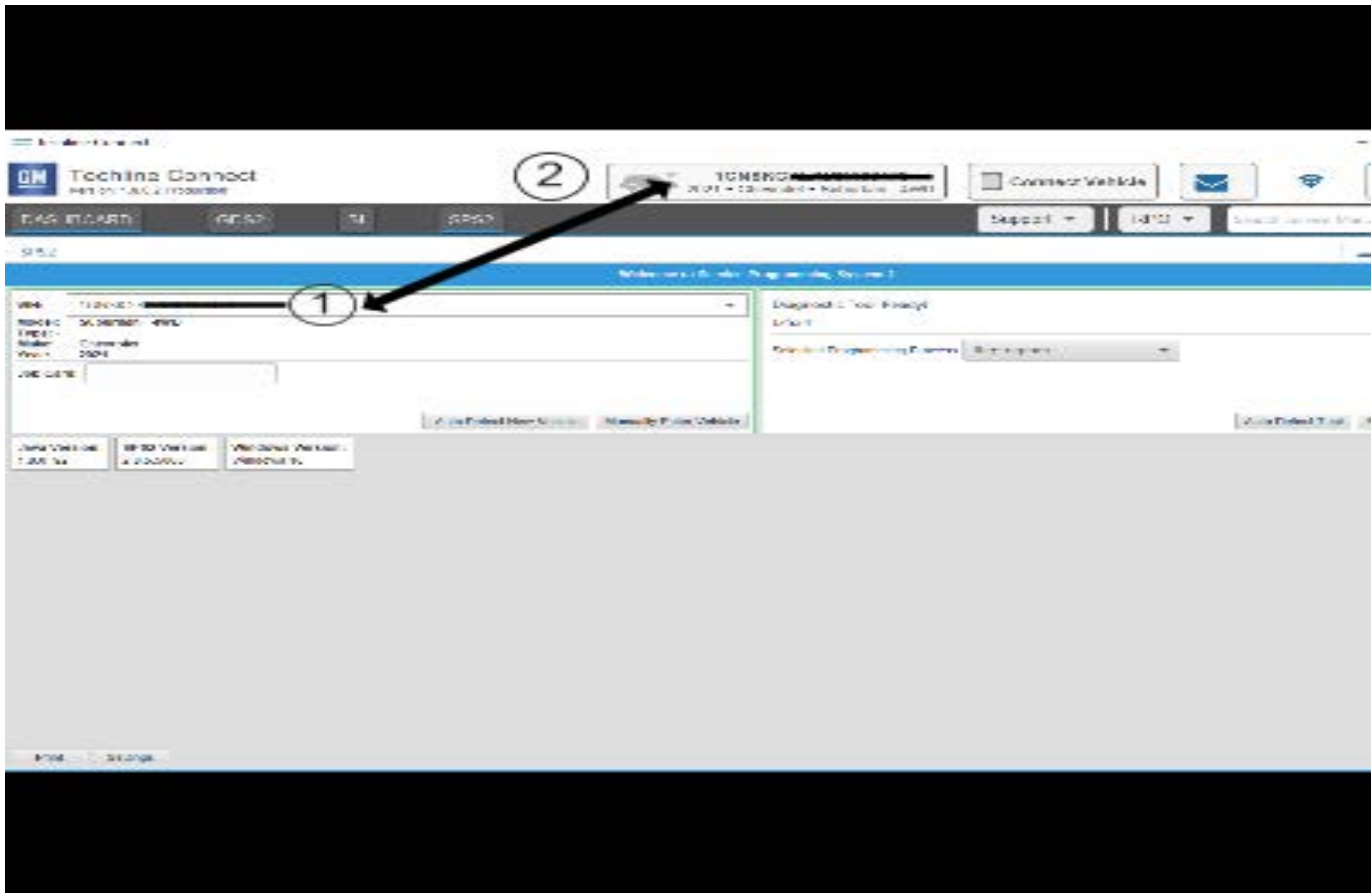
5743643

**Caution:** Be sure the VIN selected in the drop down menu (1) is the same as the vehicle connected (2) before beginning programming.

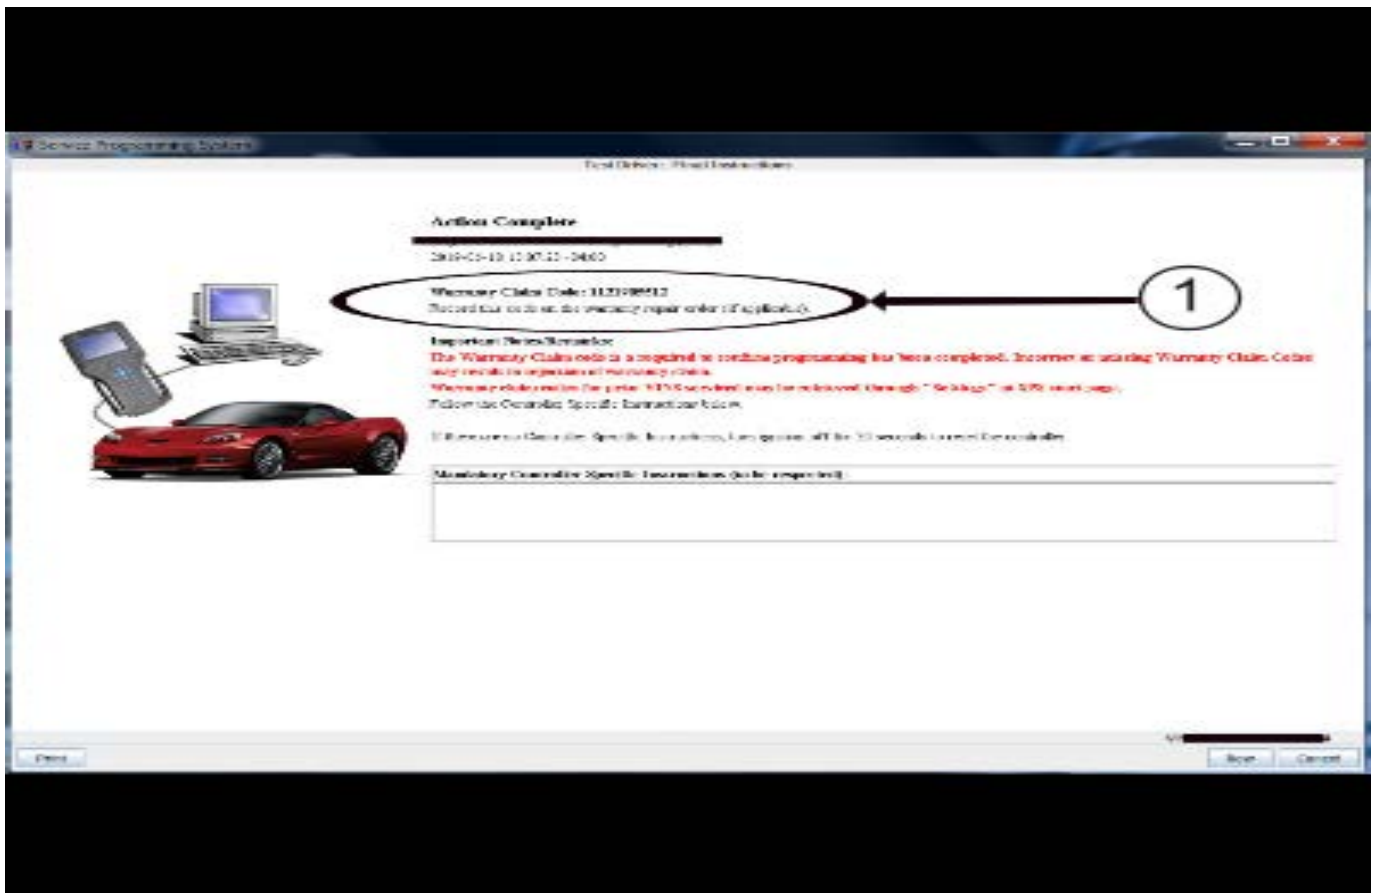
**Note:** The screenshots above are an example of module programming and may not be indicative of the specific module that is being programmed. Module selection and VIN information have been blacked out.

**Important:** To avoid warranty transaction rejections, you **MUST** record the warranty claim code provided on the SPS Warranty Claim Code (WCC) screen shown above on the job card. Refer to callout 1 above for the location of the WCC on the SPS screen.

1. Reprogram the Engine and Transmission Control Modules. Refer to *K20 Engine Control Module: Programming and Setup* and *K71 Transmission Control Module: Programming and Setup* in SI.
