Service Bulletin

Bulletin No.: 20-NA-203

Subject: Information on Manual Regeneration Displayed on Drivers Information Center (DIC)

Brand:	Model:	Model Year:		VIN:		Engine:	Transmission:
		from	to	from	to		
Chevrolet	Silverado	2018	2018			L5P	
	Silverado 2500/3500	2019	2022				
GMC	Sierra	2018	2018				
	Sierra 2500/3500	2019	2022

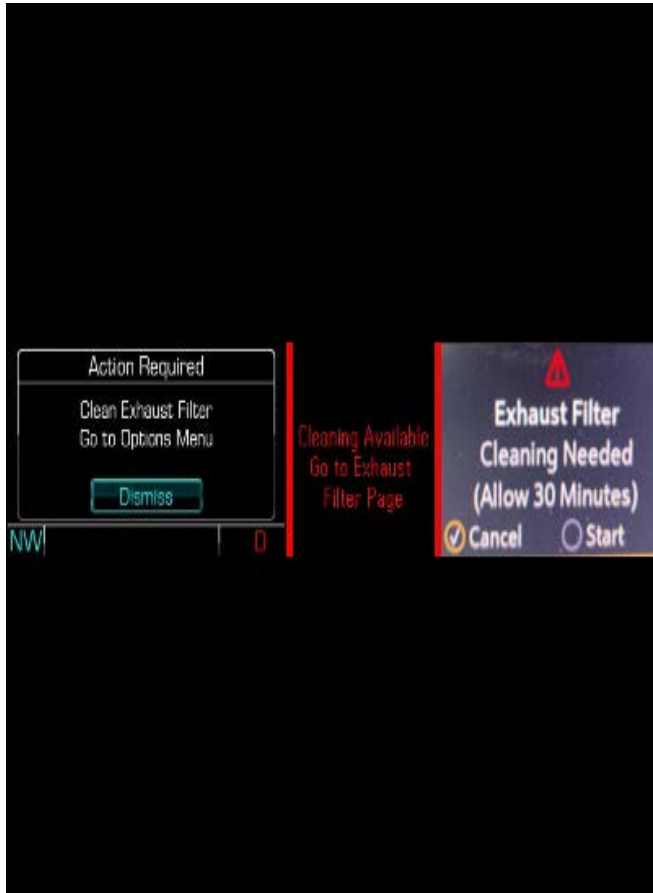
5654544

At approximately 90% soot load in the DPF, one of the messages in the graphic above will be displayed on the DIC.

These messages indicate that Manual Regeneration is available. No action is required; however, the operator may choose to perform a manual regeneration. See performing a manual regeneration below. If the message is dismissed and the vehicle has not performed a regeneration, this message will appear again on the next key on cycle.

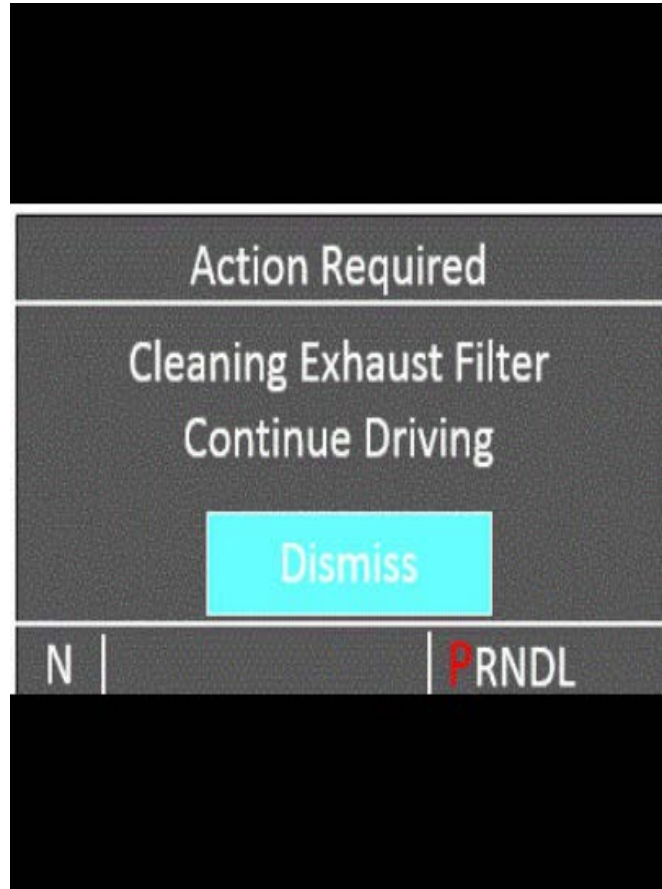
5654545

If the soot level climbs to a level near 110 - 115% in the DPF while the vehicle is moving and the vehicle is still not able to start an automatic regeneration, the message in the graphic above will display.

If the message is displayed, continue driving safely at a steady speed as close to the posted speed limit as possible until the message turns off. This can take up to 30 minutes.

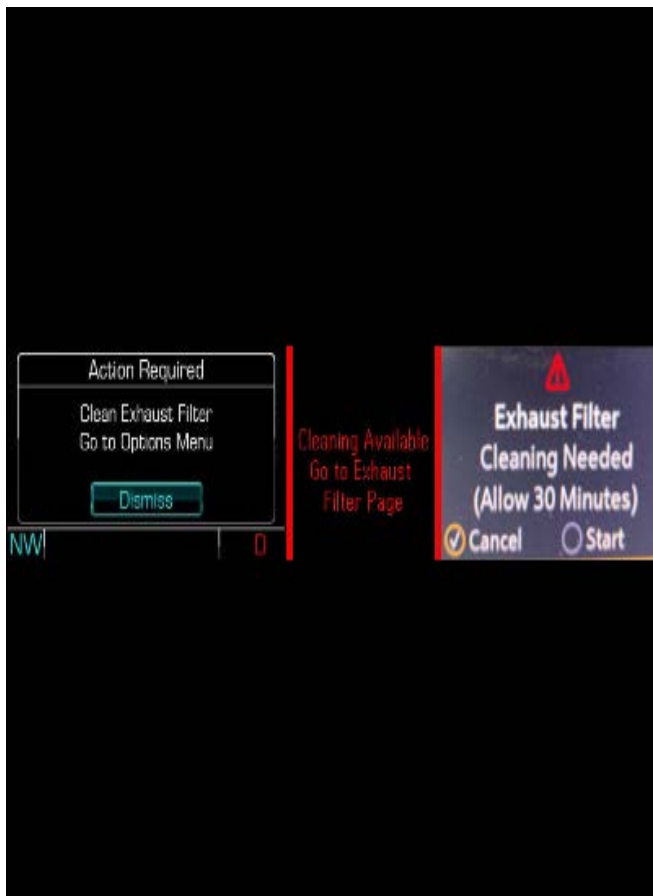
5654544

If the vehicle is shifted to park, one of the messages in the graphic above will appear.

These messages indicate that Manual Regeneration is available.

⇒ Refer to *Performing a Manual Regeneration* below.

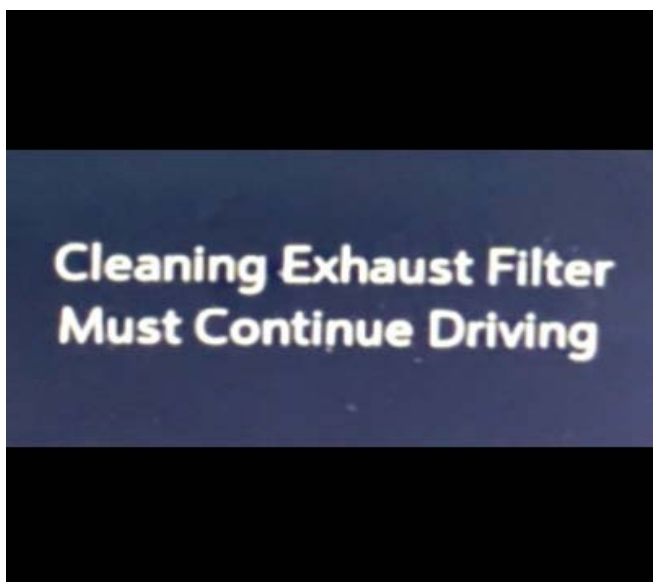
5654703

If the soot level climbs to a level near 130% in the DPF while the vehicle is moving and the vehicle is still not able to start a regeneration, the message in the graphic above is displayed.

If the vehicle is placed into park, the above message will not change and there will not be an opportunity to perform a manual regeneration. The vehicle must be driven to initiate an automatic regeneration. Continue driving safely at a steady speed as close to the posted speed limit as possible, until the message turns off. This can take up to 30 minutes.

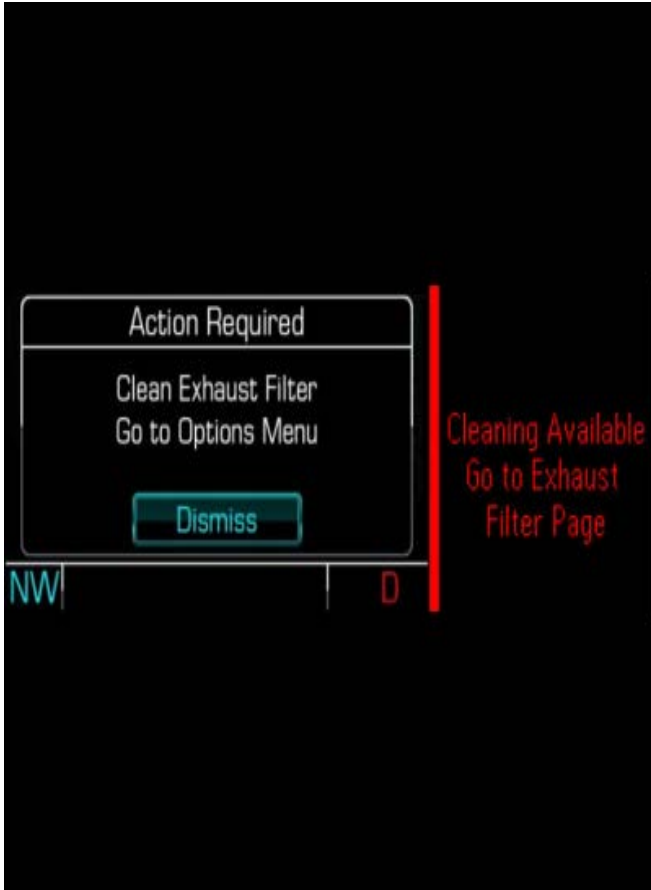
5654593

If the vehicle is being driven and the message in the graphic above is displayed, the operator may choose to stop the vehicle to perform a manual regeneration.

⇒ Please be sure to note and locate the vehicle in accordance with the warning and safety conditions listed above.

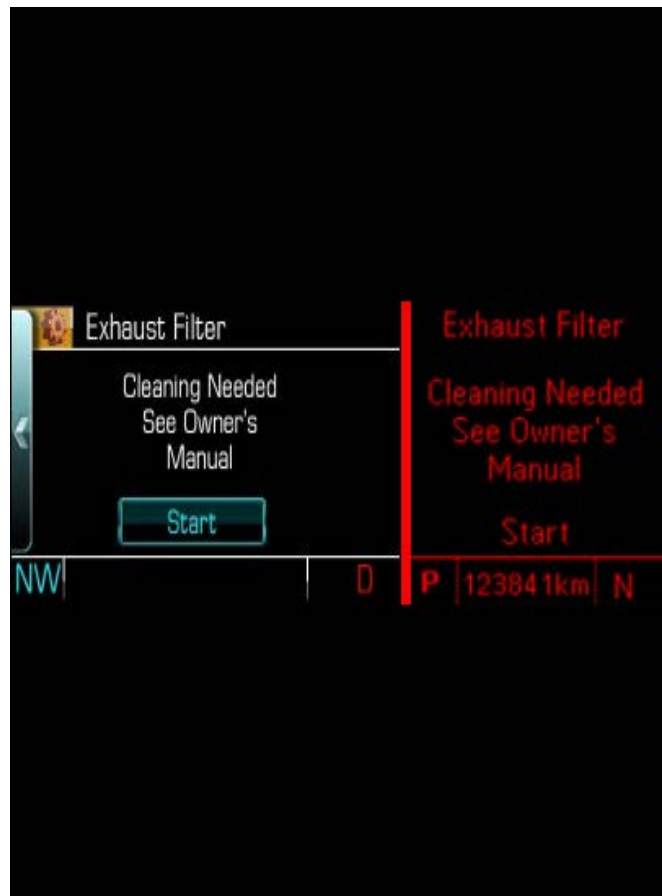
5654712

When shifting to park, scroll through the DIC pages to find the Exhaust Cleaning menu. Depending on whether the vehicle has a base or up level cluster, it may be under the Settings menu. The DIC will display a reference to refer to the Owners Manual as shown in the graphic above.

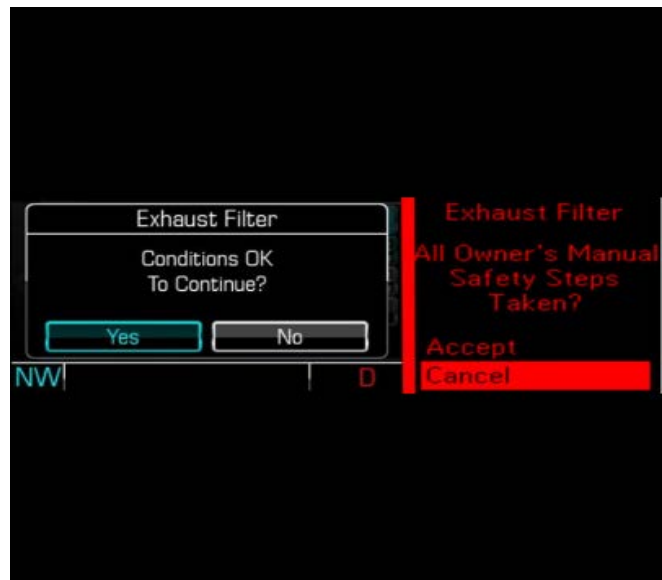
5654762

After making sure all the safety conditions have been met, press the trip odometer reset stem or the Check-Mark on the steering wheel control for at least one second to select Start on the DIC. The DIC will display in the graphic above.

Follow the instructions in the DIC messages. Select Yes or Accept to acknowledge that all the safety conditions have been met and to activate regeneration.

If the DIC returns to the previous screen, then one or more of the necessary operating conditions has not been met. If you cannot determine which condition has not been met, refer to www.gmupfitter.com to contact the GM Upfitter Integration Group for assistance.

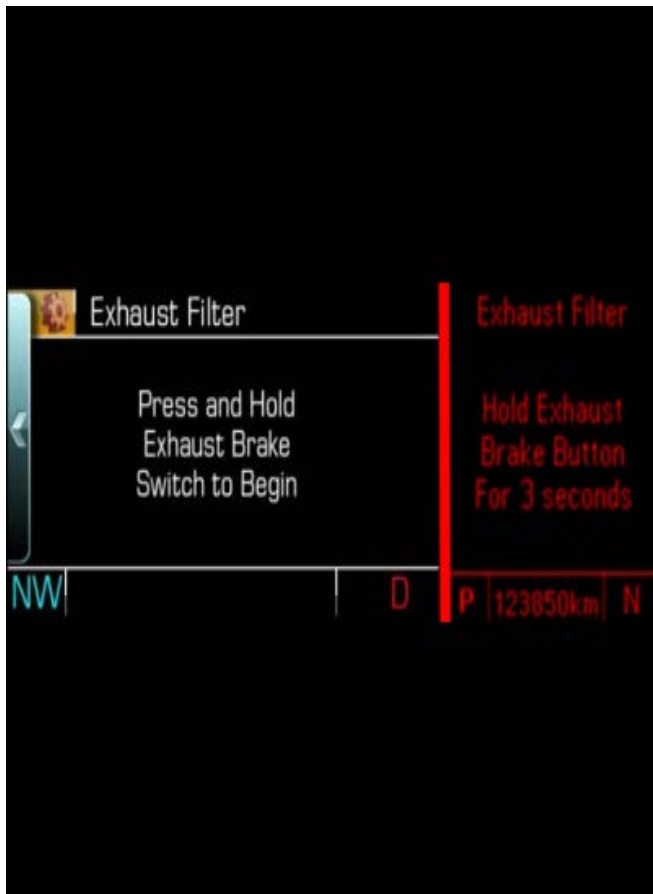
5654697

If all requirements for the manual regeneration are met, the DIC will display to Press and Hold Exhaust Brake Switch to Begin as shown in the graphic above.

Hold the exhaust brake switch on the center stack below the climate controls for more than three seconds, and then release it, to begin the regeneration process.

If the EXHAUST BRAKE ON message displays, then the switch was released too soon. Press it again to turn off the exhaust brake, then try again when the DIC message prompts.

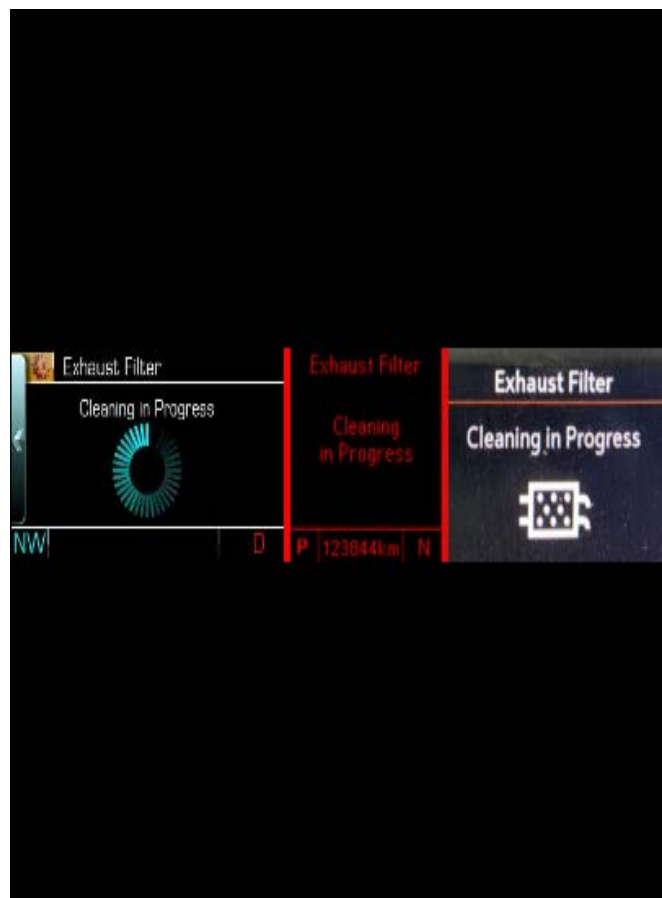
5654694

When manual regeneration begins, the engine speed increases, the engine cooling fan sound increases and the message in the graphic above will be display.

Warning: Do not leave the vehicle unattended during the Manual Regeneration.

Cleaning could take up to 30 minutes. Upon completion, the engine will return to normal idle, but exhaust components will remain hot for several minutes. Do not move the vehicle until the exhaust has had time to cool. Manual regeneration can be canceled at any time by pressing the brake pedal or turning the engine off. Unusual noises may be heard if regeneration is interrupted.

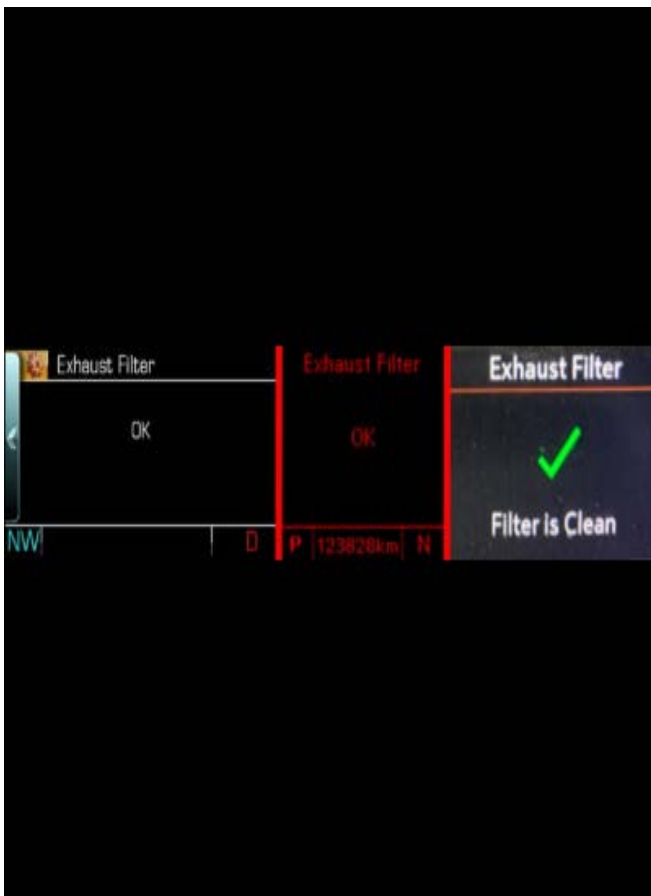
5654688

For vehicles equipped with FPF and NOT ANM, the message in the graphic above will be display when the regeneration process is finished.

The message will remain when cleaning is not necessary.

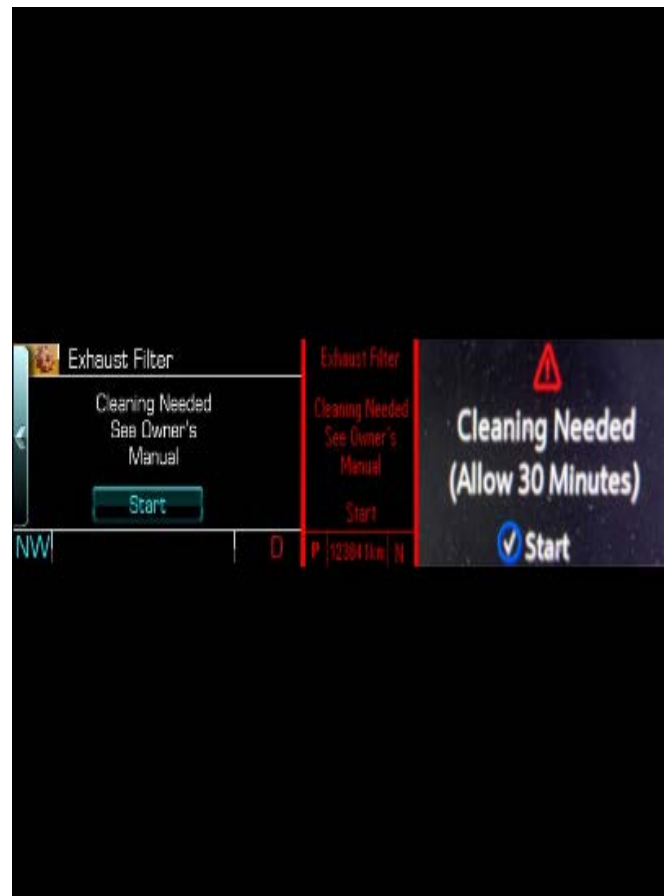
5654666

For vehicles equipped with FPF AND ANM, the message in the graphic above will be display.

If a manual regen was just performed, the presence of this message is not an indication that the vehicle needs another regeneration. The DPF is clean. This is displayed because manual regeneration can only be initiated if the above message is displayed. Since a vehicle with ANM is permitted to perform a regeneration at any soot level in the DPF, once the regeneration is complete, the above message needs to be displayed. Provided that the engine idled up, the exhaust sound changed and/or there was a different smell from the exhaust, be assured that there is a very low soot level in the DPF when this message reappears.
