Service Bulletin

Bulletin No.: 21-NA-246

Subject: Unwanted Front Windshield Wiper Swipe, Cruise Control Will Not Turn On, Steering Wheel Controls Inoperative, DTCs P155A/00, B1529/03

Brand:	Model:	Model Year:		VIN:		Engine:	Transmission:
		from	to	from	to		
Buick	Encore	2019	2020	—	—	All	All
Chevrolet	Trax

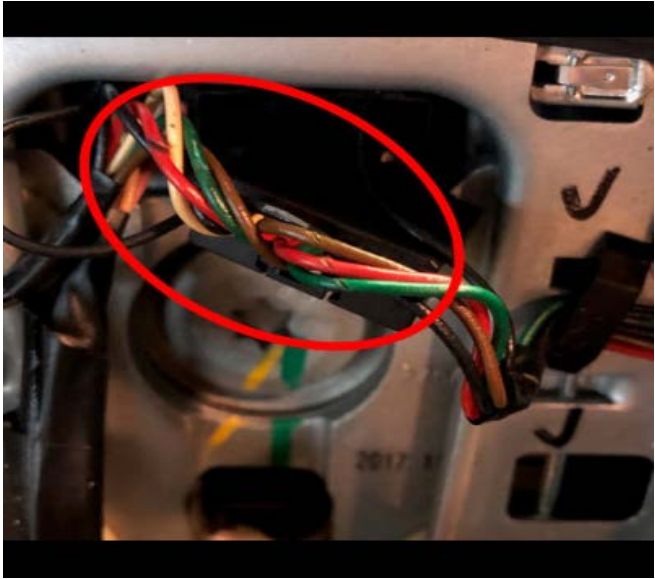
<p style="text-align: right;">5480325</p>

Involved Region or Country	North America
Condition	<p>Some customers may comment on one or more of the following conditions:</p> <ul style="list-style-type: none">• Unwanted front windshield swipe upon starting or powering up the vehicle.• Front wipers will not park.• Steering wheel controls inoperative or erratic operation.• Upon a vehicle scan check, DTCs P155A/00, B1529/03 might be stored current or in history.

<p style="text-align: right;">5480327</p> <p>The cause of the condition may be the steering wheel harness shorted under the steering wheel inflator module.</p>
<p>Correction</p>	<p>If you encounter a vehicle with the above concern, inspect and repair the steering wheel harness referring to the proper wire repair procedures. Refer to <i>Wire to Wire Repair</i> in SI.</p>
