Service Bulletin

Bulletin No.: 21-NA-277

Subject: No Crank, No Start, B2924 00, B3925 00, B3926 00, B3927 00 or P0513 Set

Brand:	Model:	Model Year:		VIN:		Engine:	Transmission:
		from	to	from	to		
Chevrolet	Malibu	2019	2022	—	—	All	All

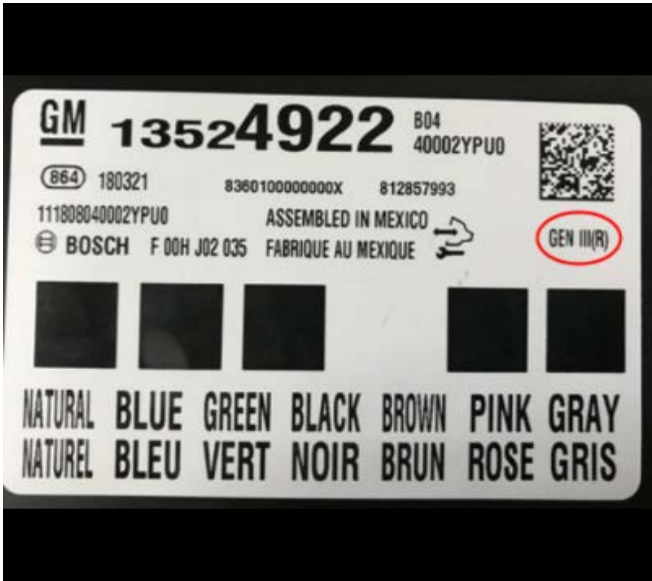
Involved Region or Country	United States, Canada
<p>Condition #1</p>	<p>Note: This is NOT related to an ongoing BCM diagnostic. Unrelated to a no start of vehicle security issue. This is a very specific issue and rare occurrence U code communication diagnostics must be resolved first. Follow the bulletin detail as written. Some customers may comment the vehicle will not crank or will start and immediately stall.</p> <div style="text-align: center;">

</div> <p style="text-align: right; font-size: small;">5926221</p> <p>This procedure ONLY applies to the Gen III® BCM! Reference (circled in red above) designation on the module. Ensure the existence of this designation before attempting this procedure!</p> <p>One or more of the following conditions may be observed:</p> <p>Multiple Environment IDs Present</p> <ul style="list-style-type: none"> • Three or more of the following Environment ID DTCs (B2924 00, B3925 00, B3926 00, B3927 00) are present, and current in the BCM. The specific codes and the number of codes present depends on the vehicle and vehicle content. • Three or more of the following Environment ID DTCs (B3978 00, B3979 00, B3980 00, B3981 00) are current in the BCM. • The BCM may have set DTC B389A 00, and it is current. *If there is no DTC B389A 00, disconnect/reconnect battery for a minimum of 30 seconds and check again for DTC B389A. <p>If the above criteria is not met, this bulletin does not apply. Continue with normal SI diagnosis.</p> <p>Important: Do not attempt the immobilizer procedure or module replacements.</p>
