Service Bulletin

Bulletin No.: 21-NA-149

Subject: Engine Wire Harness Chafing / IPC Gauges Sweep / IPC Warning Message / SES/Check Engine/MIL / No Start / No Crank / Runs Rough / Stalls / Reduced Engine Power / Various DTCs

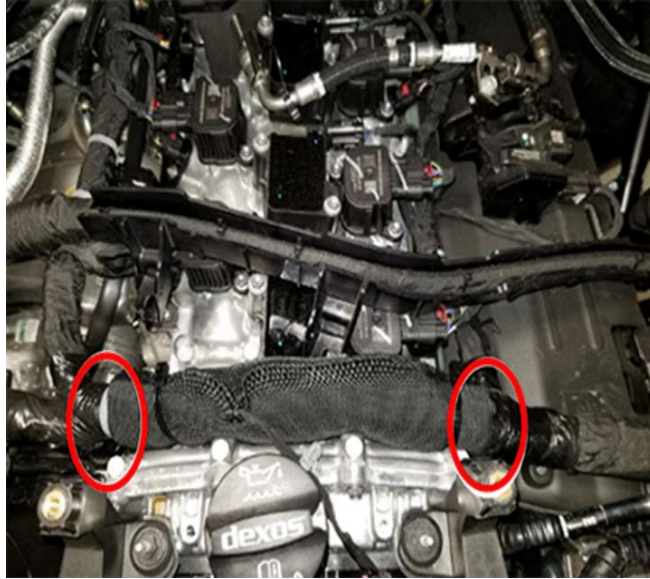
5394681

This Cause pertains to vehicles equipped with engine 2.7L, L3B only.
These concerns may be caused by engine harness contact with under hood components.
Caution: This Document Only Applies To VINs NOT Covered by Customer Satisfaction Program N192219370 Please Verify In VIS Before Proceeding
Shown below are areas that should be inspected for this concern.
Inspect the engine harness as it crosses over top of the Camshaft Carrier Cover.
Harness damage can occur at any point across the Camshaft Carrier Cover.
Typical inspection locations shown below.

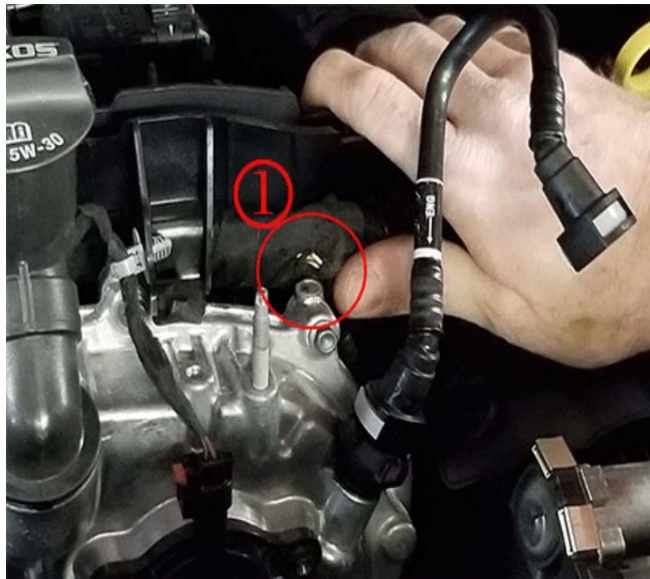
5324748

Example of engine wiring harness damage at Camshaft Carrier Cover shown below.

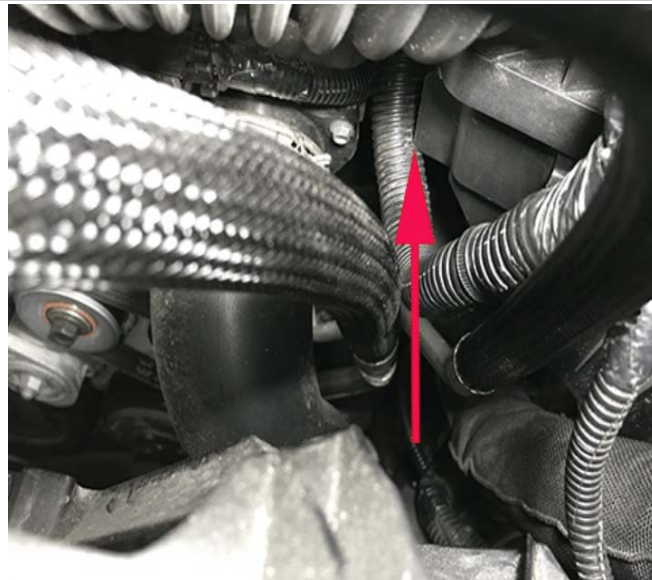
5394683

Inspect the engine harness at the Lower Air Cleaner Housing as shown below.

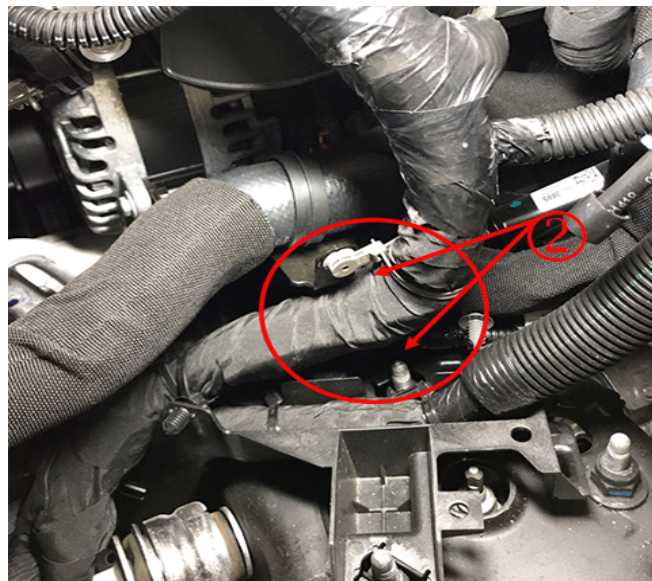
5324752

Example of engine harness damage, Lower Air Cleaner Housing removed shown below. Inspect the engine harness at the Generator Bracket and Left Front Coil Spring stud as shown below.

Note: Under normal driving conditions, the engine will rock back and forth in its mounts.

This may result in harness contact with this bracket that may not be present during engine off inspections.

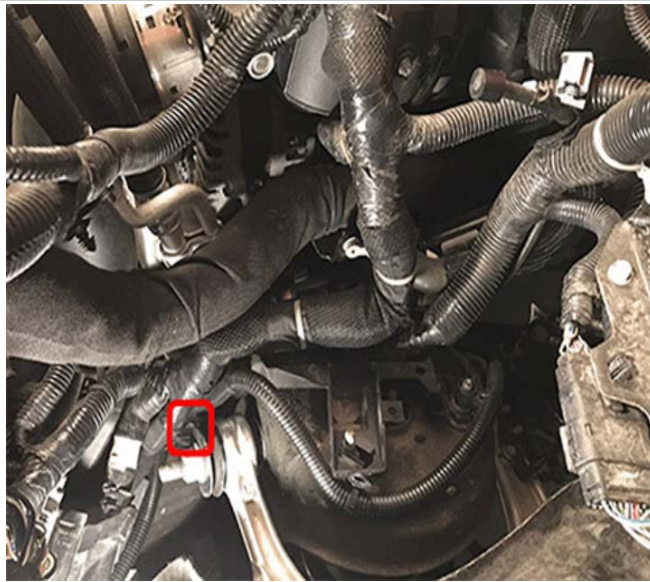
5394677

Inspect the engine harness at the Left Front Upper Control Arm Bushing as shown below.

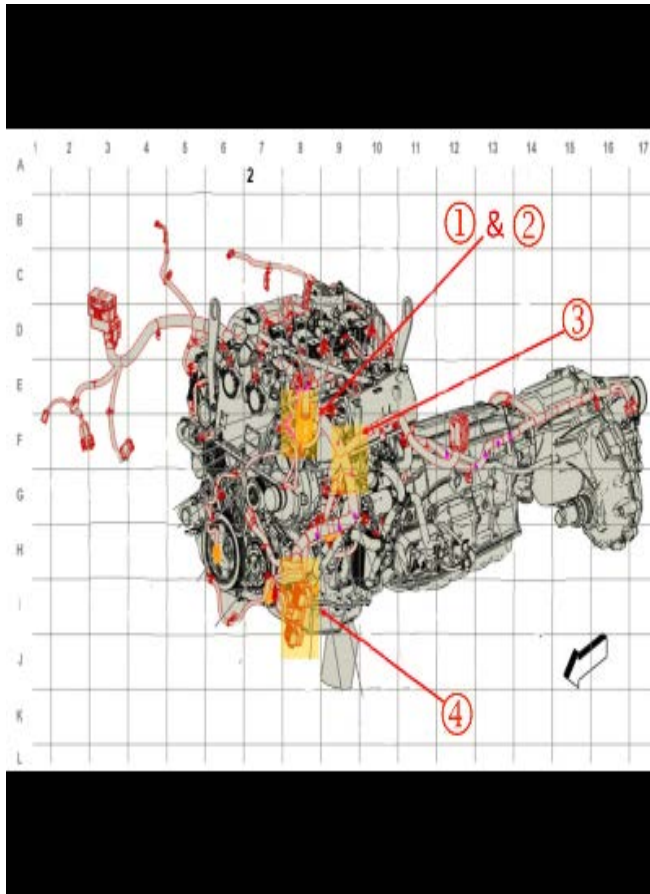
5911724

These concerns could be caused by engine wiring harness chafe on underhood components at various locations:

- Front corner of the left hand cylinder head (1)
- Drive belt idler pulley bracket (2)
- Oil Dipstick bracket (3)
- ECM/TCM bracket (4)

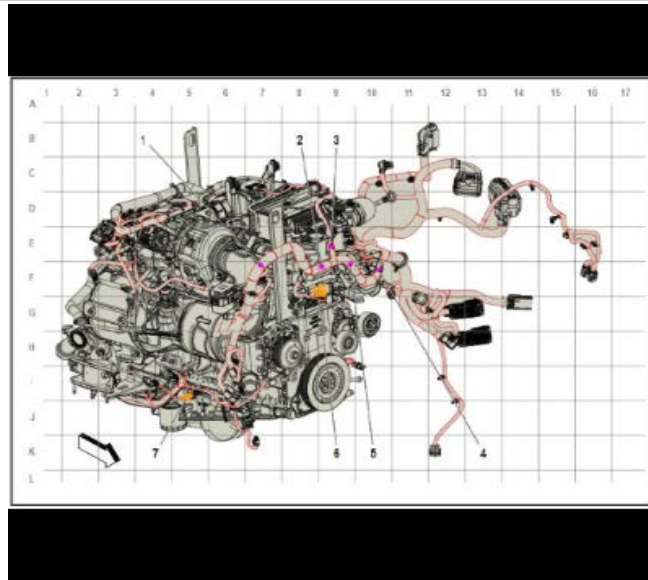
5949730

1. Inspect for poor terminal tension at connector X160, shown above, as callout 6. While inspecting X160 make sure the terminal locking feature (4) is not missing.
2. Inspect the fuel injector connectors to make sure they are fully connected/seated.
3. Inspect the fuel injector wiring harness near the X160 connector (3) for being pinched/shorted/chaffed, as shown below (5).

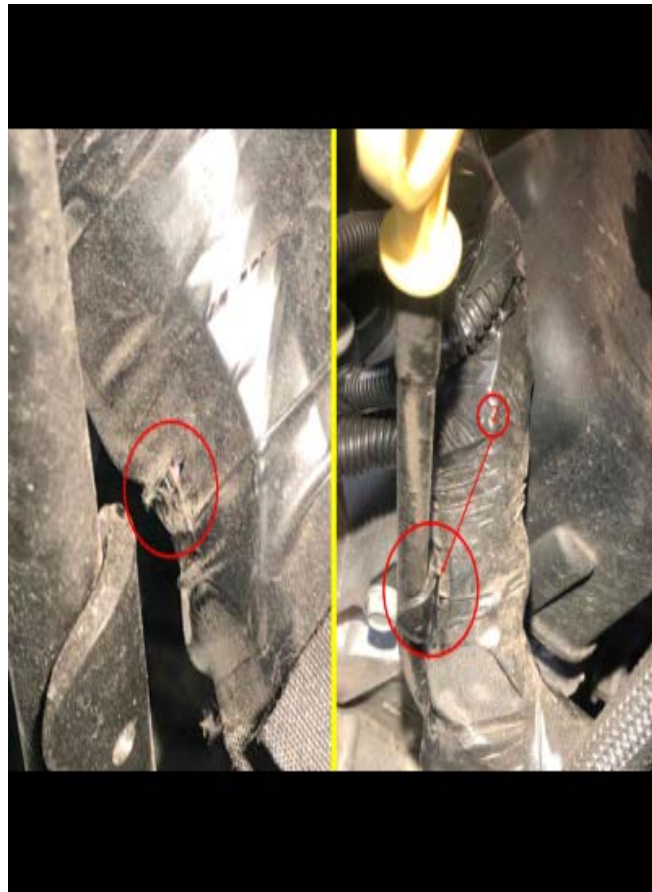
5911722

This Correction pertains to vehicles equipped with engine 4.3L, LV3 only.
Note: The first graphic below is a before, and after (2), repair example of harness chaffing at the Oil Dipstick bracket.

To correct this concern, repair the damaged wiring following the SI wire-to-wire repair procedures. Once repaired, protect and reposition the engine wiring harness to prevent future harness damage.

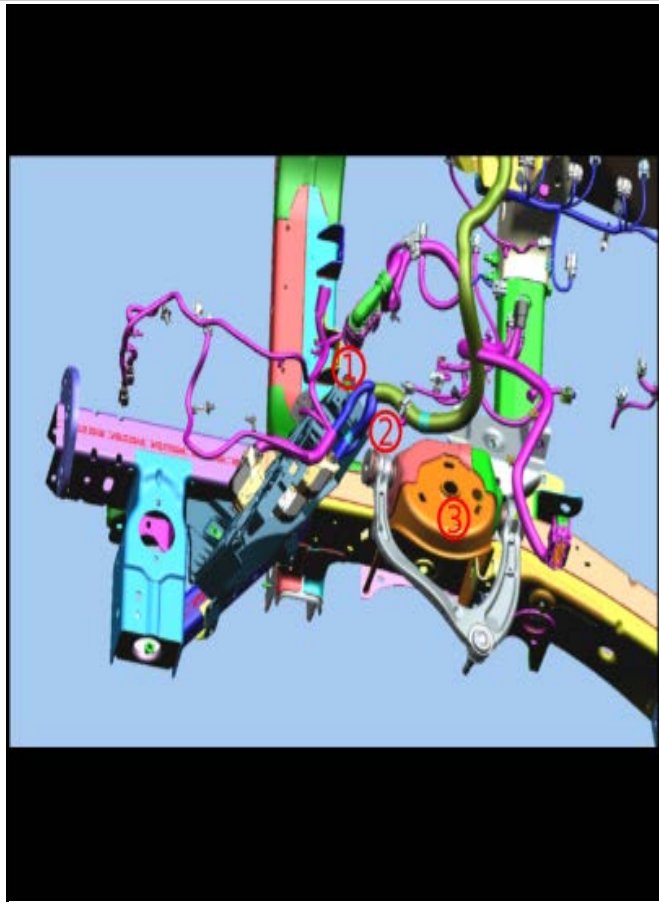
5868341

3. Locate the three contact points where the wire harness is chaffing, the ECM/TCM black bracket (1), the upper control arm (2), and the shock tower bolt (3).

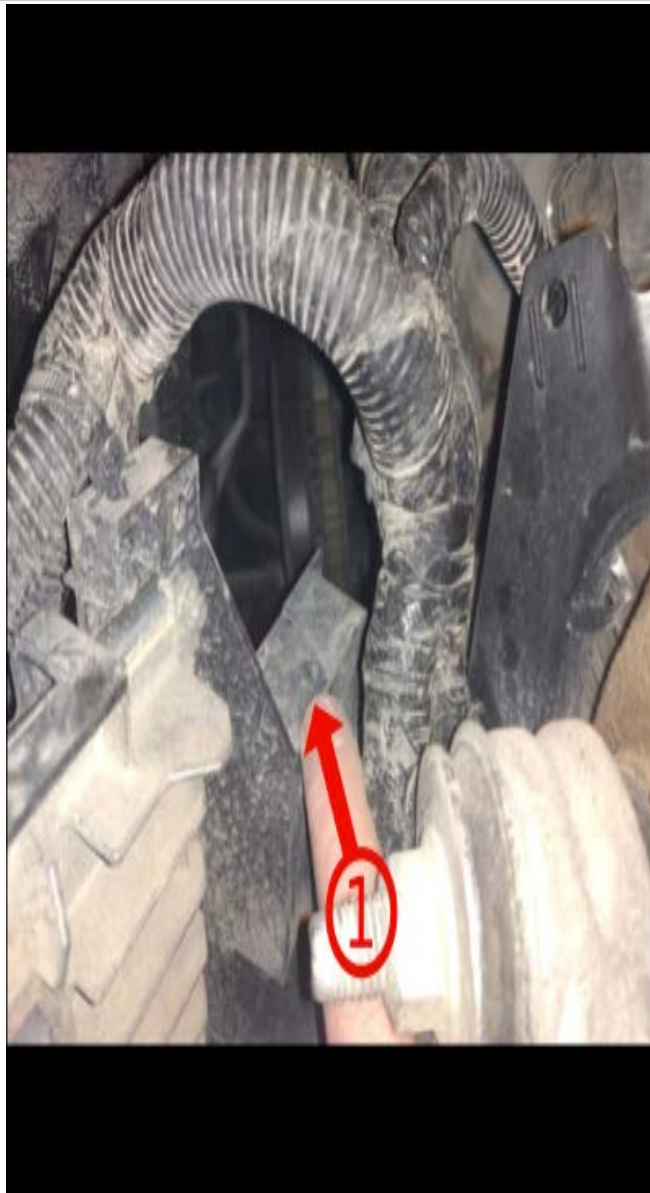
5868349

4. At the ECM/TCM bracket, locate the wire harness laying against the ledge (1).
