# Service Bulletin

Bulletin No.: 21-NA-192

**Subject:** Convertible Top May Not Lower Intermittently, DTC B19E4 SYM64 May be Stored in History

Brand:	Model:	Model Year:		Date Breakpoint:		Engine:	Transmission:
		from	to	from	to		
Chevrolet	Corvette	2020	2022	SOP	January 15, 2022	All	All

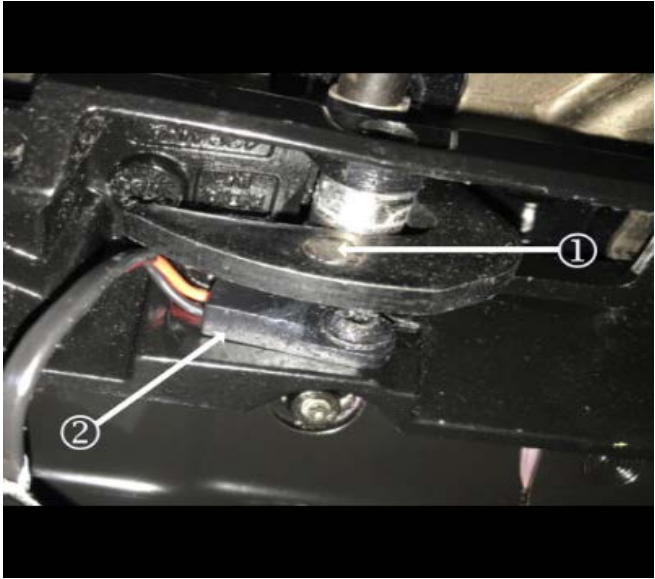
<b>Involved Region or Country</b>	North America, Middle East, Europe
<b>Condition</b>	Some customers may comment that the convertible top may not lower intermittently. Technicians may find DTC B19E4 SYM64 stored in history.
<b>Cause</b>

<p style="text-align: right; font-size: small;">5892481</p> <p><b>Note:</b> This hall effect sensor (2) is looking for the roof to be fully latched at the header. We have seen cases where the hook is not extending far enough to reach the magnet (1). The cause of the condition may be that the hall effect sensor, in the right side folding top front latch striker, may be out of position.</p>
<b>Correction</b>	The simplest solution is to adjust the right side folding top front latch striker following the steps in the Service Procedure below.
