Service Bulletin

Bulletin No.: 21-NA-219

Subject: Elevated Idle Feature Not Available

Brand:	Model:	Model Year:		VIN:		Engine:	Transmission:
		from	to	from	to		
Cadillac	Escalade	2021	2022			LM2	
Chevrolet	Silverado 1500	2020	2022				
	Suburban Tahoe	2021	2022				
GMC	Sierra 1500	2020	2022				
	Yukon Yukon XL	2021	2022

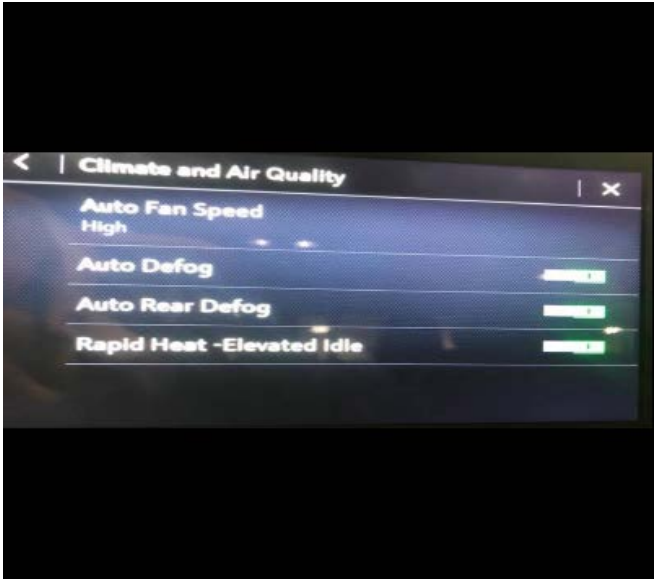
Involved Region or Country	North America, Chile and Uruguay
Additional Options (RPOs)	
Condition	<p>Some customers may comment their Elevated Idle Feature is not working. "Rapid Heat – Elevated Idle" feature appears as an infotainment display personalization menu selection under "Climate and Air Quality" that can be turned on and off.</p>

Cause	The cause of the condition may be that this feature is not functional on the vehicle and the display references to the feature need to be removed.
Correction	<p>For 2020 Applications – No updated calibration available. Inform customer this feature is not available.</p> <p>For 2021 Applications - Reprogram the ECM.</p> <p>Important: At the end of the programming, the Elevated idle function will not be on the vehicle and the messages will be removed.</p>

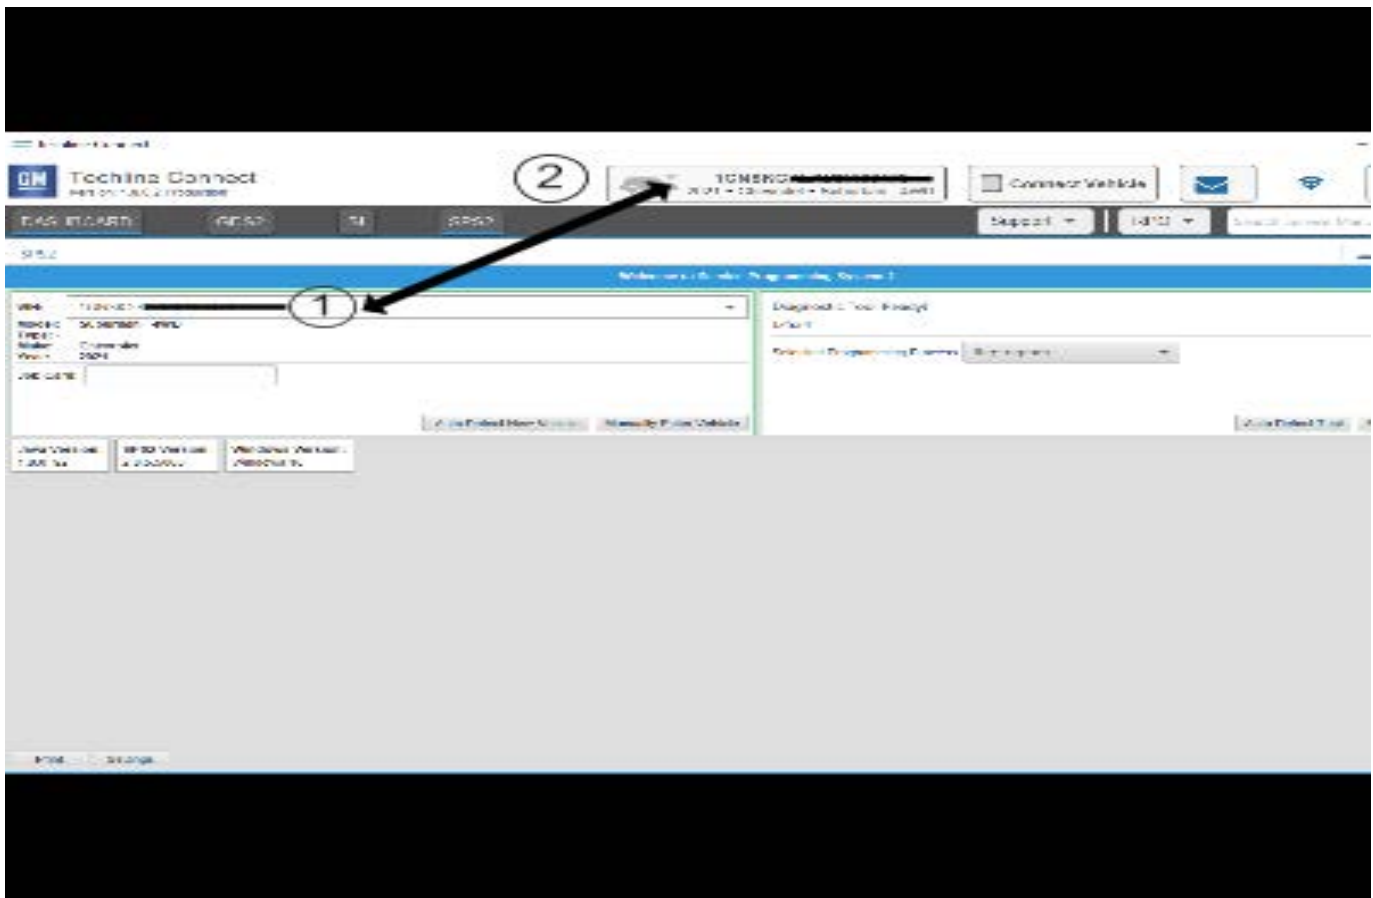
5743643

Caution: Be sure the VIN selected in the drop down menu (1) is the same as the vehicle connected (2) before beginning programming.

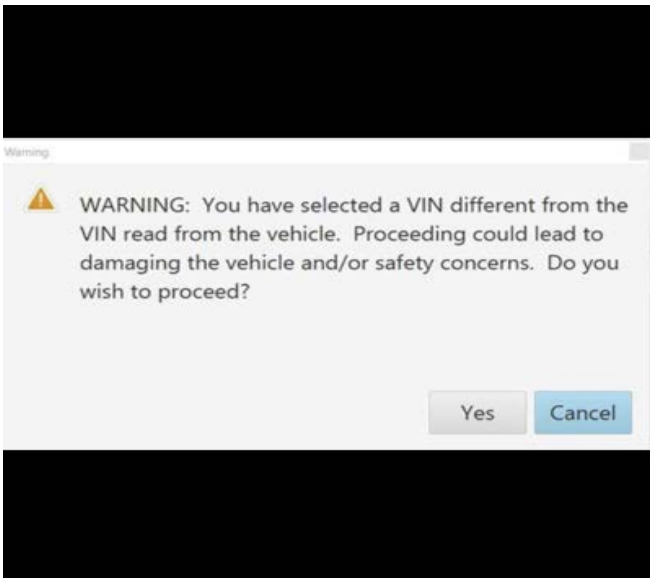
5877000

Important: If the vehicle VIN DOES NOT match, the message below will be shown
