Service Bulletin

Bulletin No.: 21-NA-228

Subject: Full Size Trucks Idle Time-out Disable

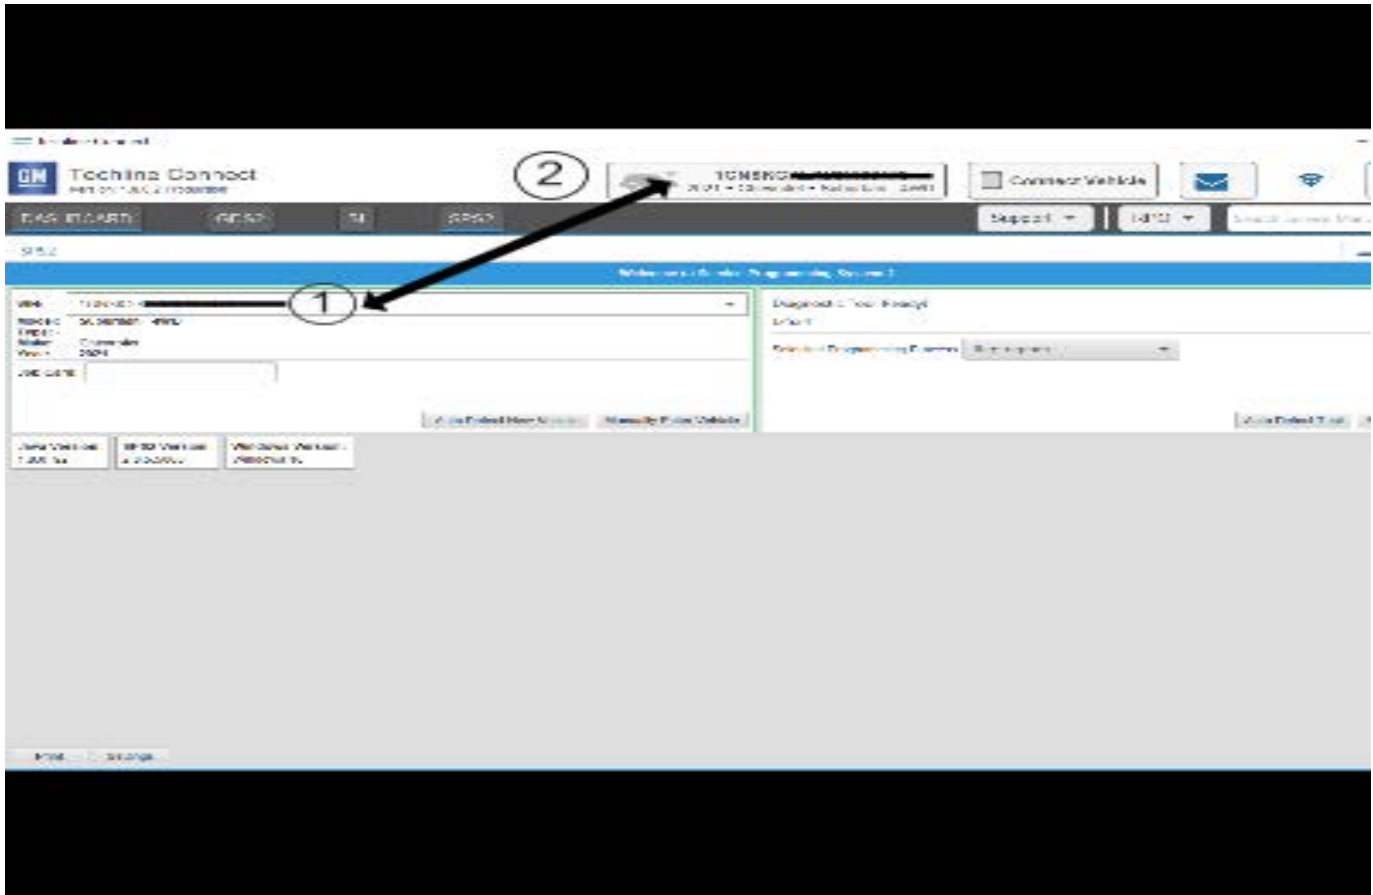
5743643

Caution: Be sure the VIN selected in the drop down menu (1) is the same as the vehicle connected (2) before beginning programming.
