Service Bulletin

Bulletin No.: 22-NA-019

Subject: Malfunction Indicator Lamp (MIL) Illuminated with DTC P2251 and/or DTC P2254 Set

Brand:	Model:	Model Year:		Breakpoint Date:		Engine:	Transmission:
		from	to	from	to		
Chevrolet	Corvette	2020	2020	—	—	6.2L (LT2)	—
		2022	2022	SOP	November 16, 2021

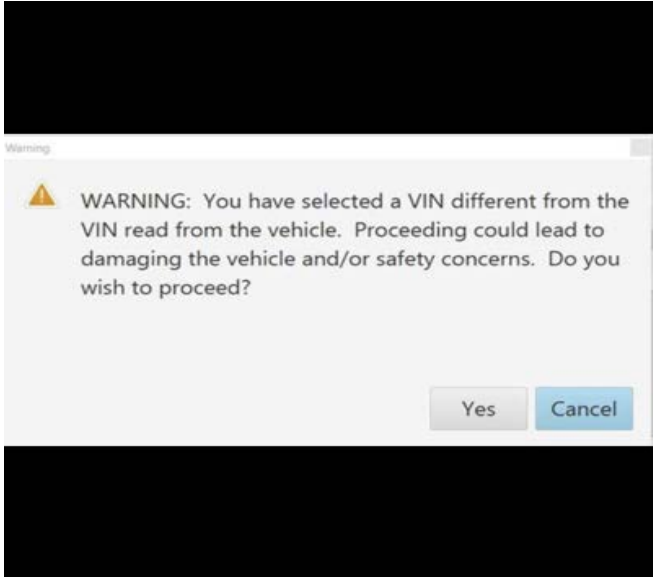
5877000

Important: If the vehicle VIN DOES NOT match, the message below will be shown.
