## **Service Bulletin**

Bulletin No.: 22-NA-022

Subject: Diagnostic Tip for LM2 Diesel with a Rear Main Oil Leak with or without DTC P06DD set

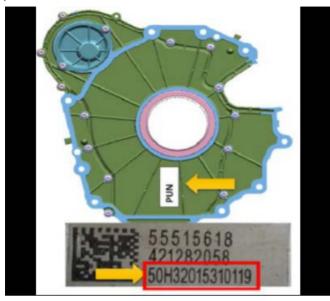
5786767

Refer to Timing Chain Lower Cover Installation in SI. Record the Part Unique Number found on the white label attached to the back of the cover as shown in the picture below.

Example: PUN 50H32015310119

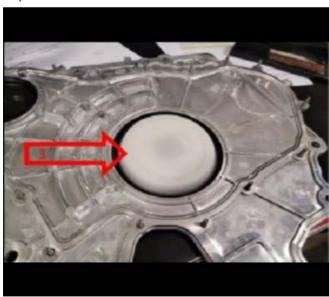
5786654

The Timing Chain Lower Cover comes with a 2 piece protector/installer.

The inner piece becomes an installation tool.

The outer piece simply holds them together for shipment.

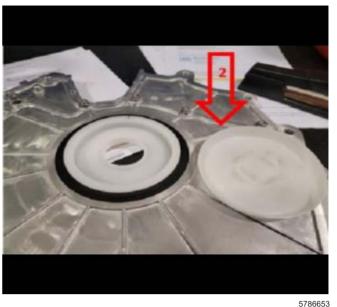
Note: The inner piece is an installation tool designed to be a substitute for the EN52466-2 installation tool. It fits over the bevel on the end of the crankshaft to facilitate installation. Be extremely mindful that the inner lip of the seal slides over the rear of the crankshaft without rolling or a repeat oil leak will occur. The protector/installer has a snug fit to the pilot of the crankshaft.

Remove the outer piece (2) and discard it.

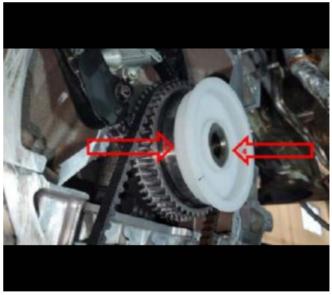
5786655

The picture below is shown without the cover for clarity.
