# Service Bulletin

Bulletin No.: 22-NA-023

Date: February, 2022

**Subject: Instrument Cluster Driver Information Center (DIC) Displays Programming in Progress Message and Progress Bar**

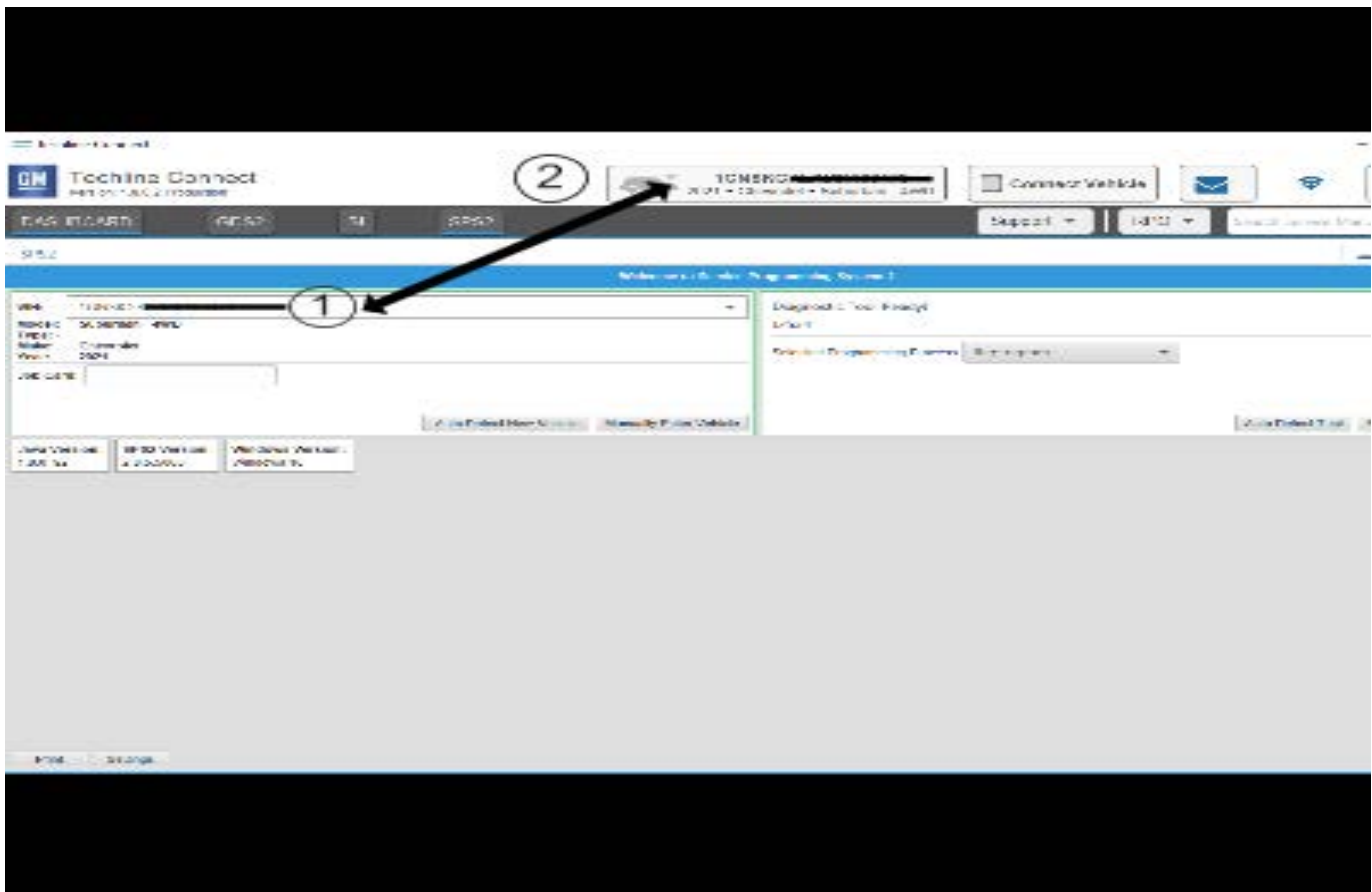
**Caution:** Be sure the VIN selected in the drop down menu (1) is the same as the vehicle connected (2) before beginning programming.
