## **Service Bulletin**

Bulletin No.: 22-NA-025

Subject: Belt Chirp Noise and-or Harmonic Balancer Rubbing on Timing Cover

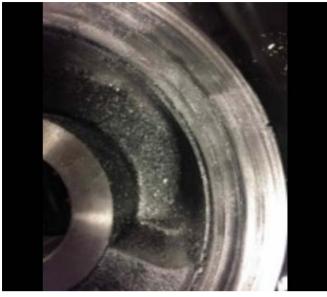
5621077

- Harmonic balancer damage due to contact.

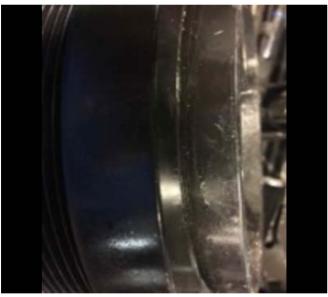
5621078

Separation of the harmonic balancer's inner and outer rings.

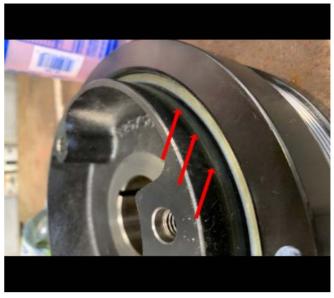
5627017

The new damper has a hub that is longer than the inertia ring. Movement can be identified by inspecting the hub directly at the elastomer. Look for a witness mark of where the elastomer was originally positioned.

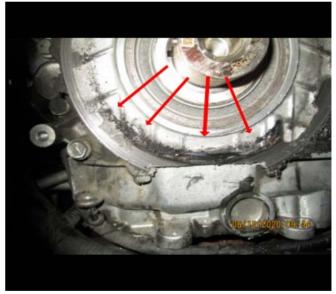
5621076

- Damage to the timing cover and upper oil pan.

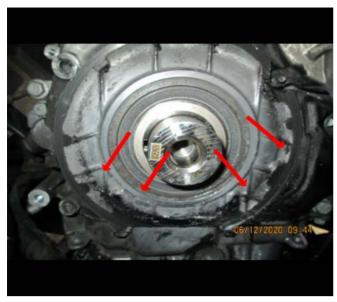
5621075

- Damage to the timing cover and upper oil pan.
