Service Bulletin

Bulletin No.: 22-NA-026

Subject: Information on Brake Pulsation, Noise and/or Visible Pitting Condition to Brake Rotor Surface

Brand:	Model:	Model Year:		VIN:		Engine:	Transmission:
		from	to	from	to		
Chevrolet	Corvette	2020	2022	—	—	All	All

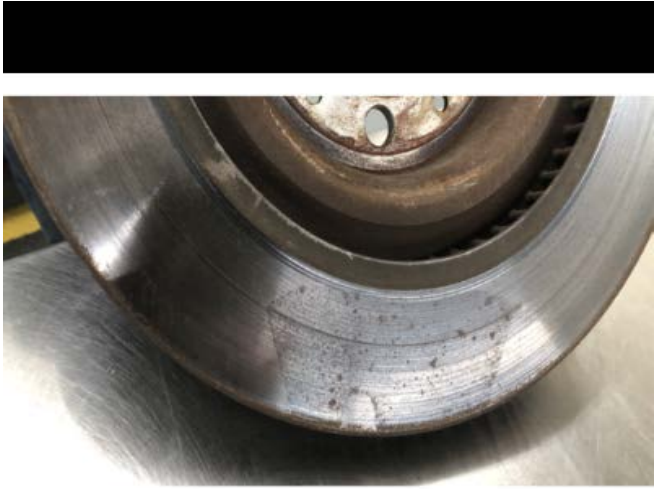
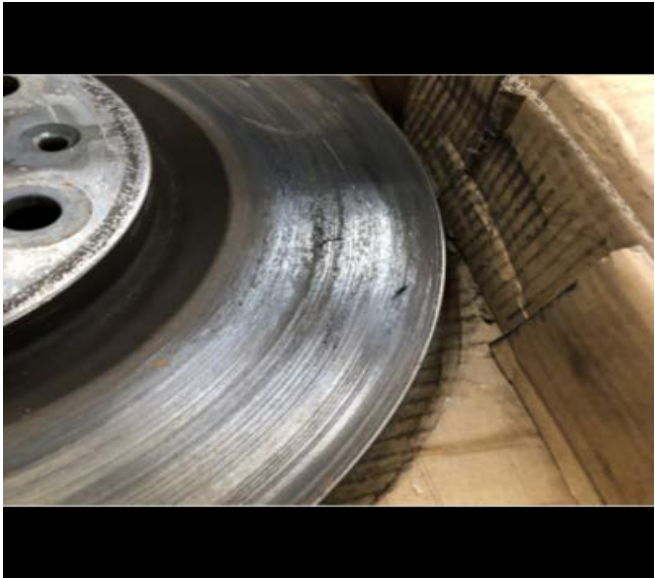
<p>5969661</p> <p>5969664</p> <p>The cause of this condition may be corrosion pad spotting and surface grooving on the brake rotor surface.</p>
<p>Correction</p>	<p>To help restore optimal braking performance and reduce noise, complete the Procedure noted below.</p>

1. The customer or technician should use the Instrument Cluster's DIC performance menu's friction bubble that calls out longitudinal G forces to determine braking forces. Use the Friction Bubble in the DIC display to determine the correct deceleration rates. Apply the brakes 10 times starting at 100 km/h (60 mph) to 50 km/h (30 mph) while decelerating at 0.4g. This a medium brake application. Drive for at least 0.5 km (0.3 mi) between applying the brakes.
2. If further cleanup of the brake discs is needed, repeat this procedure with 0.7g applications.
