# Service Bulletin

Bulletin No.: 22-NA-027

**Subject: LM2 Diesel With Possible Oil Consumption - DTC P06DD Set**

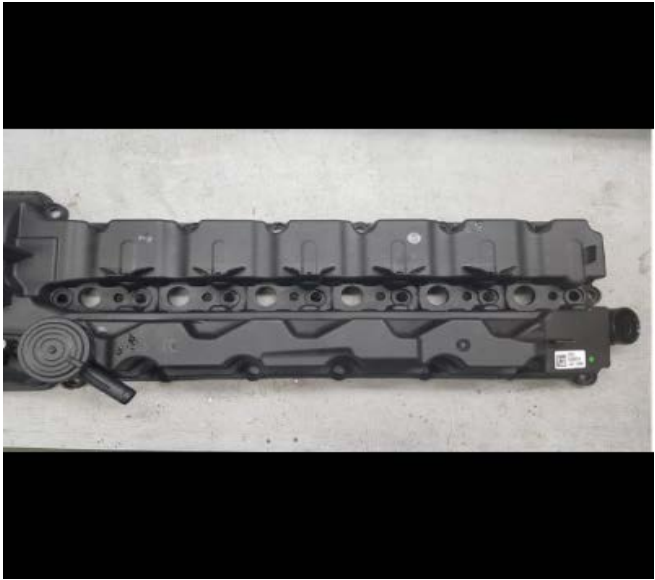
<p><b>Correction</b></p>	<div style="text-align: right; margin-bottom: 10px;">5671019</div>

<b>Involved Region or Country</b>	North America, Russia, Middle East, Chile (West), Colombia (West), Ecuador (West), Paraguay (West), Peru (West), Japan, Cadillac Korea (South Korea), Thailand (ASEAN), Australia/New Zealand
<b>Condition</b>	Some customers may comment on oil consumption. Some technician may find DTC P06DD set.
<b>Cause</b>	Camshaft housing (cover) may have a baffle plate weld that is not adequate.

<ul style="list-style-type: none"> <li>• If the serial number is greater than 21298JDXXX, this bulletin does not apply. Refer to bulletin 21-NA-272 and SI for appropriate diagnostics.</li> <li>• If the serial number is less than 21298JDXXX and the customer's concern is oil consumption:             <ol style="list-style-type: none"> <li>1. 1) Replace the camshaft housing cover.</li> <li>2. 2) Replace the #2 glow plug.</li> </ol> </li> </ul> <p>Re-evaluate the oil consumption.</p>
--------------------------	--
