Service Bulletin

Bulletin No.: 22-NA-028

Subject: Whining/Whirring, Whistle, Squeaking, Groaning/Growling Noise Coming from Front

Wheel/Engine Area

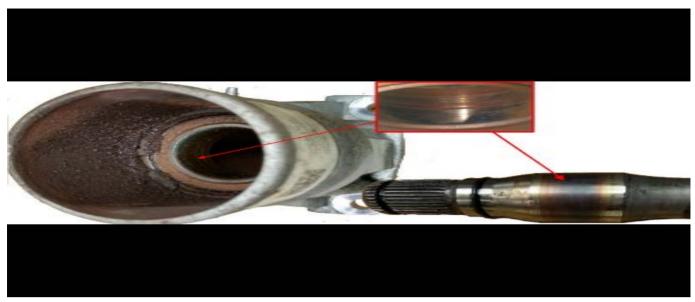
5875997

Note: Fretting worn IDS shaft and bracket must discarded and replaced with new parts.
