F95 (X5 M Sports Activity Vehicle)	F96 (X6 M Sports Activity Coupe)	F97 (X3 M Sports Activity Vehicle)	F98 (X4 M Sports Activity Coupe)
G01 (X3 Sports Activity Vehicle)	G02 (X4 Sports Activity Coupe)	G05 (X5 Sports Activity Vehicle)	G06 (X6 Sports Activity Coupe)
G07 (X7 Sports Activity Vehicle)

SITUATION

During inspection and/or diagnosis there is noticeable dirt/grease buildup on the axles near the inner and/or outer CV boots.

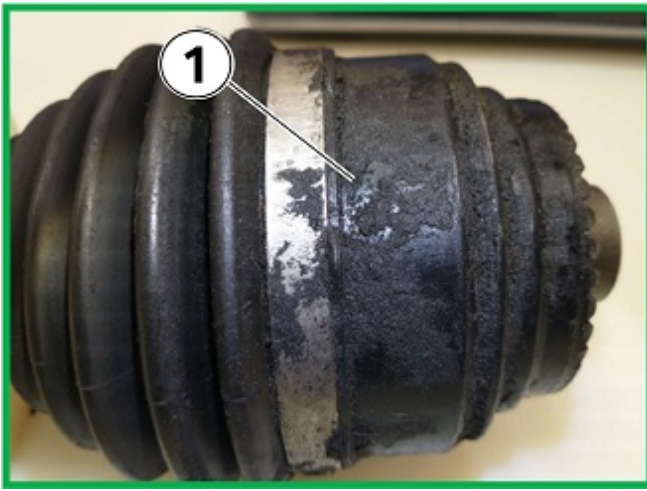
Example of dirt/contamination from outside influence (1).

A. The following are examples of good axles/boots. Do not replace.

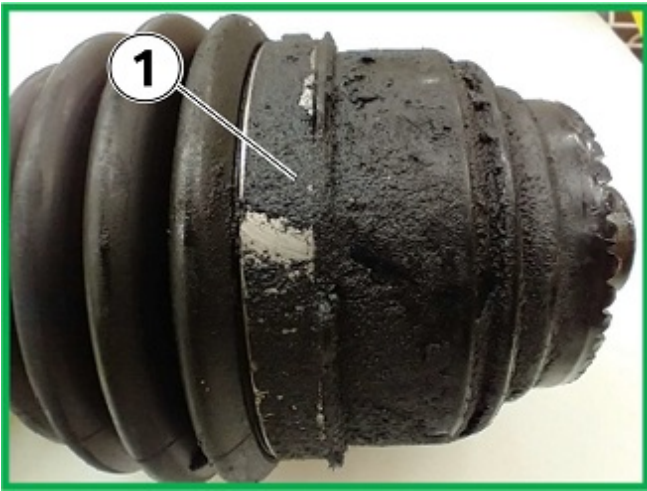
Example of dirt/contamination from outside influence (1).

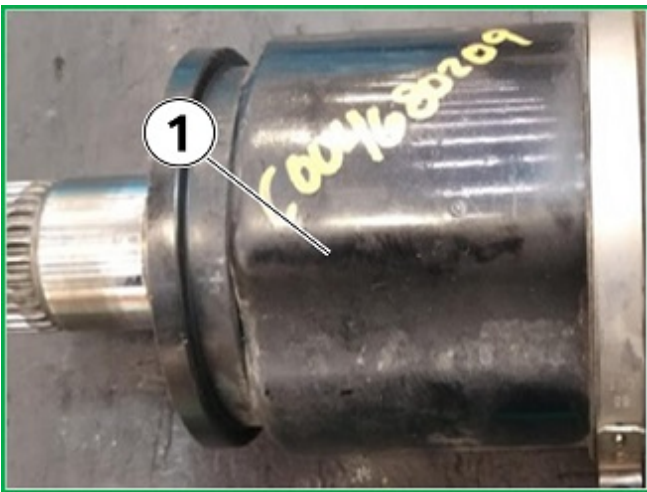
Example of dirt/contamination from outside influence (1).

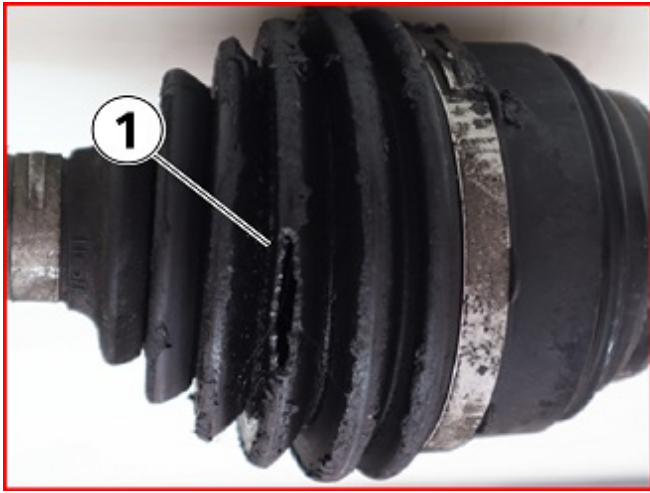
Tear in the boot (1).

B. The following are examples of torn and/or leaking CV boots that require the necessary corresponding repair to be performed (CV boot/bellows repair kit installation or axle/output shaft replacement)

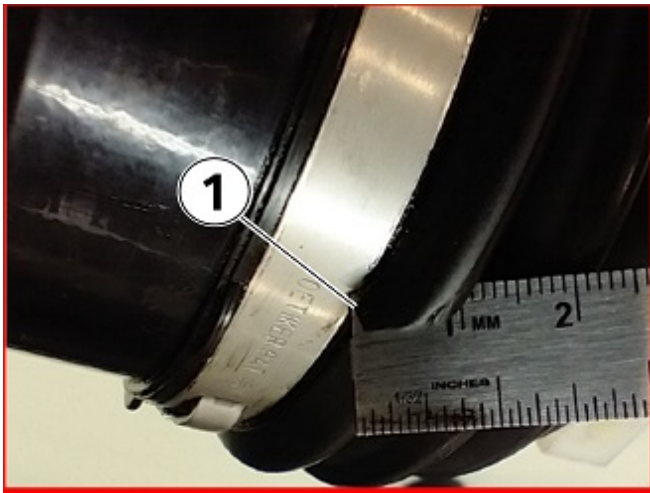
Tear or cut in the boot (1).

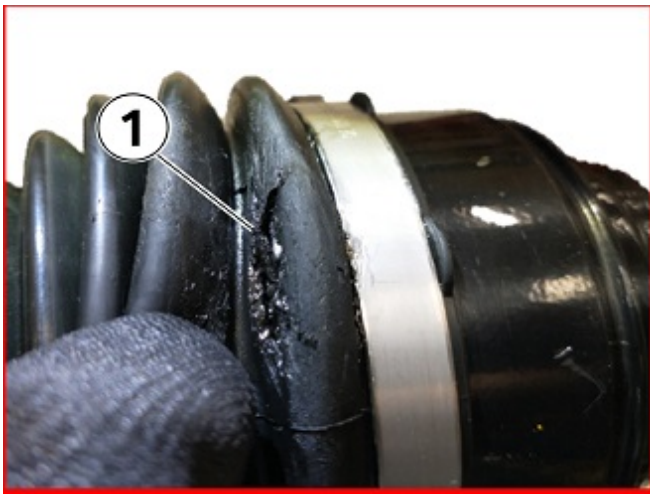
Tear or cut in the boot (1).

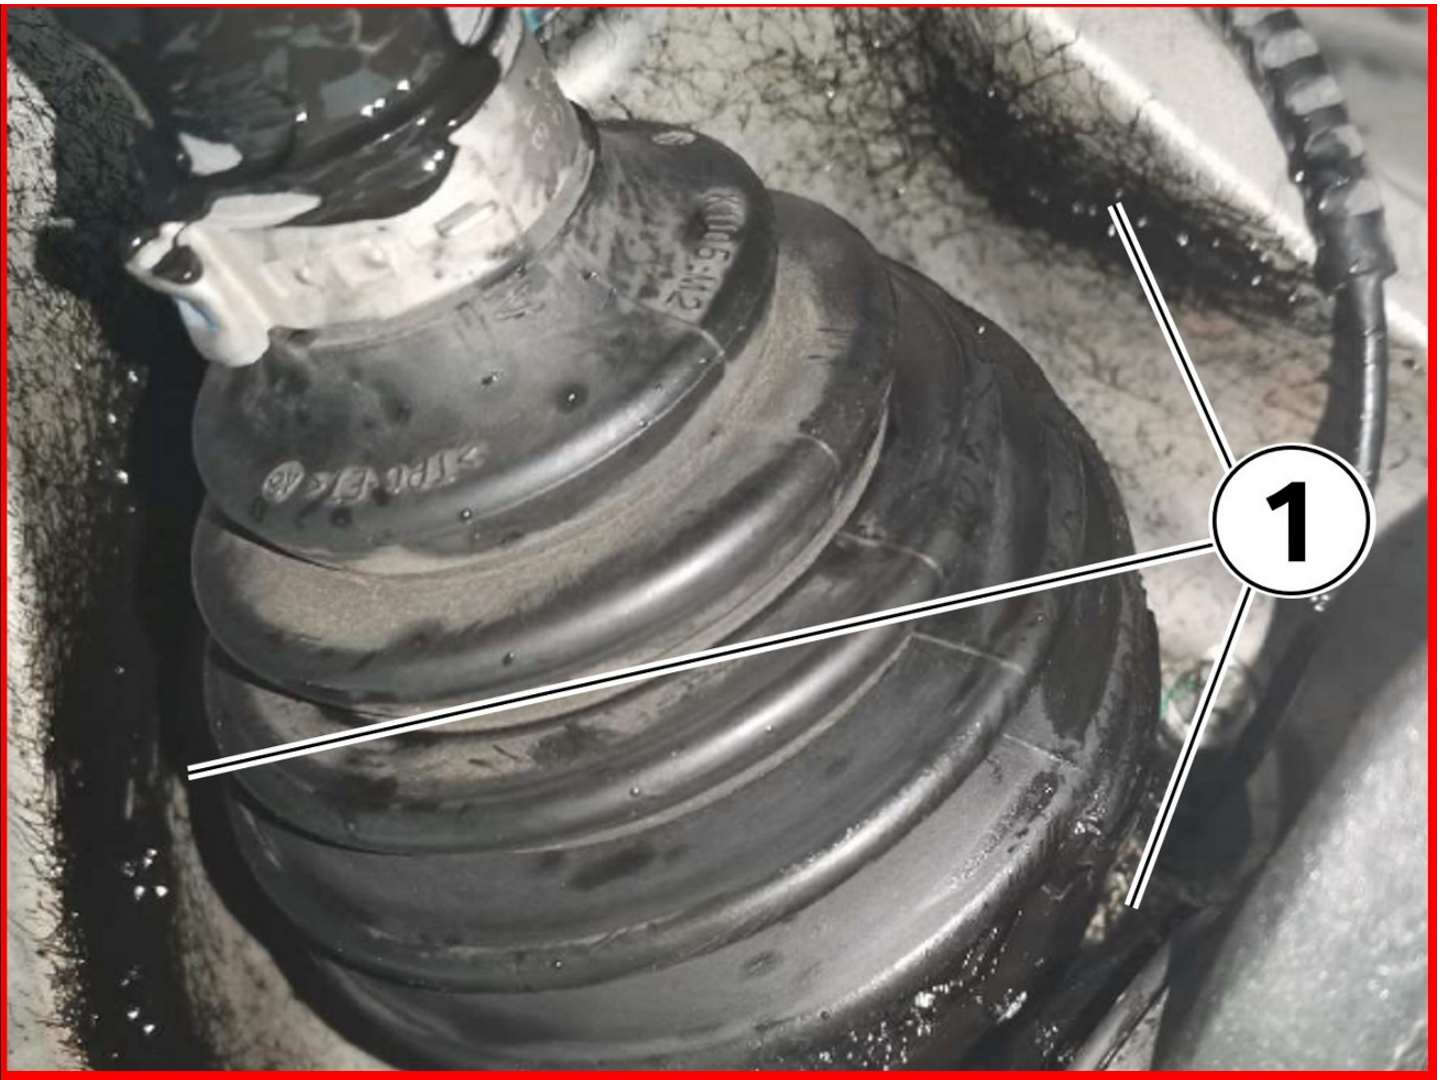
The below example is a boot that is dispersing grease around the outer carrier (1).
