E-Series	Model Description	Production Date
F97	X3 M Sports Activity Vehicle	Up to February 1, 2022 production
F98	X4 M Sports Activity Coupe

A groaning noise can be heard when accelerating and cornering from the area of the shoulder safety belt support(s)- Refer to sound file attachment.

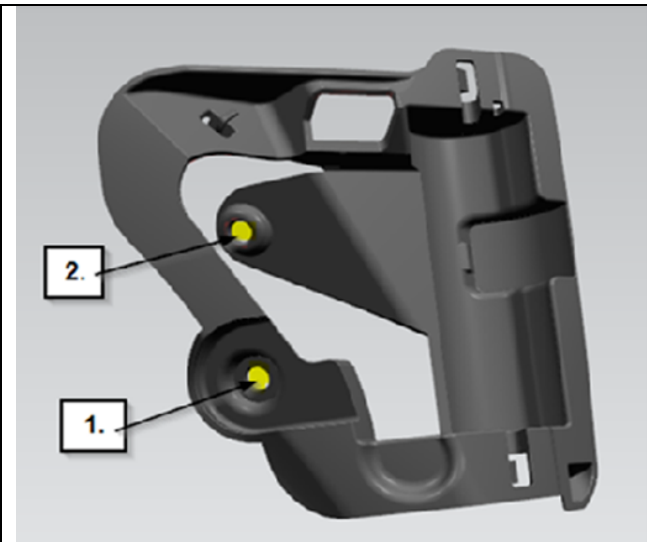
Process fault during the riveting of the shoulder supports.

Drill out the rivet connection (1 and 2) of the affected backrest cushion support(s).

Hole diameter 5 mm.
