FRONT ROLLER SUNSHADE LOOSE

This Service Information Bulletin (Revision 2) replaces SI 51 13 19 **dated August 2020**.

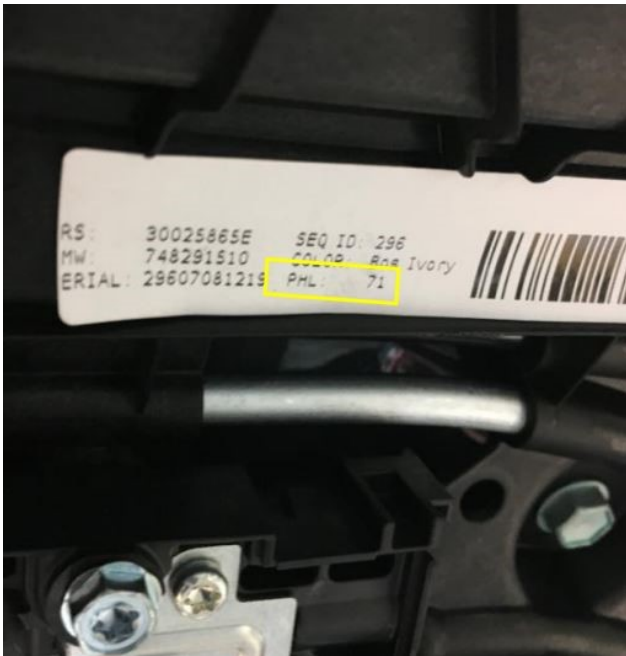
1. Completely open the roller sunshade.
2. Remove the FZD (Roof function center), following repair instructions REP 61 31 544 "Replace roof function center (FZD)".
3. With the FZD removed, inspect the "PHL" number on the ID sticker of the sunroof frame in the area shown.

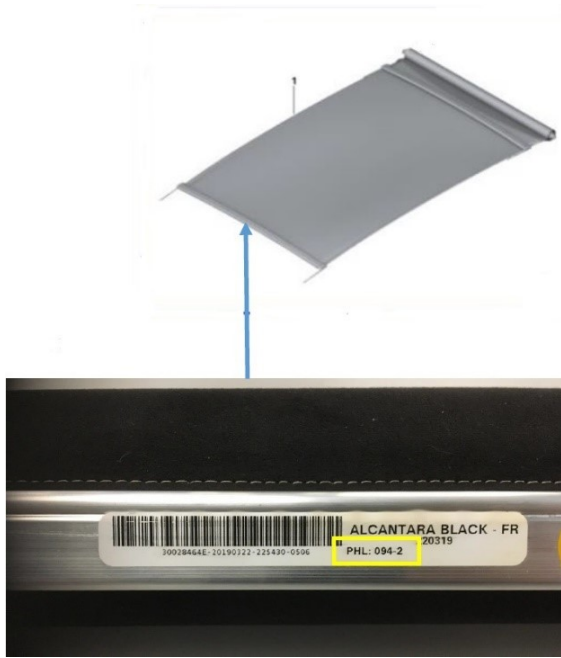
Before installing a replacement sunshade, ensure that the “PHL” number printed on the ID sticker for the sunshade is 095-2 or higher.

Note: Reference photo for location of ID sticker. Unrolling the sunshade is not required to perform the inspection.

Do not install a sunshade that is below PHL 095-2.
