**SIB 65 01 22**

Knee Air Bag Check Control Message G01 Variants

This Service Information Bulletin (Revision 2) replaces SI B65 01 22 **dated April 2022**.

Audio, Navigation, Information, Safety Systems

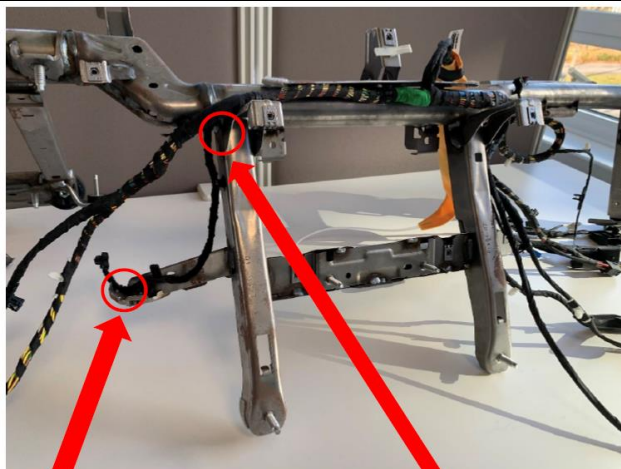
The wiring harness going to the knee air bag(s) may be rubbing against the support tube of the instrument panel.

Drivers side locations 1 and 2.

If metal residue or welding residue are visible on the support tube, they must be removed.

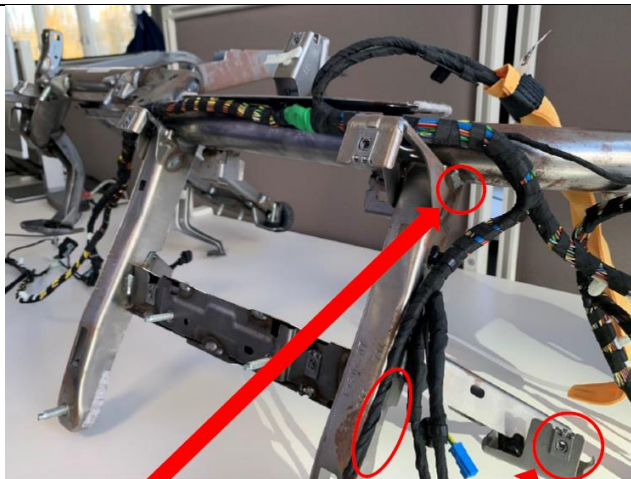
Overall view of passenger side locations 3, 4, 5.

If metal residue or welding residue are visible on
the support tube, they must be removed.
