Under Floor Wire Harness for Motor Generator - Connector Cover has Missing or Damaged Appearance

Highlander HV/RAV4 HV/RAV4 Prime/Venza

2021-2022	Venza HV	2021-2022	Highlander HV
2021-2022	RAV4 Prime	2021-2022	RAV4 HV

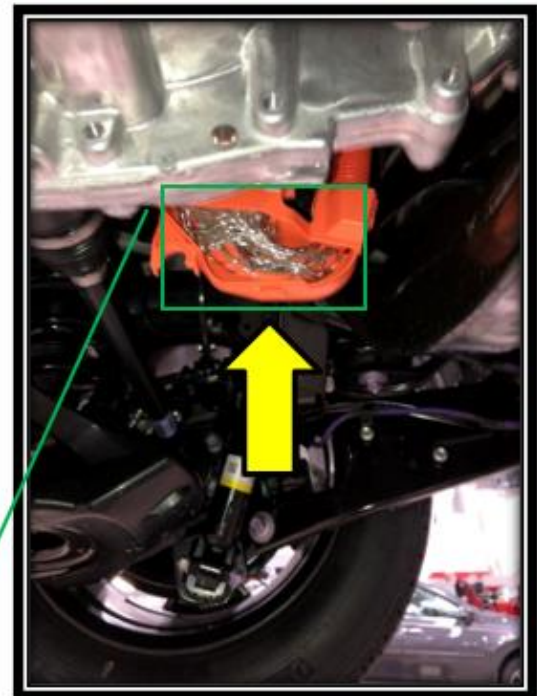
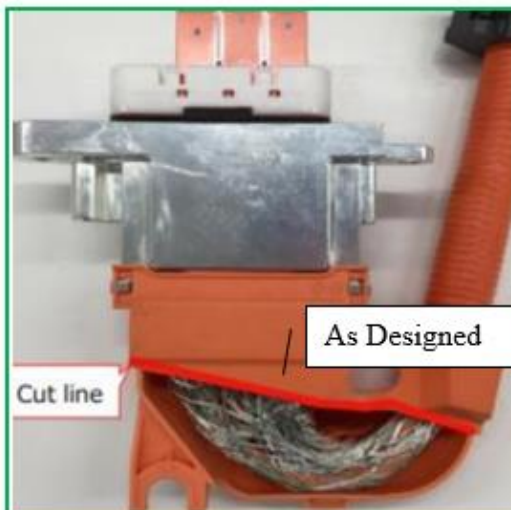
On some 2021-2022MY Highlander HV, RAV4 HV, RAV4 Prime and Venza models, the connector cover for the Under Floor Wire Harness for the Rear Motor Generator may have the appearance of being damaged or missing. Please review the image below to see the connector cover condition.

This appearance is normal and is part of the connector cover design. No repairs are needed.
