Abnormal Noise From the AWD Dynamic Torque Vectoring Disconnect System

Service Category Drivetrain

Section Axle/Differential

YEAR(S)	MODEL(S)	ADDITIONAL INFORMATION
2019 - 2020	RAV4	VDS(s): J1RFV, N1RFV

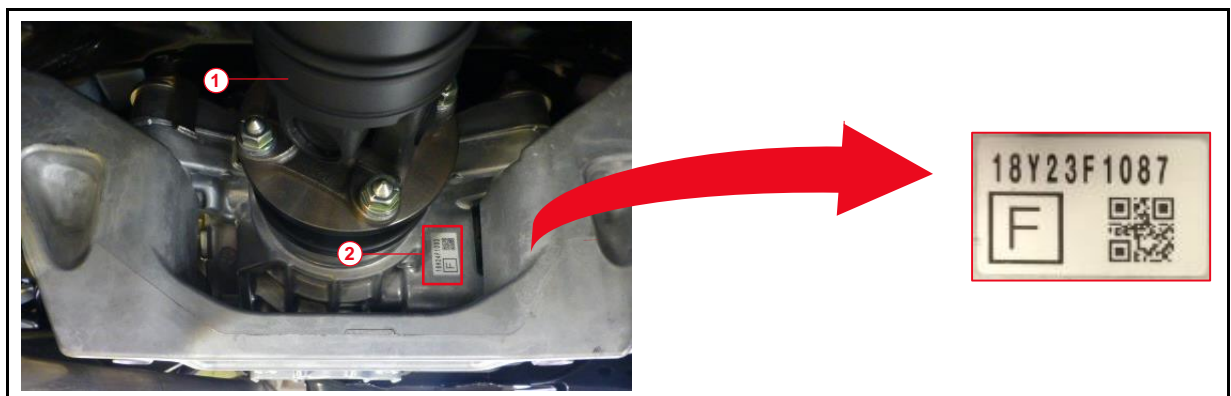
Figure 1. Rear Differential Carrier Assembly Differential Front View

1	Propeller Shaft
2	Rear Differential Carrier Assembly Serial Number

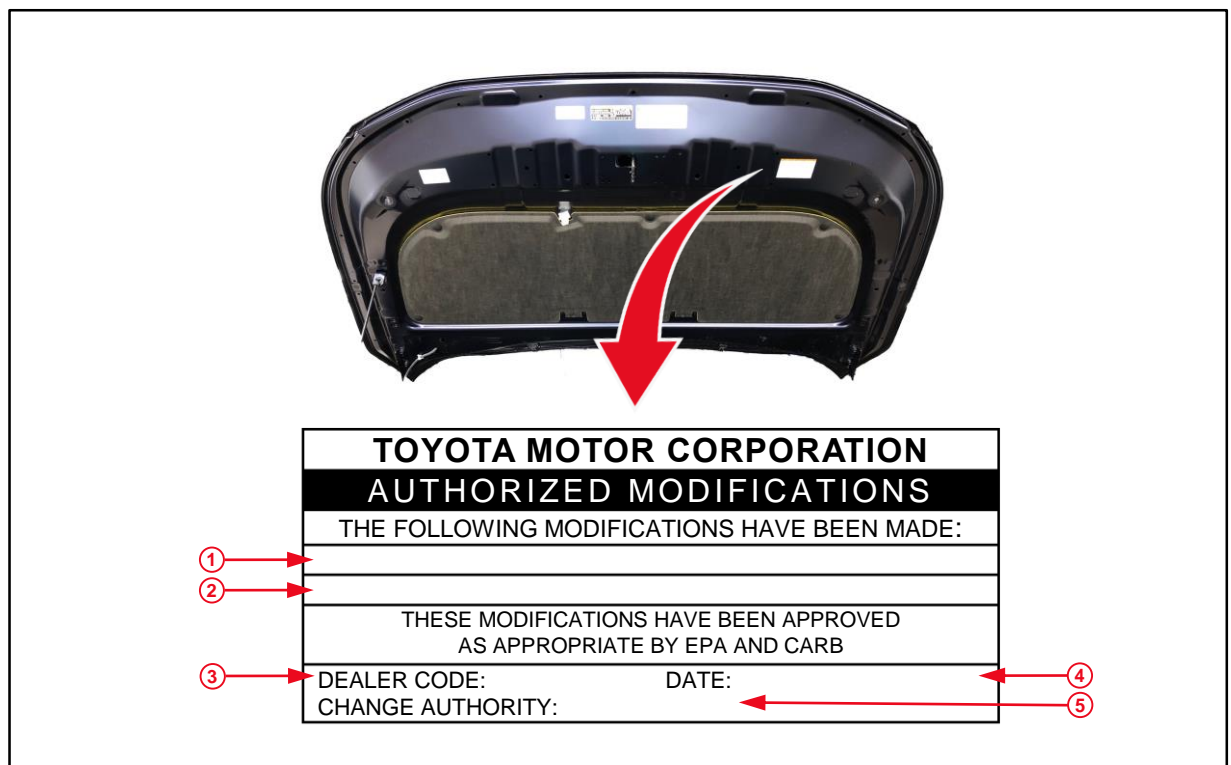
Figure 4. Location of Authorized Modifications Label on 2019 – 2020 RAV4

1	Replacement ECM (PCM) Part Number (e.g., 89630-42161)
2	New Calibration ID (e.g., F15364212000)
3	Dealer Code

4	Date Completed
5	This SB Number

1. Use Techstream to confirm if the 4WD ECU calibration has been updated and check for the Authorized Modifications Label affixed to the vehicle in the location shown below.
Is the calibration ID listed in Techstream and on the label the latest 4WD ECU calibration?
 - **YES** — Go to step 4.
 - **NO** — Continue to step 2.
