TECHNICAL INSTRUCTIONS

SPECIAL SERVICE CAMPAIGN 22TC04

SOFTWARE UPDATE FOR EV CONTROL COMPUTER

CERTAIN 2021 MODEL YEAR MIRAI VEHICLES

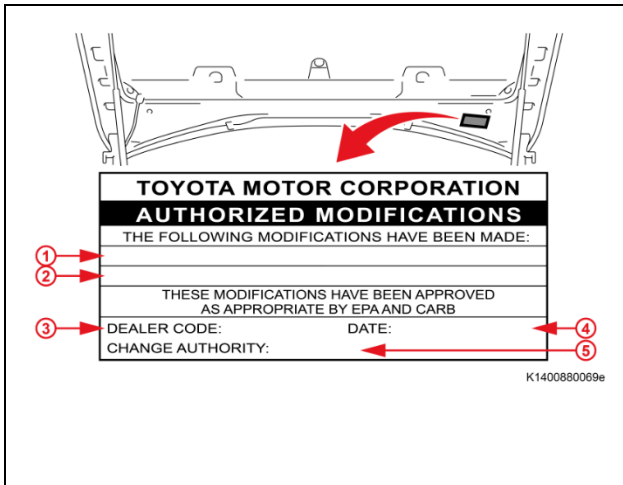
The authorized modification label only needs to have the EV Control ECU Information.

1	Repair ECU P/N*
	#####-#####
	#####-#####
	#####-#####
Part # varies by/depends on the vehicle model and specifications.	
2	New EV Control ECU Calibration ID
3	Dealer Code
4	Date Completed
5	Campaign Code (xxx)

- A. Fill out the label.
- B. Affix the label to the under-side of the hood.
